OUTFALL SUMMARY REPORT

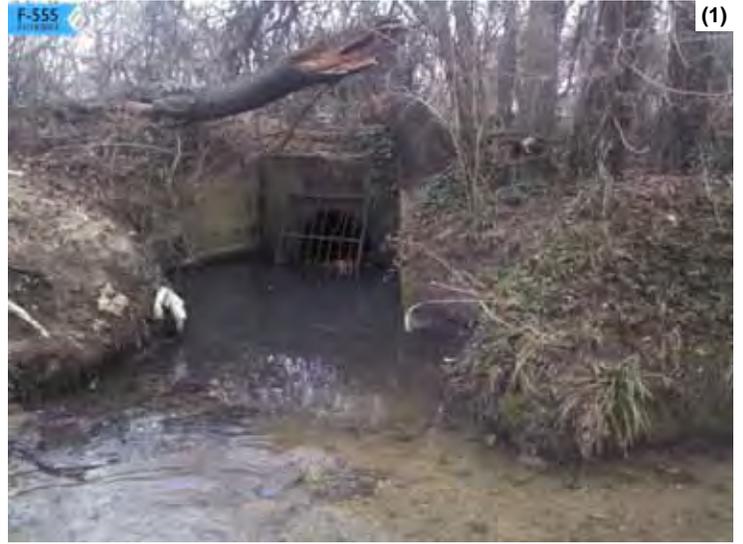
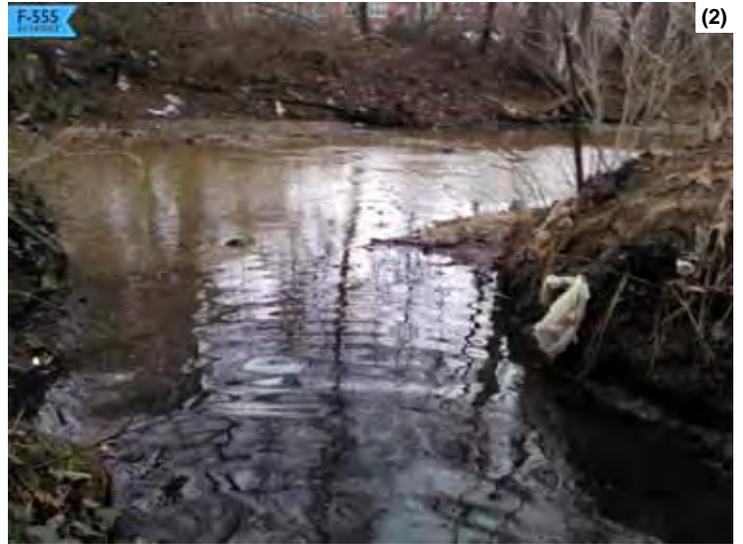
Stream Bank / Pool	<input type="text" value="1"/>	<input type="text" value="Some Erosion"/>	Repairs Recommended? NO
Stream Bank / Pool (x2)	<input type="text" value="2"/>		
Structure	<input type="text" value="0"/>	<input type="text" value="Excellent / Like New"/>	
Criticality	<input type="text" value="0"/>	<input type="text" value="Normal"/>	
Total Score	<input type="text" value="2"/>	<small>Total = Stream Bank / Pool x2 + Structure + Criticality</small>

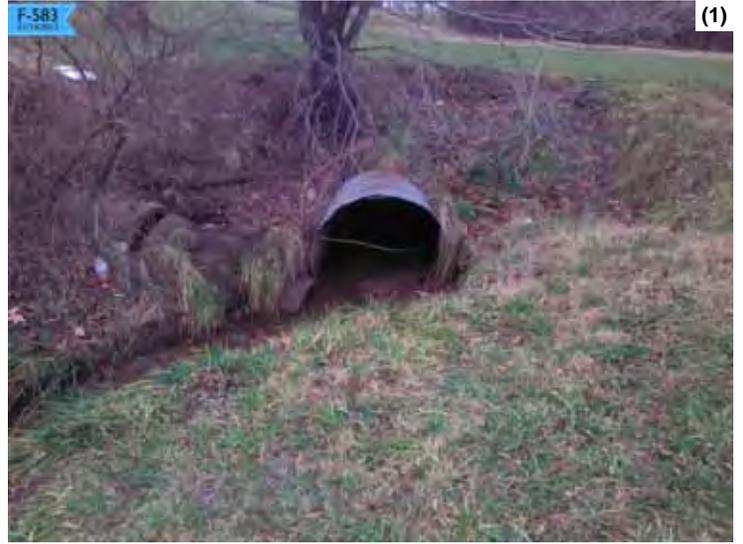
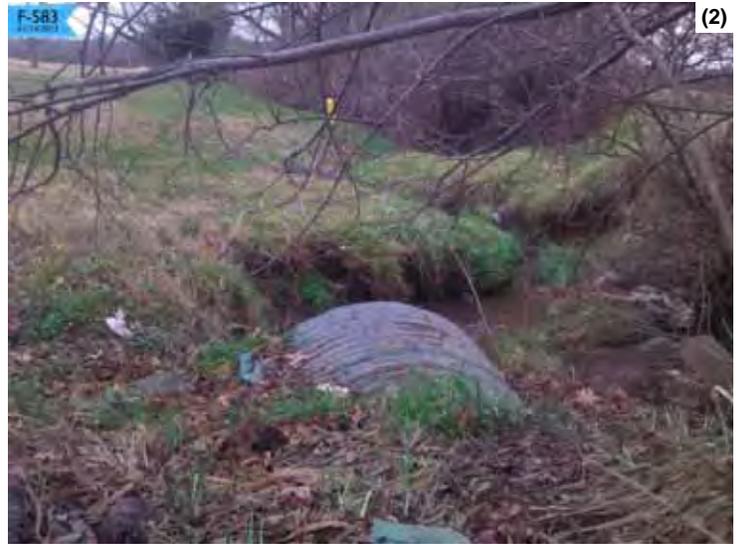
Stream Bank / Pool	<input type="text" value="1"/>	<input type="text" value="Some Erosion"/>	Repairs Recommended? NO
Stream Bank / Pool (x2)	<input type="text" value="2"/>		
Structure	<input type="text" value="1"/>	<input type="text" value="Moderate"/>	
Criticality	<input type="text" value="0"/>	<input type="text" value="Normal"/>	
Total Score	<input type="text" value="3"/>	<small>Total = Stream Bank / Pool x2 + Structure + Criticality</small>

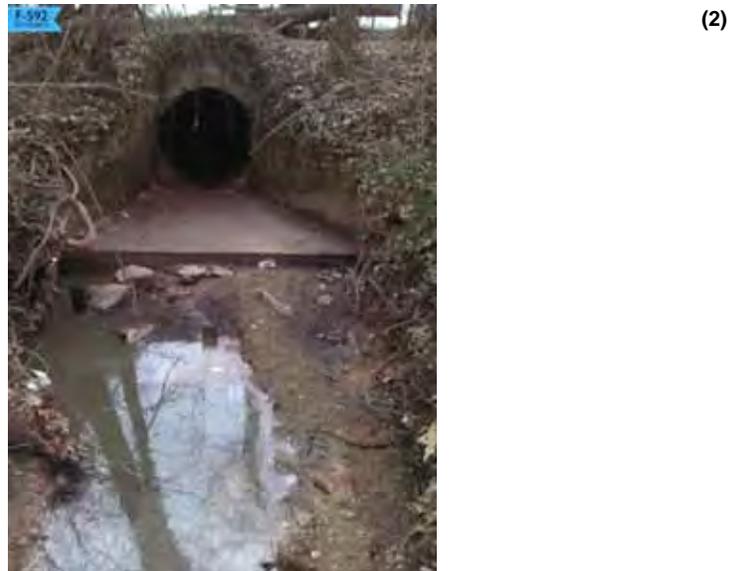
Stream Bank / Pool	<input type="text" value="1"/>	<input type="text" value="Some Erosion"/>	Repairs Recommended? NO
Stream Bank / Pool (x2)	<input type="text" value="2"/>		
Structure	<input type="text" value="0"/>	<input type="text" value="Excellent / Like New"/>	
Criticality	<input type="text" value="0"/>	<input type="text" value="Normal"/>	
Total Score	<input type="text" value="2"/>	<small>Total = Stream Bank / Pool x2 + Structure + Criticality</small>

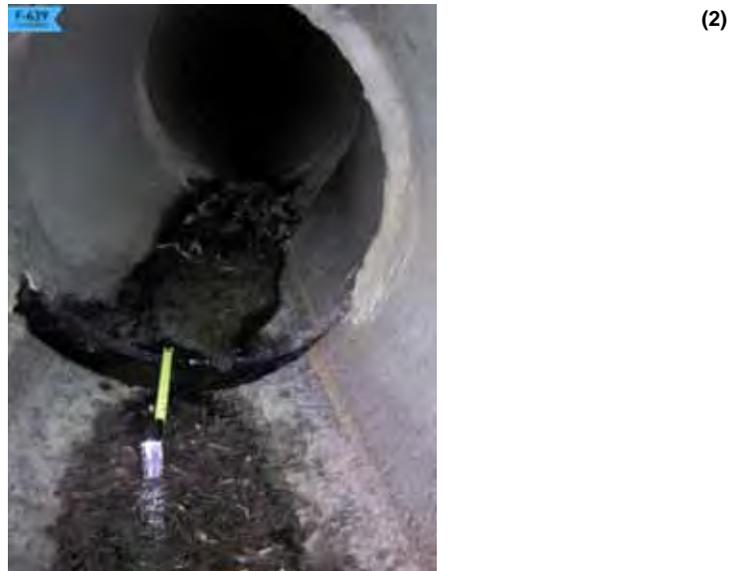
Stream Bank / Pool	<input type="text" value="2"/>	<input type="text" value="Active Erosion"/>	Repairs Recommended? YES
Stream Bank / Pool (x2)	<input type="text" value="4"/>		
Structure	<input type="text" value="1"/>	<input type="text" value="Moderate"/>	
Criticality	<input type="text" value="0"/>	<input type="text" value="Normal"/>	
Total Score	<input type="text" value="5"/>	<small>Total = Stream Bank / Pool x2 + Structure + Criticality</small>

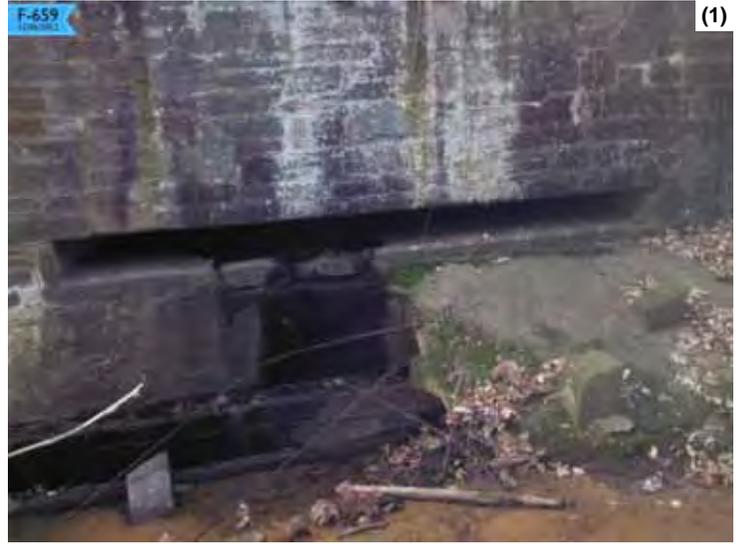
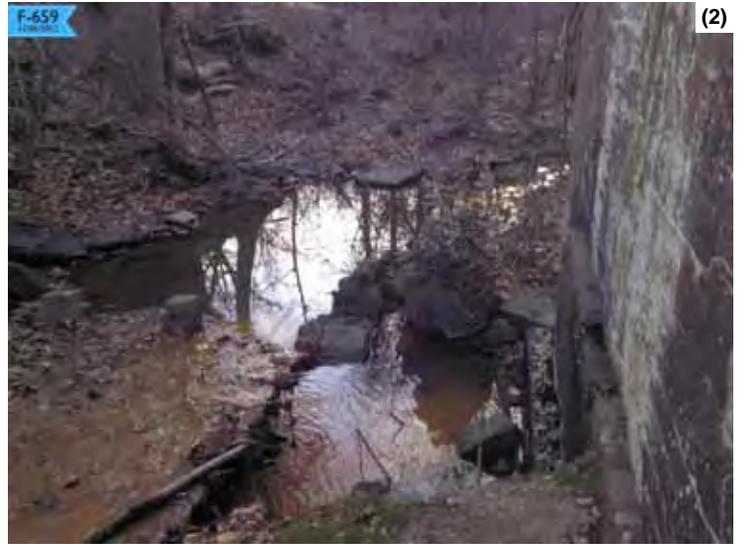
Stream Bank / Pool	<input type="text" value="2"/>	<input type="text" value="Active Erosion"/>	Repairs Recommended? YES
Stream Bank / Pool (x2)	<input type="text" value="4"/>		
Structure	<input type="text" value="1"/>	<input type="text" value="Moderate"/>	
Criticality	<input type="text" value="0"/>	<input type="text" value="Normal"/>	
Total Score	<input type="text" value="5"/>	<small>Total = Stream Bank / Pool x2 + Structure + Criticality</small>

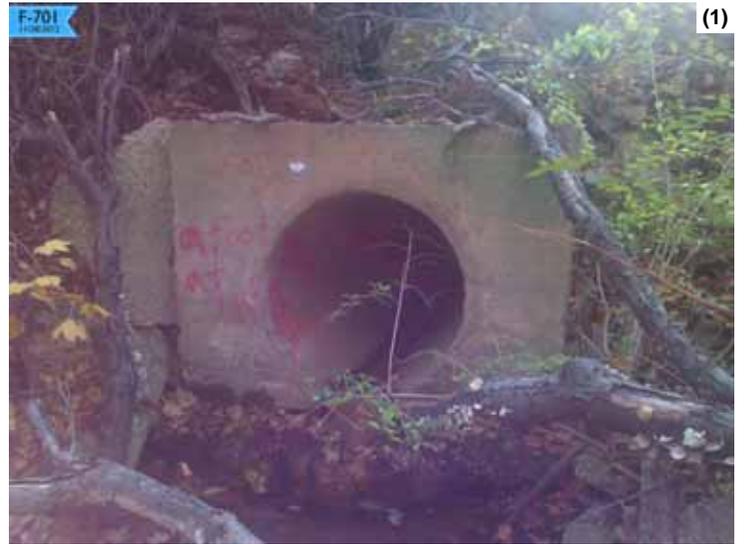
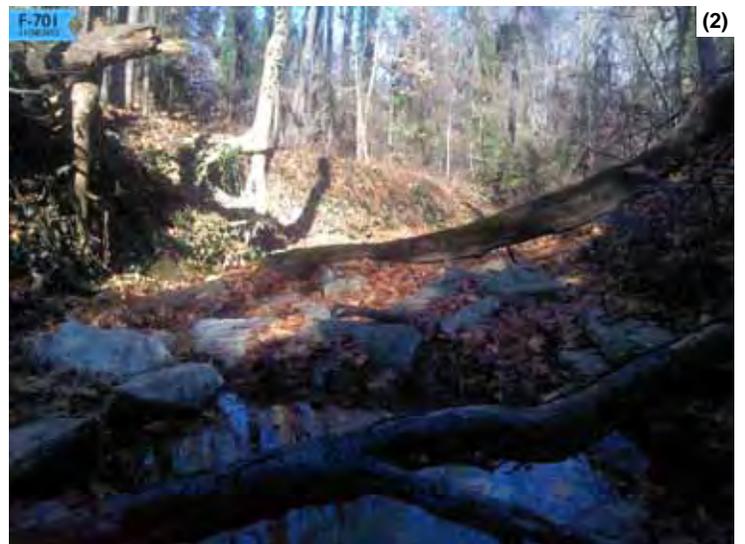
Stream Bank / Pool	<input type="text" value="2"/>	<input type="text" value="Active Erosion"/>	Repairs Recommended? YES
Stream Bank / Pool (x2)	<input type="text" value="4"/>		
Structure	<input type="text" value="1"/>	<input type="text" value="Moderate"/>	
Criticality	<input type="text" value="0"/>	<input type="text" value="Normal"/>	
Total Score	<input type="text" value="5"/>	<small>Total = Stream Bank / Pool x2 + Structure + Criticality</small>
