# DISTRICT DEPARTMENT OF THE ENVIRONMENT

## Underground Storage Tank Branch Leaking Underground Storage Tank (LUST) Contaminated Sites LUST Cleanup Success Story

Site Name: 1410 H Street  
Site Address: 1410 H Street NE, Washington DC 20019  
Ward #: 6  
Square / Lot No: 1049N / 0802  
Size: 2,215 SFLUST ID #: 2013002  
Facility ID: 6004018  
Property Owner: UOH H Street LLC  
Remediating Party: UOH H Street LLC

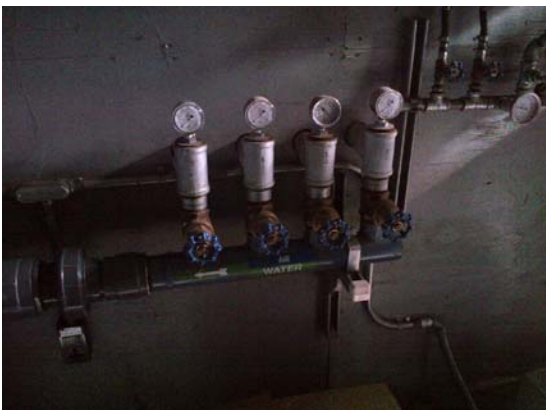
REMEDIATION SYSTEM – VAPOR EXTRACTION MANIFOLD

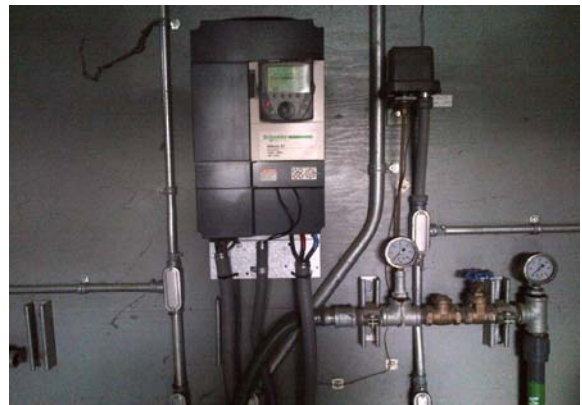
REMEDIATION SYSTEM – CONTROL UNIT

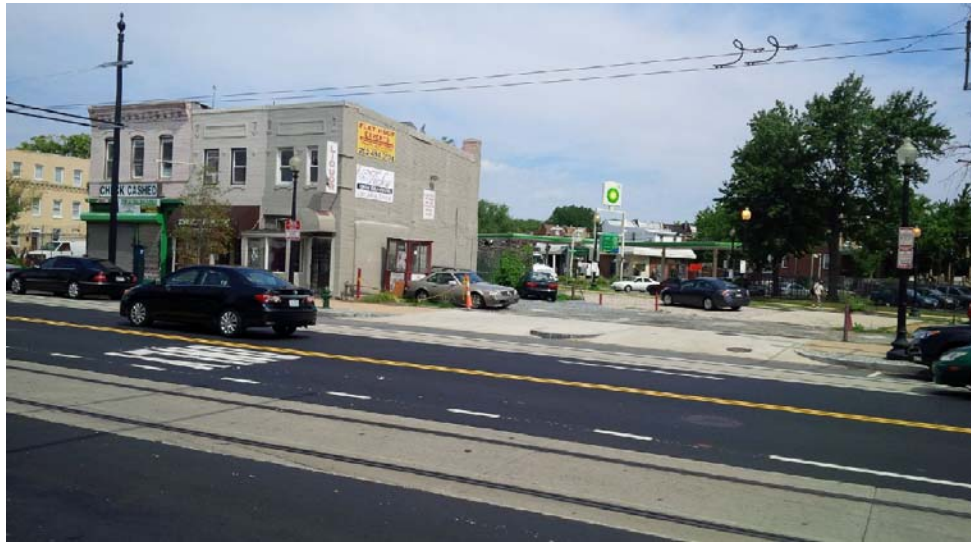
RECENT SITE PHOTOGRAPH- SITE INCLUDES PARKING AREA AND BUILDINGS
