Anacostia River Watershed Restoration Plan

Pope Branch Subwatershed Provisional Restoration Project Inventory

August 2009

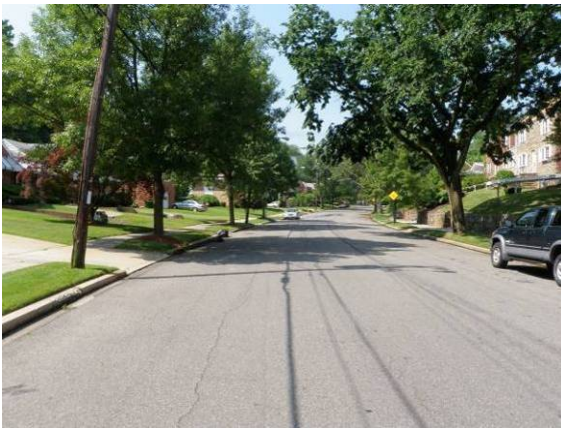
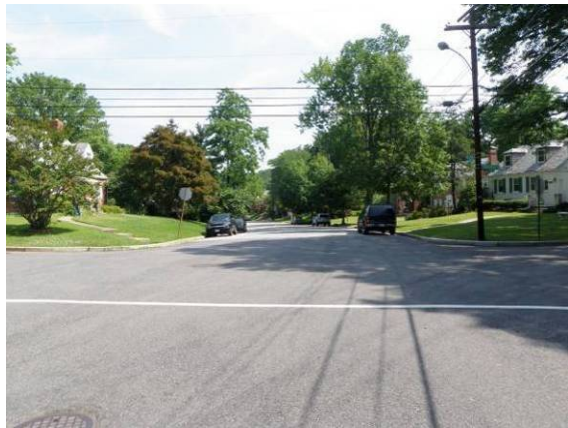
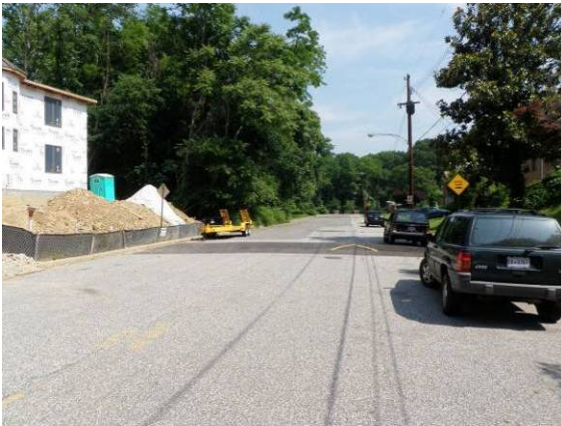
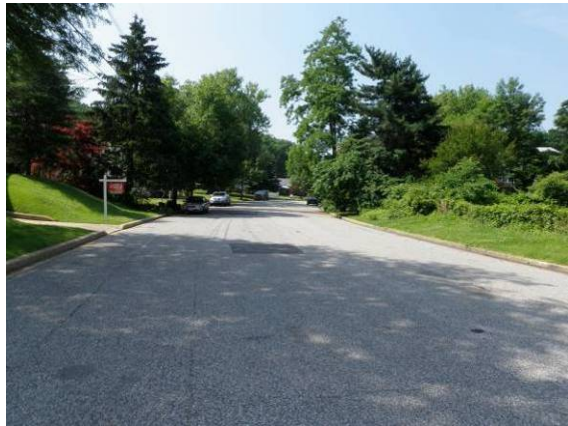
Figure 8a – Candidate Stormwater Retrofit Project

Site Location:	Texas Avenue SE between Pope Branch and S Street SE, Washington, DC	
Project No.:	PO-U-01-S-1	
ADC Map Book Location:	18 B 6	Map ID: 27
Approximate Associated Drainage Area (acres):	11.5	
Approximate Imperviousness:	80%	9.2 acres
Description of Existing Conditions:	Texas Avenue SE is a two-lane residential street with parking on either side. South of Carpenter Street SE there is a sidewalk and grassy berm. North of Carpenter Street SE there is no public sidewalk. The stormwater runoff from the street drains to the north through multiple curb inlet drains.	
Project Description:	LID Bioretention, LID Tree Box Filters – Construct a bioretention system at the dead end near Nash Street SE. Install tree box filters at the curb inlet drains.

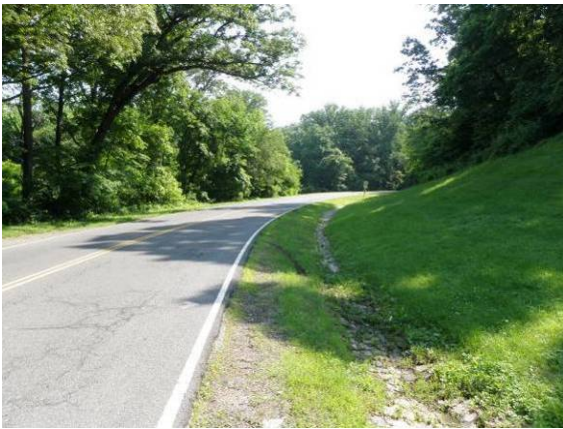
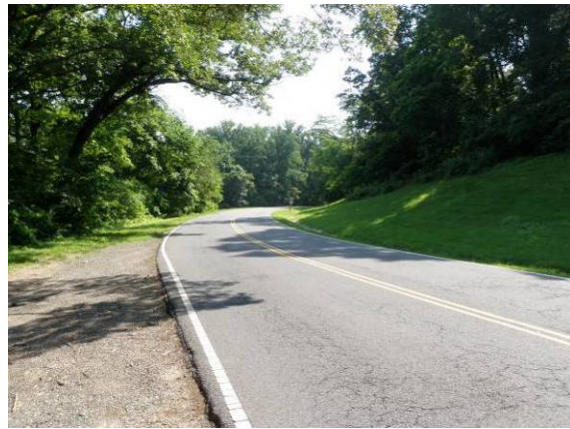
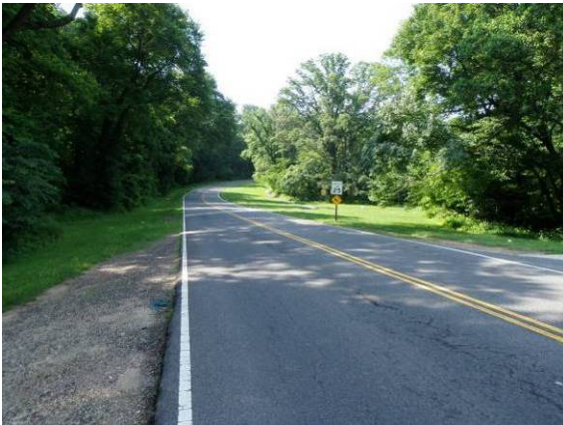
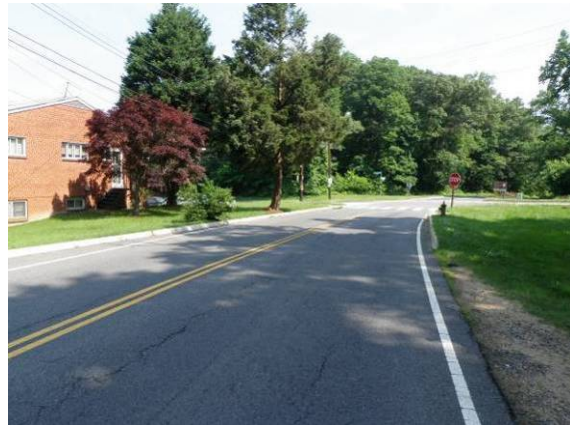
Figure 8b – Candidate Stormwater Retrofit Project

Site Location:	Fort Davis Drive SE between Massachusetts Avenue SE and Pennsylvania Avenue SE, Washington, DC	
Project No.:	PO-U-01-S-2	
ADC Map Book Location:	18 C 6	Map ID: 26
Approximate Associated Drainage Area (acres):	12.8	
Approximate Imperviousness:	80%	10.2 acres
Description of Existing Conditions:	The road is surrounded by forested area. Stormwater runoff drains north and south to curb inlet drains at the intersections. Some areas have constructed ditches, while others only have a grassy berm.	
Project Description:	LID Bioretention – Construct bioretention systems on either side of the road in the grassy areas.

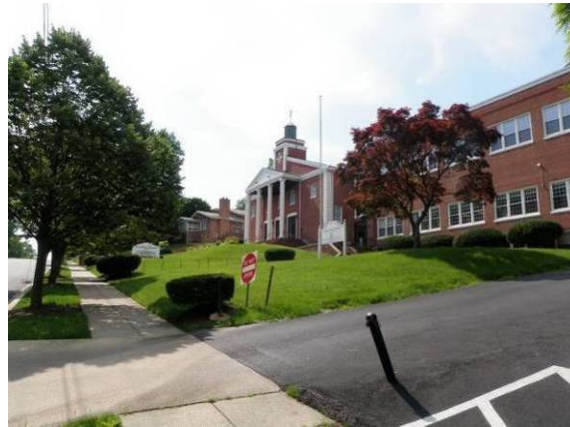
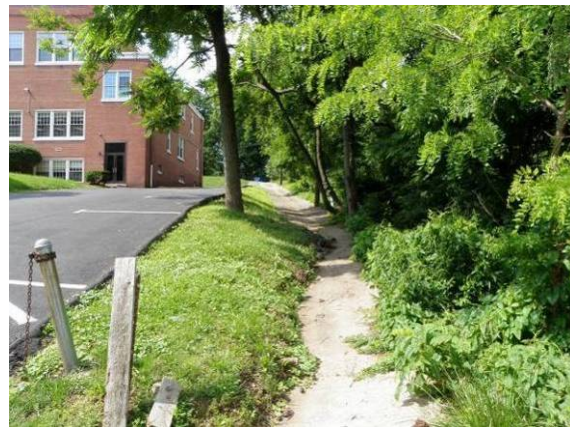
Figure 8e – Candidate Stormwater Retrofit Project

Site Location:	DuPont Park Seventh Day Adventist Church and DuPont Park School, 3985 Massachusetts Avenue SE, Washington, DC	
Project No.:	PO-U-01-S-5	
ADC Map Book Location:	18 C 6	Map ID: 21
Approximate Associated Drainage Area (acres):	0.4	
Approximate Imperviousness:	60%	0.2 acres
Description of Existing Conditions:	This site includes a two-story private school and church with a small parking area to the south. The downspouts are connected to the stormwater system. Stormwater runoff drains to Massachusetts Avenue SE by a concrete ditch located on the west side of the property.	
Project Description:	LID Bioswale, LID Rain Garden - Disconnect the downspouts from the stormwater system and install rain gardens at the downspouts. Replace the concrete ditch on the west side of the property with a bioswale.

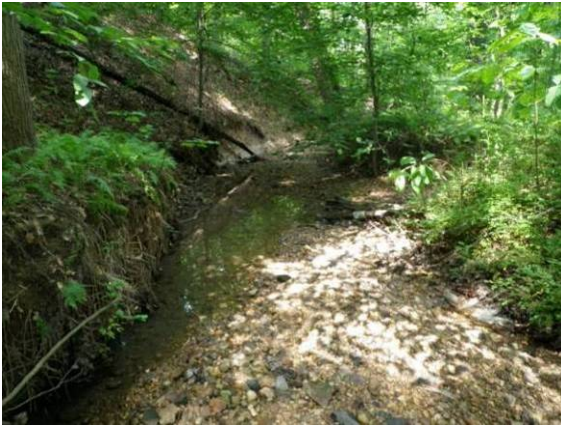
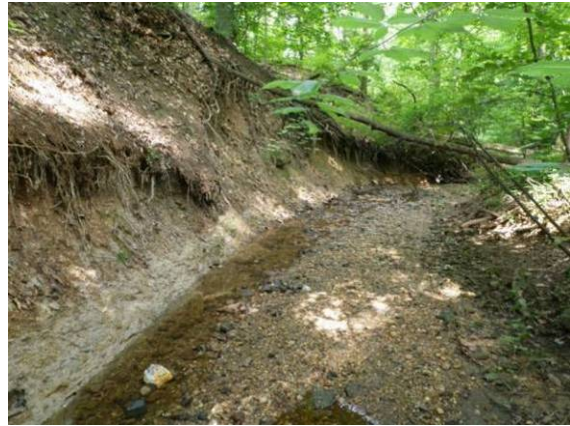
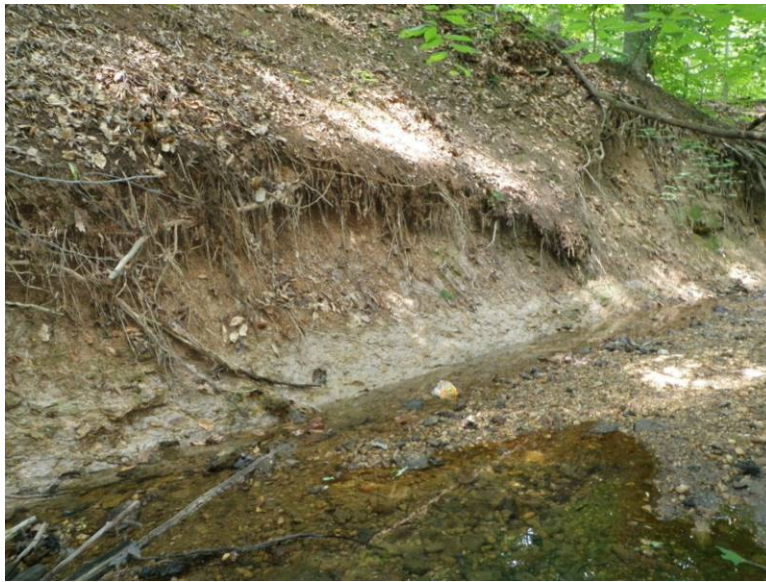
Figure 10a – Candidate Stream Restoration Project

Site Location:	Sewer line perpendicular to stream, downstream of O Street SE, Washington, DC	
Project No.:	PO-U-02-SR-1	
ADC Map Book Location:	18 D 6	Map ID: 19
Approximate Length (feet):	300	
Description of Existing Conditions:	This site consists of a perched, one-foot sewer pipe on concrete pillars located in an area of heavy stream erosion. The utility line lacks armor.	
Project Description:	Stream Channel Morphology Restoration - Armor the utility line as a part of the stream restoration.

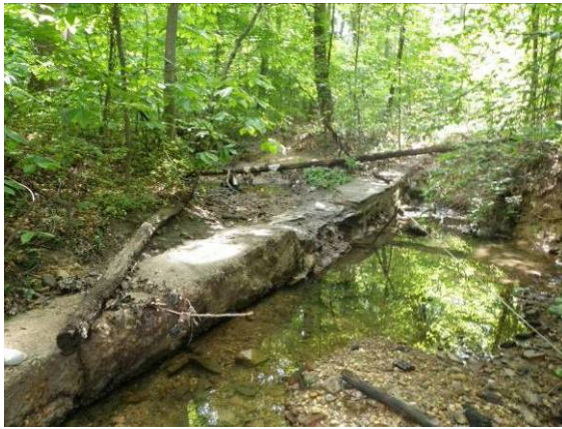
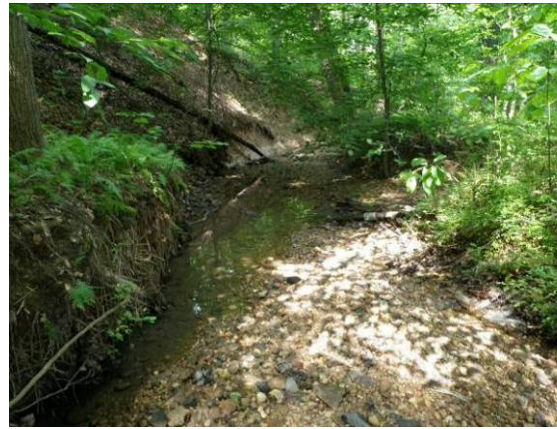
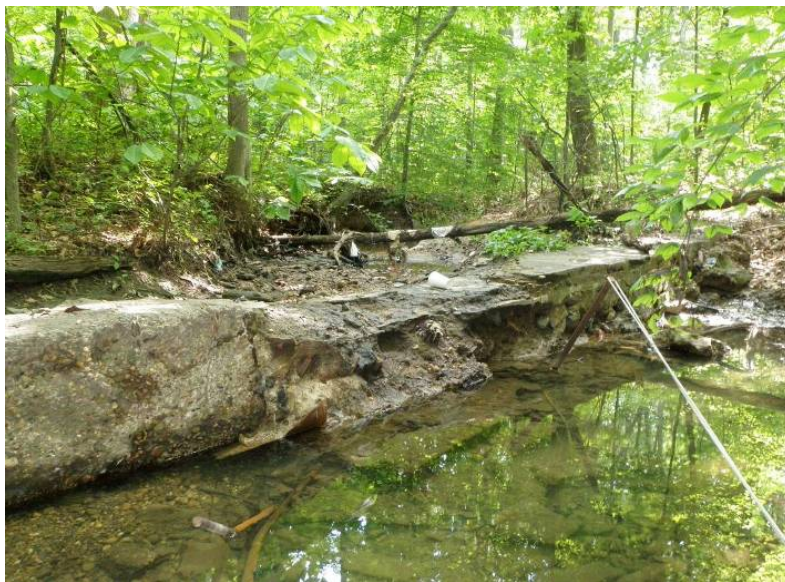
Figure 12a – Candidate Fish Blockage Removal Project

Site Location:	Pope Branch mainstem, south of Nash Place SE, Washington, DC	
Project No.:	PO-U-04-F-1	
ADC Map Book Location:	18 D 6	Map ID: 20
Approximate Upstream Length Open (feet):	800	
Description of Existing Conditions:	There is an armored concrete sewer line presenting a complete fish blockage. The blockage is not directly perpendicular to the stream, and spans approximately 30 feet. It is two feet thick and two feet tall.	
Project Description:	Fish Blockage Removal - Install a series of riffle and pool complexes to facilitate fish passage.

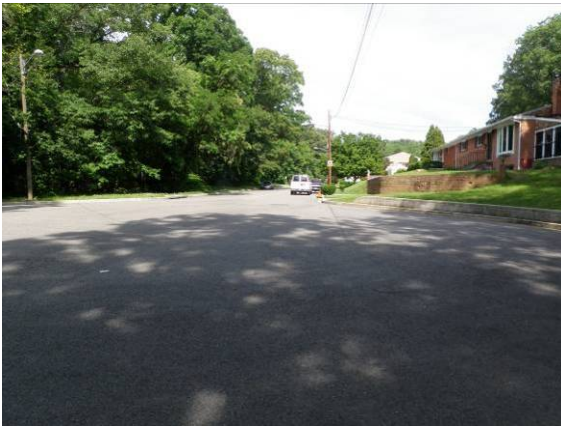
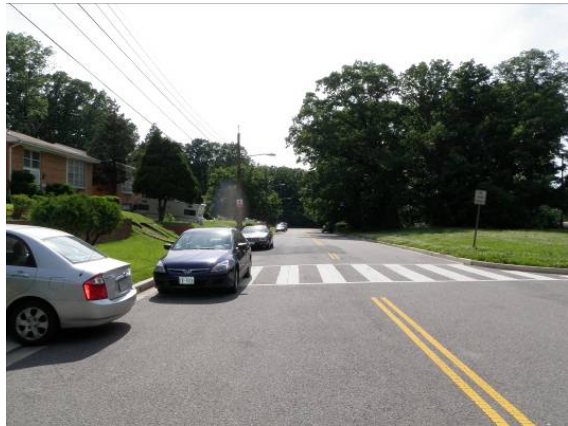
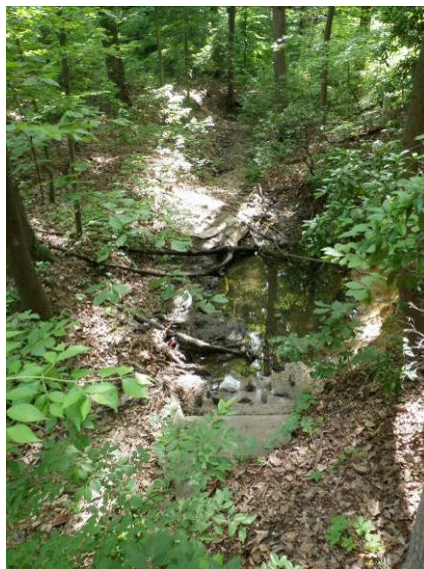
Figure 14a – Candidate Trash Reduction Project

Site Location:	Massachusetts Avenue SE from Alabama Avenue SE to O Street NE, Washington, DC	
Project No.:	PO-U-01-T-1	
ADC Map Book Location:	18 B 6	Map ID: 31
Approximate Length (miles):	0.40	
Description of Existing Conditions:	This two-lane street has parking on either side and is surrounded by residences and forested land. Massachusetts Avenue SE drains to an outfall at the end of O Street SE. Stormwater runoff reaches the outfall by means of curb inlet drains. A moderate amount of sediment was observed at the inlet drains, and a small amount of trash was observed at the outfall.	
Project Description:	Street Sweeping, Trash Removal, Trash Grates - Conduct street sweeping monthly to decrease the amount of sediment entering the inlet drains. Install trash grates at the curb inlet drains and conduct trash cleanup at the outfall.

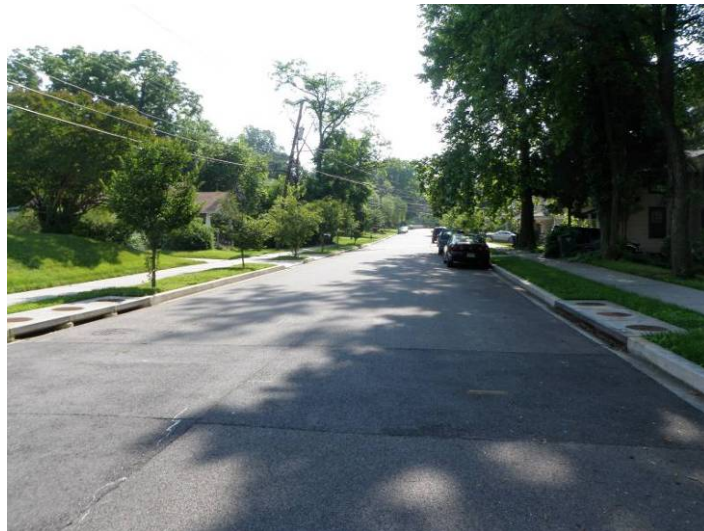
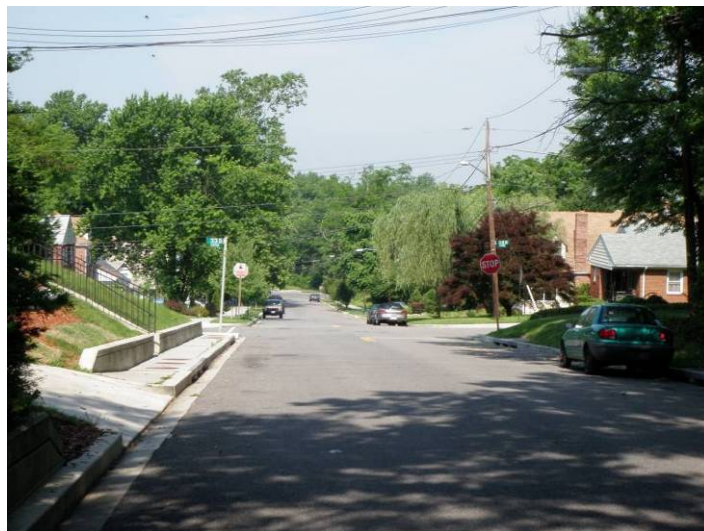
Figure 19a – Candidate Stormwater Retrofit Project

Site Location:	M Street SE between 34th Street SE and 33rd Place SE, Washington, DC	
Project No.:	PO-M-01-S-1	
ADC Map Book Location:	18 A 5	Map ID: 24
Approximate Associated Drainage Area (acres):	1.3	
Approximate Imperviousness:	80%	1.0 acres
Description of Existing Conditions:	This site includes a moderately sloped residential street. Stormwater runoff drains west by means of numerous curb inlet drains. There is only a small amount of space between the asphalt and sidewalk.	
Project Description:	LID Tree Box Filters - Install tree box filters at the curb inlet drains.

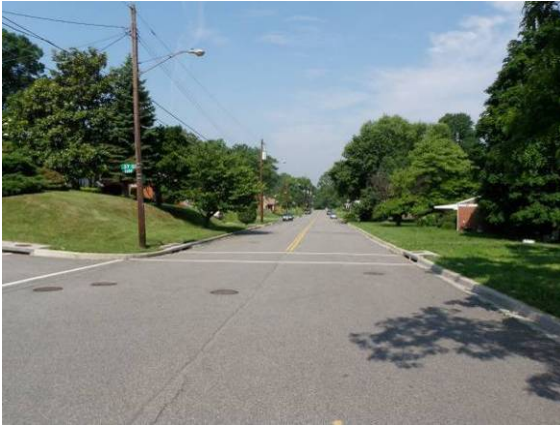
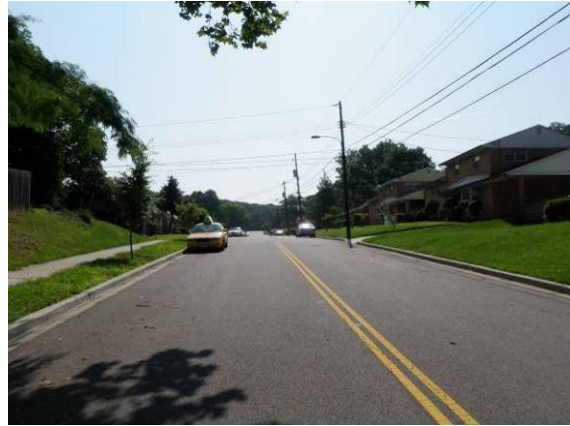
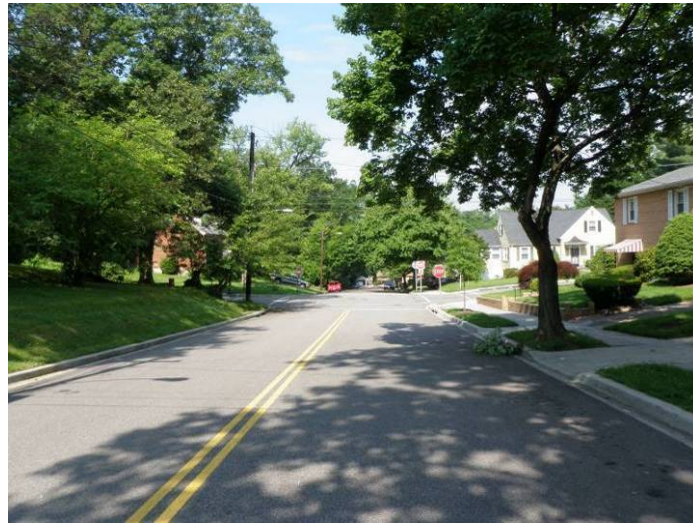
Figure 19b – Candidate Stormwater Retrofit Project

Site Location:	N Street SE between Massachusetts Avenue SE and 33rd Place SE, Washington, DC	
Project No.:	PO-M-01-S-2	
ADC Map Book Location:	18 B 5	Map ID: 25
Approximate Associated Drainage Area (acres):	1.6	
Approximate Imperviousness:	70%	1.1 acres
Description of Existing Conditions:	N Street SE is a two-lane residential street with parking on either side and multiple curb inlet drains. The portion east of 34th Place SE is relatively flat; however, the portion west of 34th Place SE is fairly steep. The street drains to the east.	
Project Description:	LID Tree Box Filters - Install tree box filters at curb inlet drains.

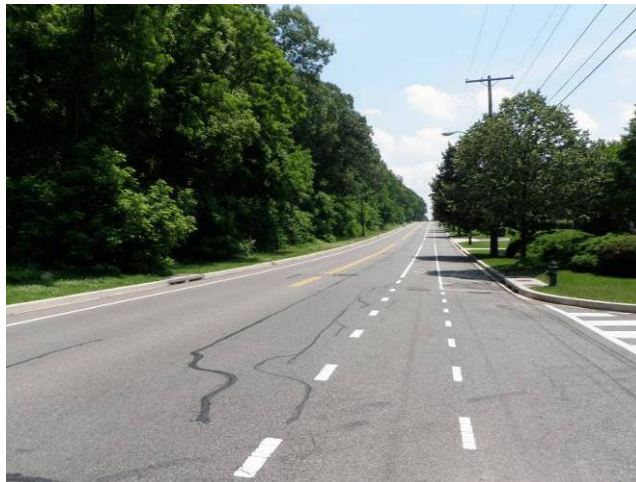
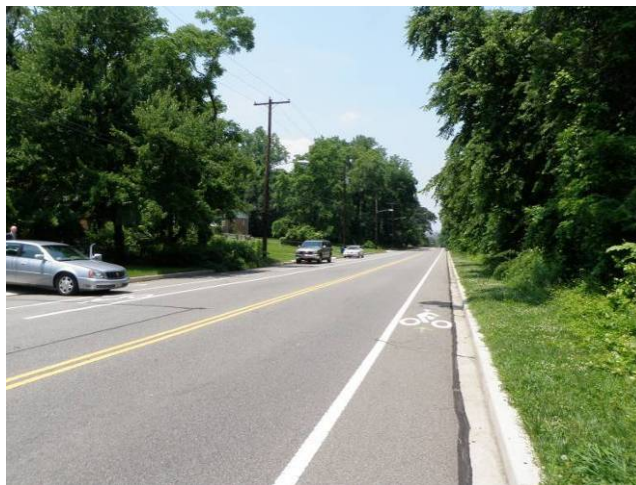
Figure 19c – Candidate Stormwater Retrofit Project

Site Location:	Massachusetts Avenue SE between Randle Circle SE and Alabama Avenue SE, Washington, DC	
Project No.:	PO-M-01-S-3	
ADC Map Book Location:	18 A 5	Map ID: 28
Approximate Associated Drainage Area (acres):	6.5	
Approximate Imperviousness:	98%	6.4 acres
Description of Existing Conditions:	Massachusetts Avenue SE, between Randle Circle SE and Alabama Avenue SE, is a two-lane road with a bike lane and a parking lane on the south side surrounded by residences and forested areas. The road is moderately sloped and stormwater runoff drains to numerous curb inlet drains. Drainage is generally towards the west.	
Project Description:	Infiltration Trenches, LID Bioswale - Replace the storm sewer line on the north side with infiltration trenches and bioswale.

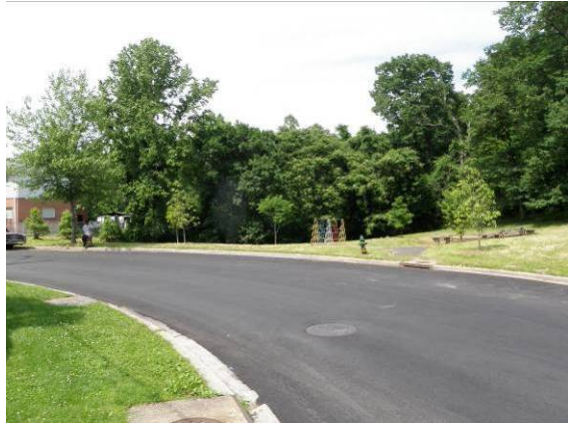
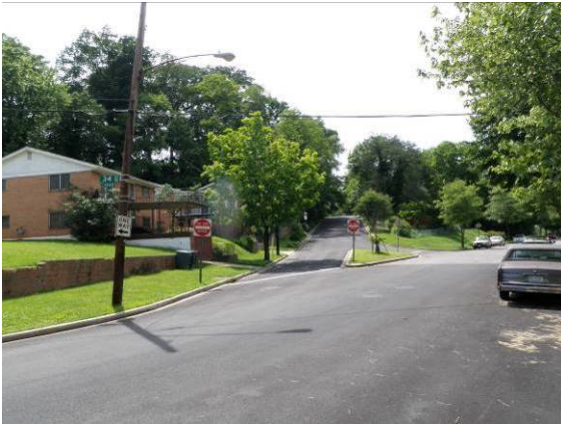
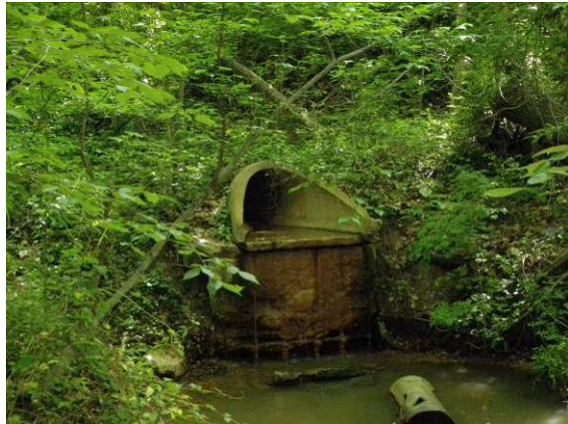
Figure 19d – Candidate Stormwater Retrofit Project

Site Location:	Residential neighborhood composed of 34th Street SE north of Carpenter Street SE to three residences into Pope Street SE, and Nash Place SE, Washington, DC	
Project No.:	PO-M-01-S-4	
ADC Map Book Location:	18 A 6	Map ID: 6
Approximate Associated Drainage Area (acres):	55.7	
Approximate Imperviousness:	25%	13.9 acres
Description of Existing Conditions:	The neighborhood is composed of one- and two-story residences. Stormwater runoff drains to curb inlet drains to outfall SS#1073.	
Project Description:	Regenerative Stormwater Conveyance, LID Bioretention, Rainscape - Install a regenerative stormwater conveyance at the outfall. Construct bioretention systems in the small community park above the outfall and install rain gardens and rain barrels at downspout locations in the neighborhood.

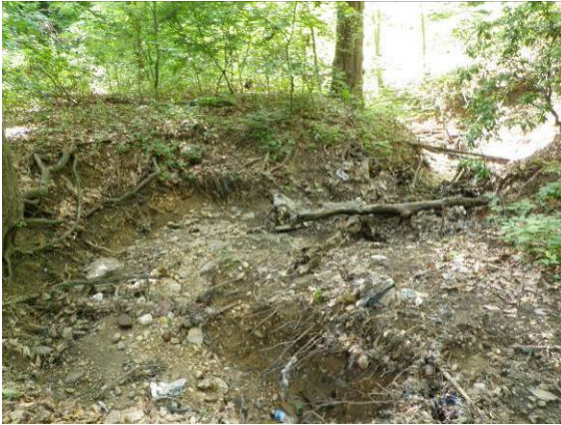
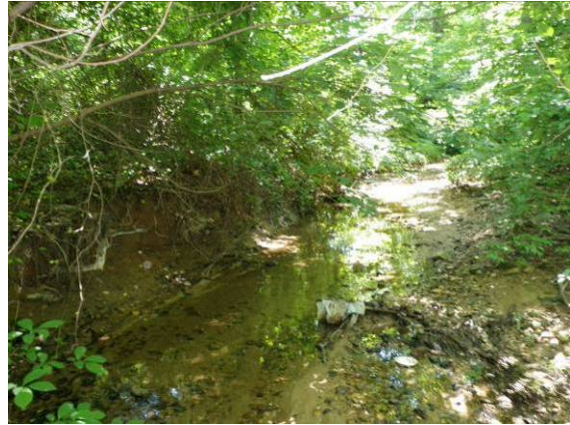
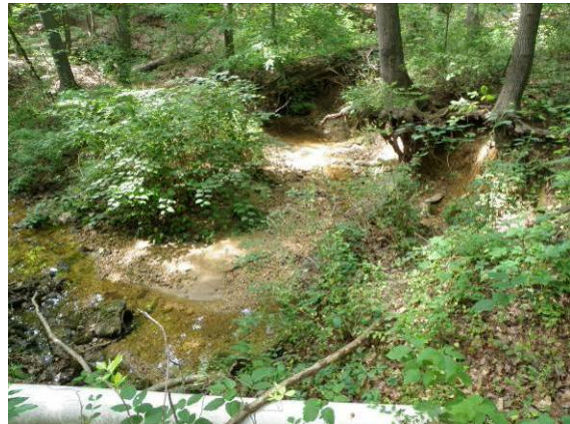
Figure 21a – Candidate Stream Restoration Project

Site Location:	Pope Branch between the headwaters and Fairlawn Avenue SE, Washington, DC	
Project No.:	PO-M-02-SR-1	
ADC Map Book Location:	18 A 6	Map ID: 7
Approximate Length (feet):	6,900	
Description of Existing Conditions:	Pope Branch has been confined to a narrow floodplain throughout its open reach. The majority of the stream is incised, and lacks sinuosity and connection to its floodplain.	
Project Description:	Stream Channel Morphology Restoration, In-stream Habitat Enhancement – Regrade banks and install appropriate bank stabilization measures (i.e. brush layering, live stakes) and toe protection. Install log vanes and riffle-pool sequences to protect banks and improve habitat.

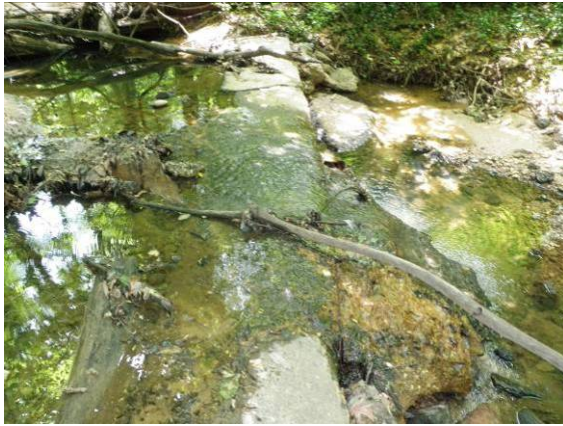
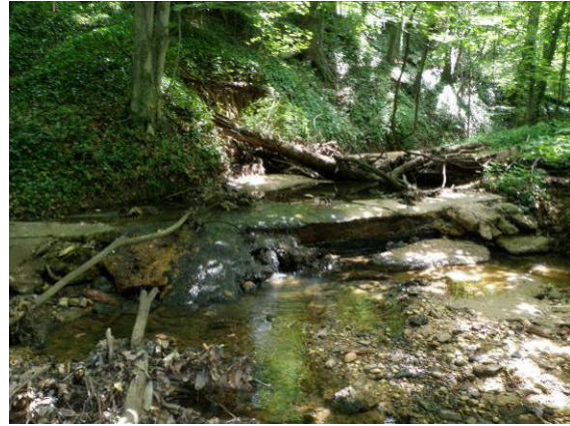
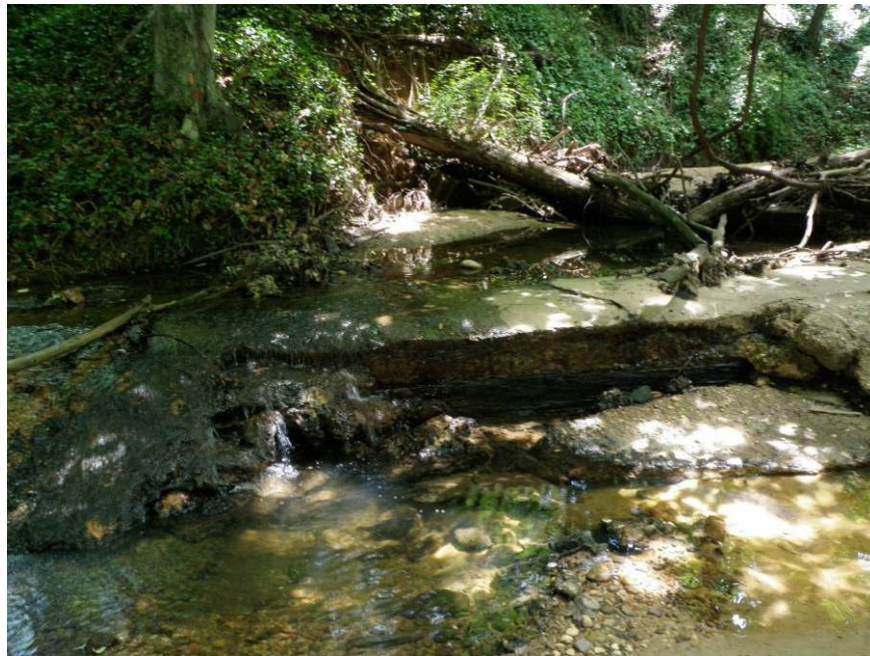
Figure 23a – Candidate Fish Blockage Removal Project

Site Location:	Sewer line crossing Pope Branch near 3208 Pope Street SE, Washington, DC	
Project No.:	PO-M-04-F-1	
ADC Map Book Location:	18 A 5	Map ID: 15
Approximate Upstream Length Open (feet):	2,700	
Description of Existing Conditions:	This site consists of an armored sewer line crossing Pope Branch that forms a complete fish blockage approximately one-and-a-half feet high, eight feet wide and two feet thick.	
Project Description:	Fish Blockage Removal - Install a series of riffle and pool complexes to facilitate fish passage.

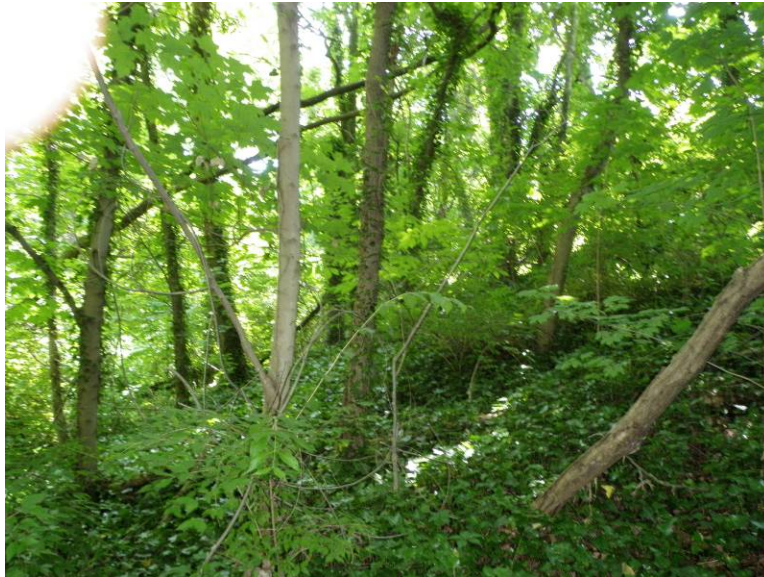
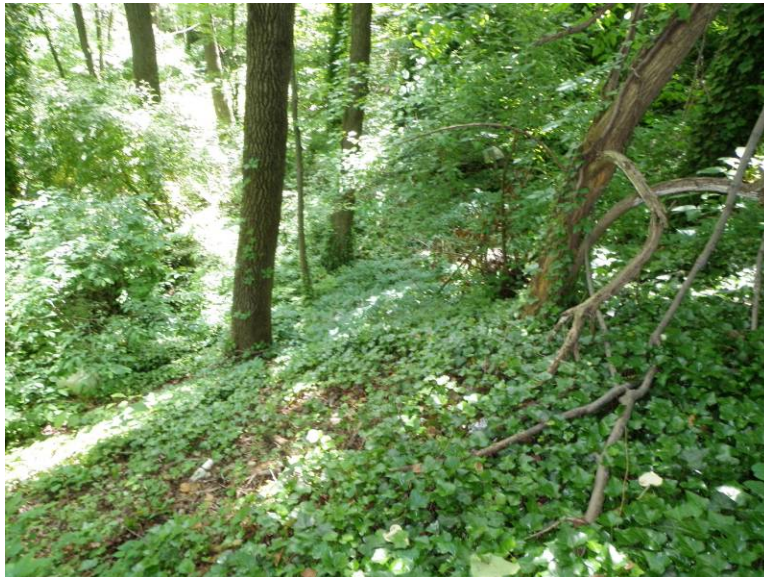
Figure 25a – Candidate Riparian Restoration Project

Site Location:	Riparian area of Pope Branch between Branch Avenue SE and 34th Street SE, Washington, DC	
Project No.:	PO-M-05-R-1	
ADC Map Book Location:	18 A 5	Map ID: 16
Approximate Acreage (acres):	4.8	
Description of Existing Conditions:	The understory of the riparian area is a monoculture of English ivy (<i>Hedera helix</i>), an invasive plant species. The ivy is killing many of the native trees in the riparian area.	
Project Description:	Invasive Species Removal - Remove the invasive plant species and revegetate using endemic species.

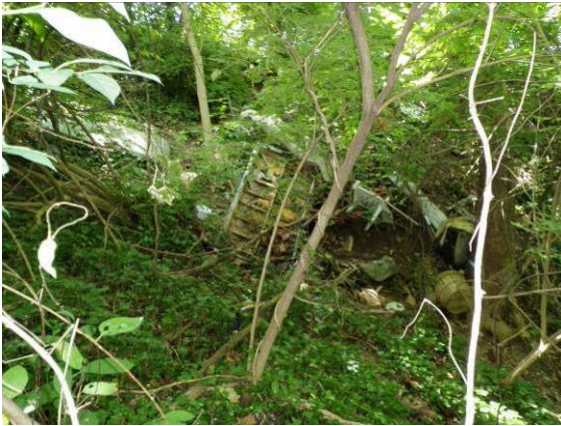
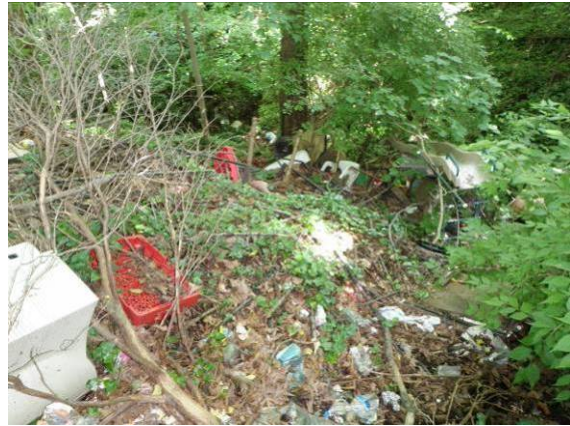
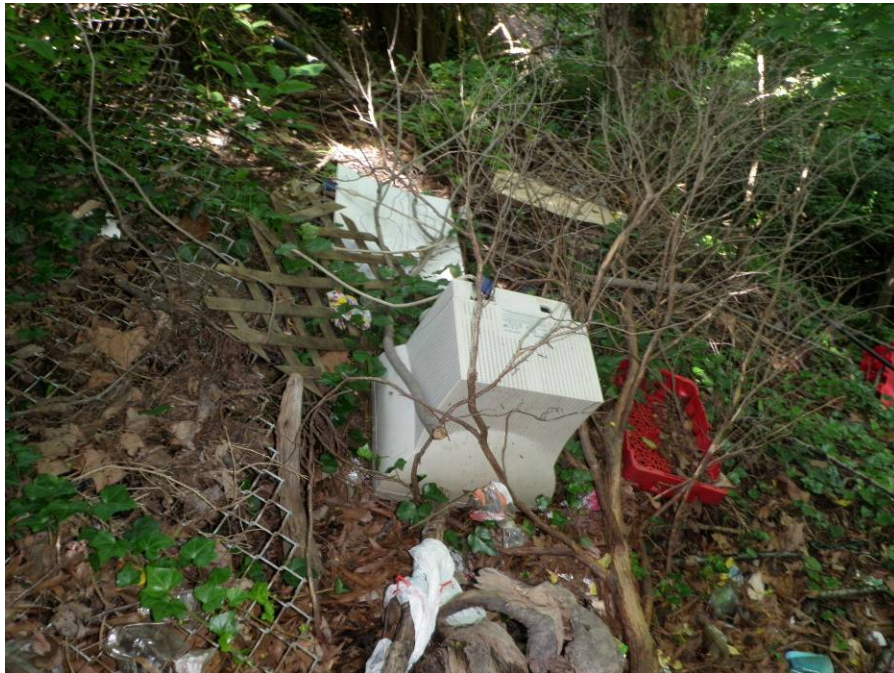
Figure 27a – Candidate Trash Reduction Project

Site Location:	South bank of Pope Branch, between 3208 Pope Street SE and the Branch Avenue SE culvert, Washington, DC	
Project No.:	PO-M-06-T-1	
ADC Map Book Location:	18 A 5	Map ID: 14
Approximate Length (miles):	0.05	
Description of Existing Conditions:	Trash has been thrown over the bank, primarily consisting of appliances.	
Project Description:	Trash Removal, Community Cleanup - Remove trash and debris and perform community outreach.

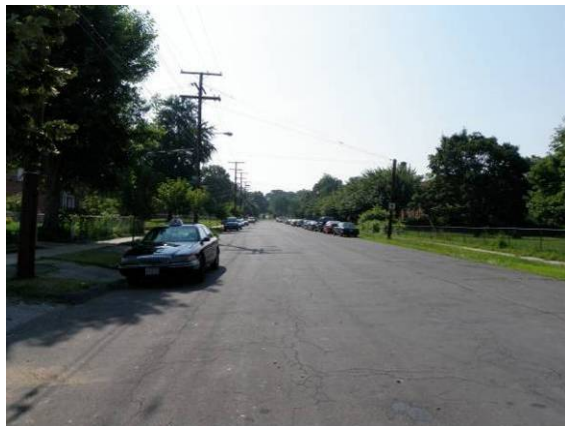
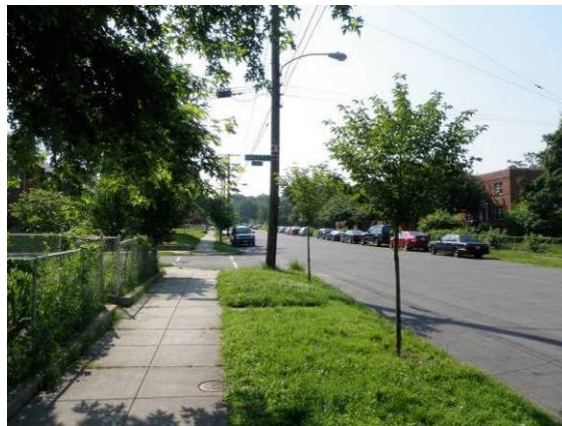
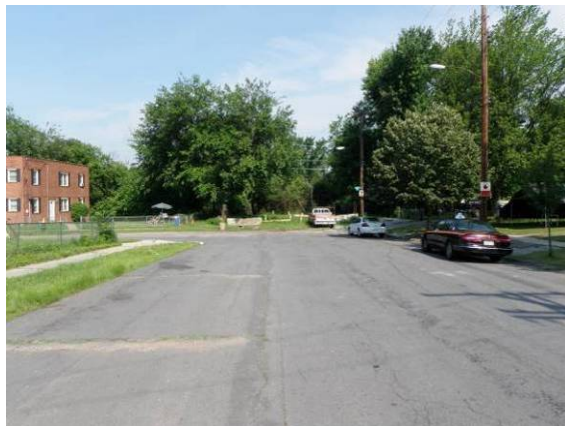
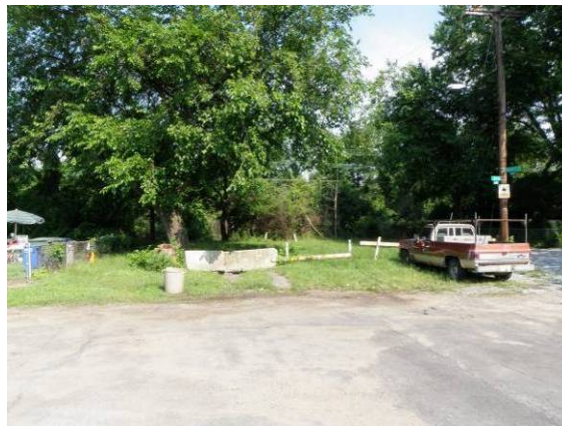
Figure 31a – Candidate Stormwater Retrofit Project

Site Location:	Massachusetts Avenue SE and 30th Street SE, Washington, DC	
Project No.:	PO-L-01-SW-1	
ADC Map Book Location:	17 K 4	Map ID: 22
Approximate Associated Drainage Area (acres):	2.7	
Approximate Imperviousness:	80%	2.2 acres
Description of Existing Conditions:	Massachusetts Avenue SE is two lanes wide with additional parking lanes, sidewalks, and grassy medians on both sides. There are no concrete curbs; the grassy area directly connects to the asphalt. Stormwater runoff from Massachusetts Avenue SE drains west into the dead end, where there is a grassy area between the dead end and the railroad.	
Project Description:	LID Bioretention - Construct bioretention systems between the road and the sidewalk in the grassy area and at the dead end.

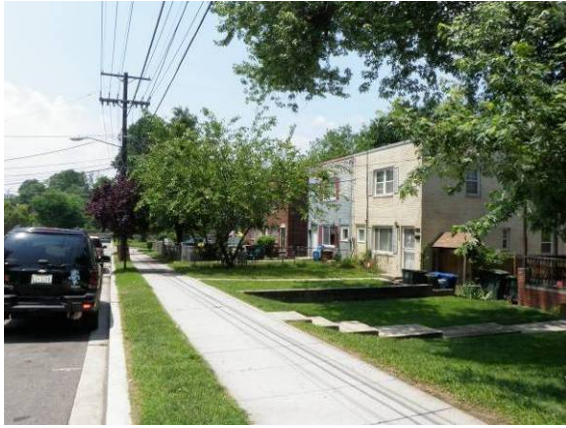
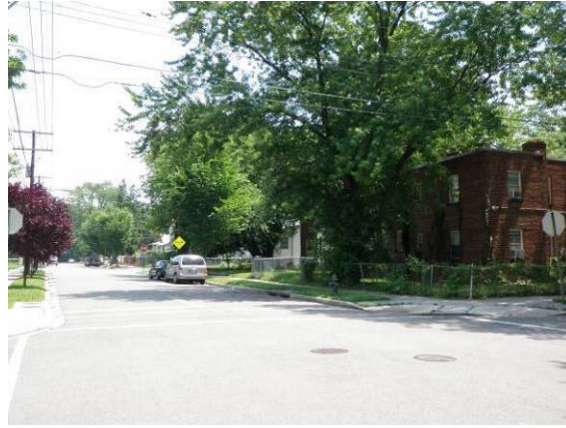
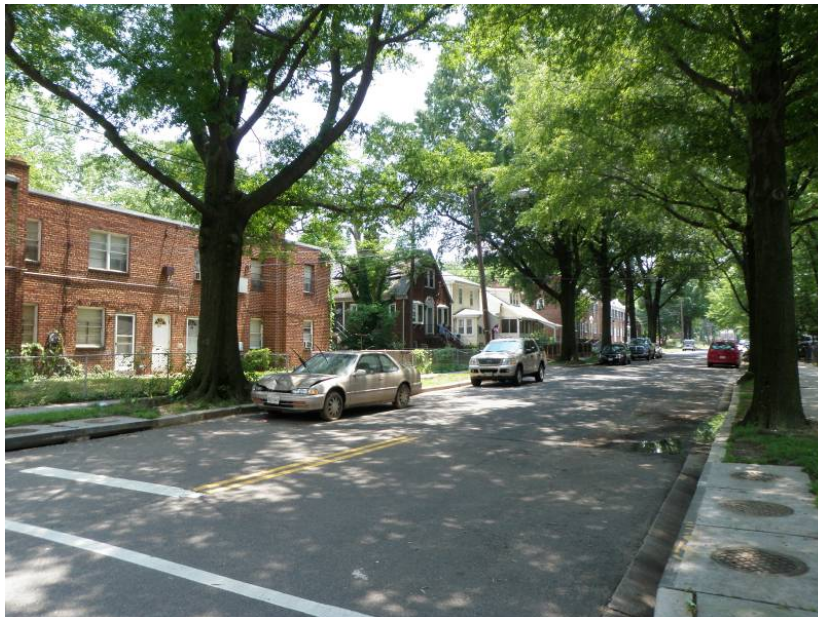
Figure 31b – Candidate Stormwater Retrofit Project

Site Location:	G Street SE, 31st Street SE and 32nd Street SE, Washington, DC	
Project No.:	PO-L-01-SW-2	
ADC Map Book Location:	17 K 4	Map ID: 29
Approximate Associated Drainage Area (acres):	8.9	
Approximate Imperviousness:	50%	4.5 acres
Description of Existing Conditions:	The residential neighborhood consists of houses and two-story apartments. The lots are small and the houses have small lawns.	
Project Description:	Rainscape - Install rain gardens and rain barrels at downspouts.

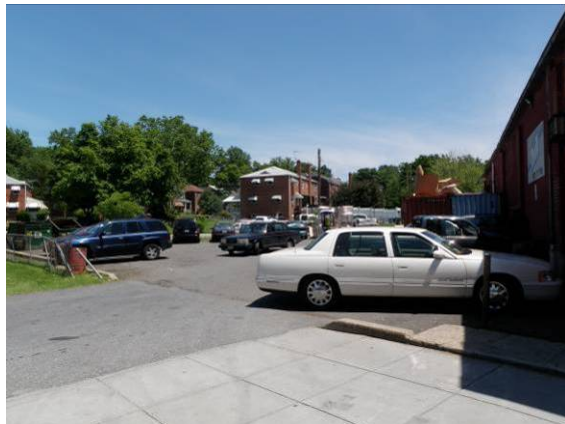
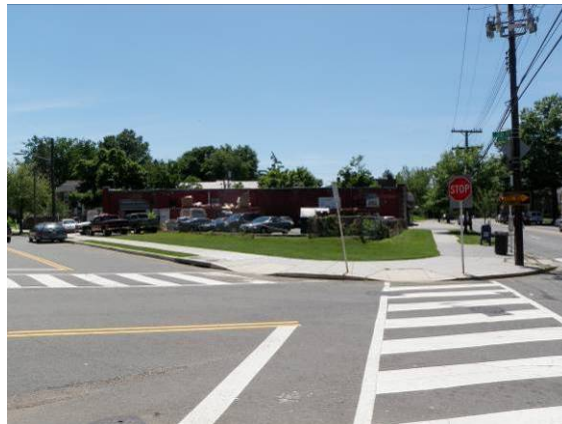
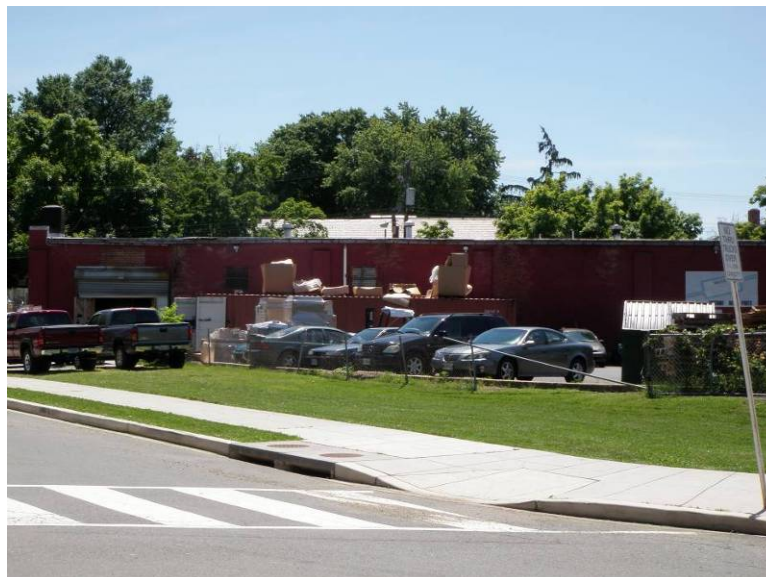
Figure 31c – Candidate Stormwater Retrofit Project

Site Location:	Earl's Discount Auto Parts, 2901 Minnesota Avenue SE, Washington, DC	
Project No.:	PO-L-01-SW-3	
ADC Map Book Location:	17 K 5	Map ID: 10
Approximate Associated Drainage Area (acres):	0.6	
Approximate Imperviousness:	85%	0.5 acres
Description of Existing Conditions:	The parcel consists of a one-story commercial structure with a parking lot to the north. Downspouts are connected to the stormwater system. Stormwater runoff drains to Minnesota Avenue SE.	
Project Description:	LID Bioretention – Construct a bioretention system in the grassy area between the parking lot and the Minnesota Avenue SE / 30th Street SE intersection. Disconnect downspouts from the stormwater system.

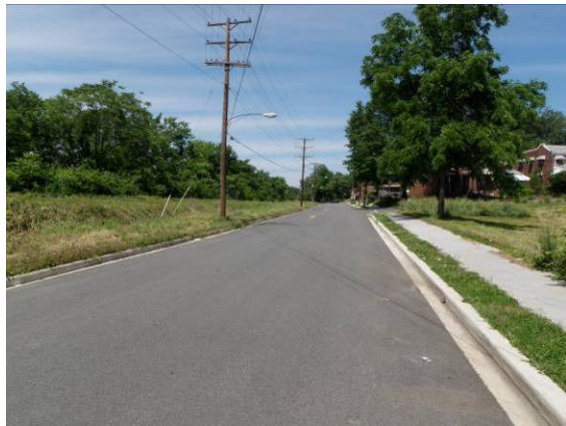
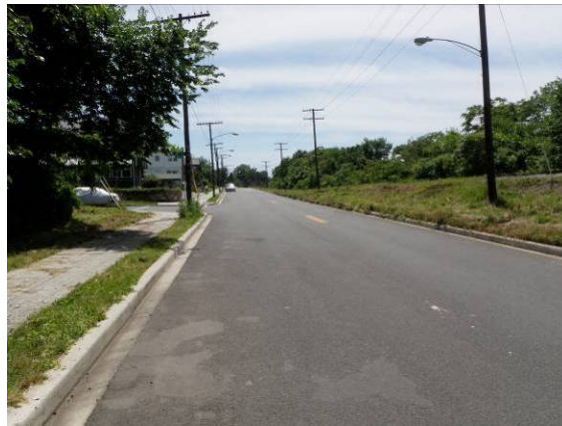
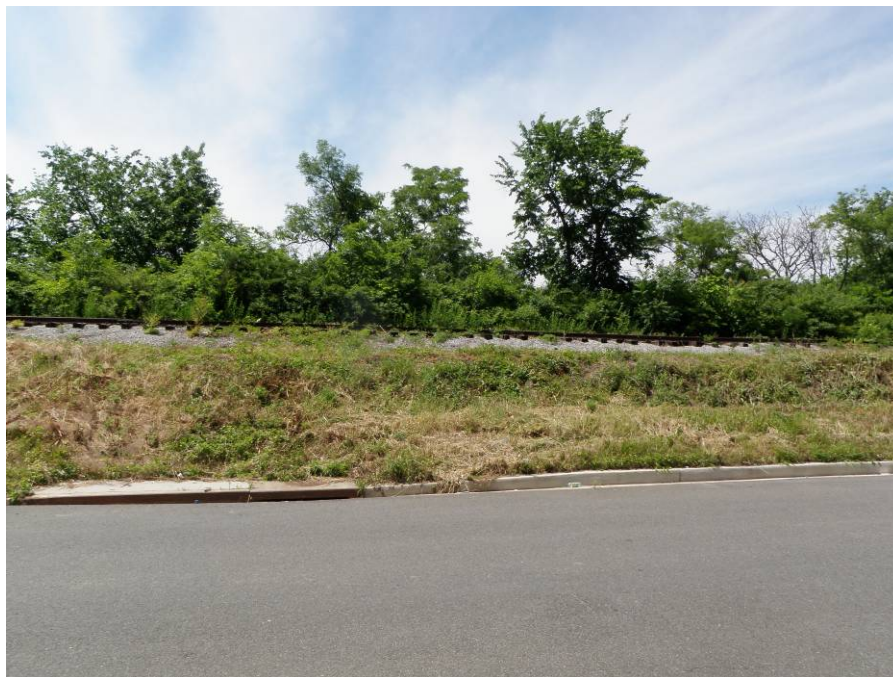
Figure 31d – Candidate Stormwater Retrofit Project

Site Location:	Fairlawn Avenue SE between M Street SE and G Street SE, Washington, DC	
Project No.:	PO-L-01-SW-4	
ADC Map Book Location:	17 K 5	Map ID: 5
Approximate Associated Drainage Area (acres):	1.3	
Approximate Imperviousness:	80%	1.0 acres
Description of Existing Conditions:	Fairlawn Avenue SE is a two-lane suburban street. Stormwater runoff drains to Pope Branch by means of curb inlet drains. A railway track and utility line parallel the road to the west.	
Project Description:	LID Bioretention – Construct a bioretention system in the grassy area between the roadway and railway.

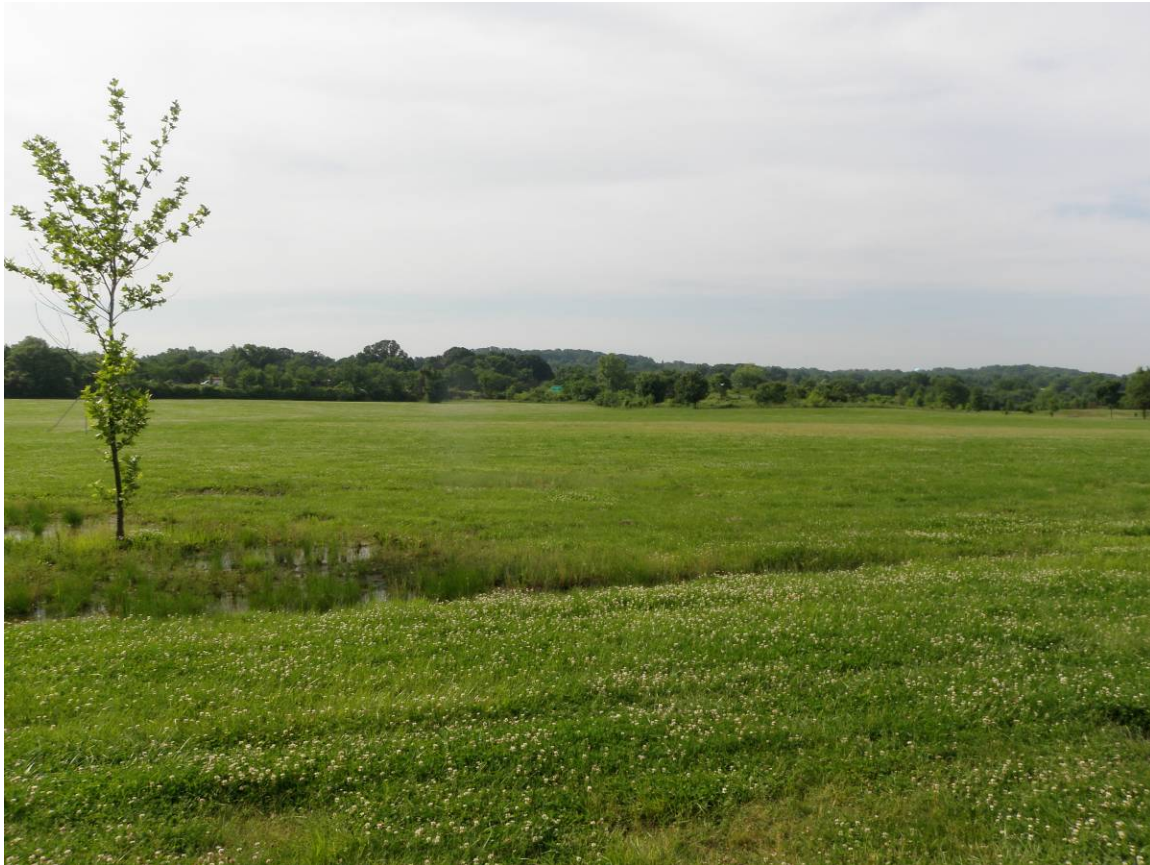
Figure 33a – Candidate Stream Restoration Project

Site Location:	Pope Branch between Fairlawn Avenue SE and the Anacostia River, Washington, DC	
Project No.:	PO-L-02-SR-1	
ADC Map Book Location:	17 K 5	Map ID: 3
Approximate Length (feet):	1,600	
Description of Existing Conditions:	Pope Branch is piped from the Fairlawn Avenue SE culvert to the Anacostia River.	
Project Description:	Stream Daylighting - Daylight the stream and establish a natural stream channel.

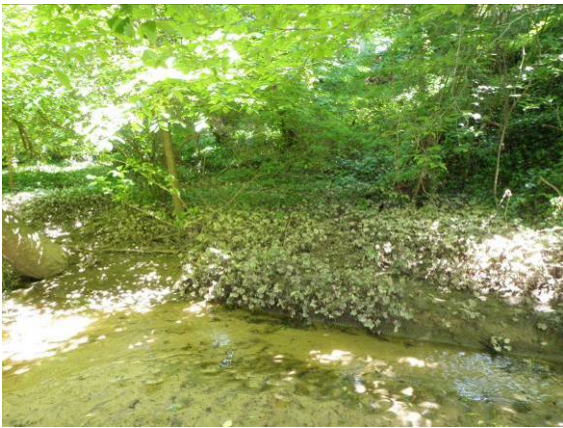
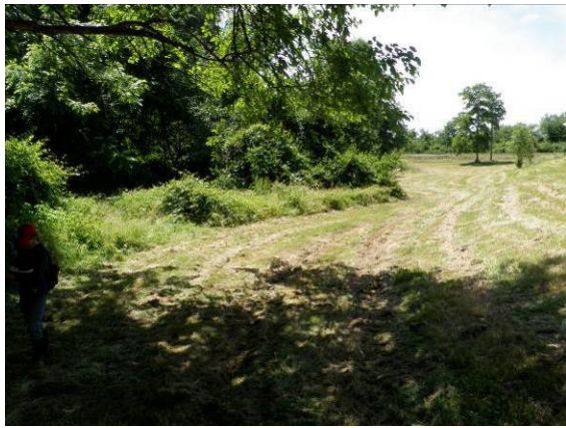
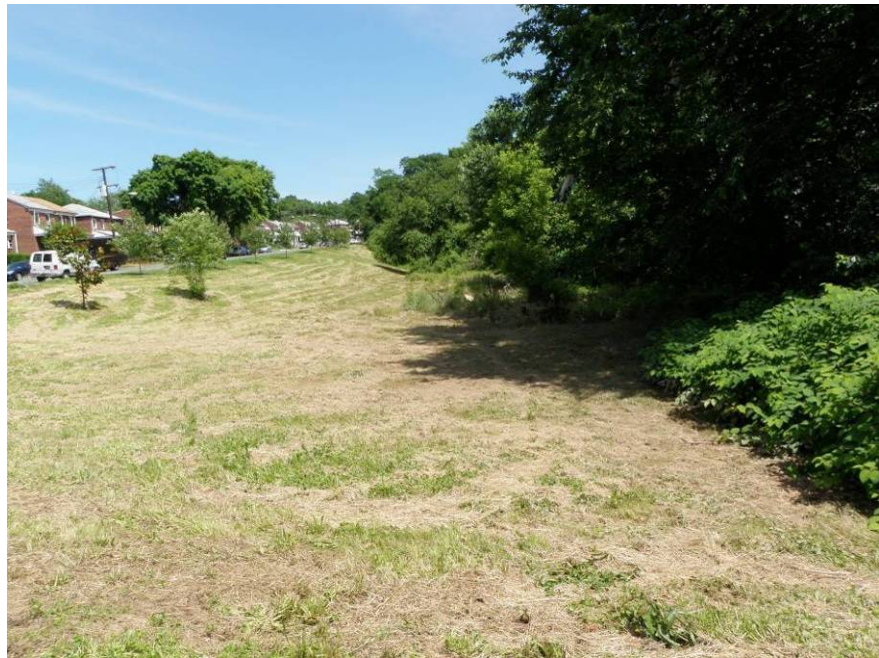
Figure 35a – Candidate Wetland Restoration Project

Site Location:	Pope Branch floodplain, just east of Fairlawn Avenue SE, Washington, DC	
Project No.:	PO-L-03-W-1	
ADC Map Book Location:	17 K 5	Map ID: 2
Approximate Acreage (acres):	1.0	
Description of Existing Conditions:	Pope Branch is connected to the floodplain in this region. The south bank is forested and has water marks indicative of flooding. The north bank has a small riparian area and maintained lawn. The lawn area was saturated to the surface at the time of the survey.	
Project Description:	Wetland Restoration, Invasive Species Removal - Excavate portions of the north floodplain to expand the wetland area. Remove the invasive English ivy (<i>Hedera helix</i>) dominating the forest understory.

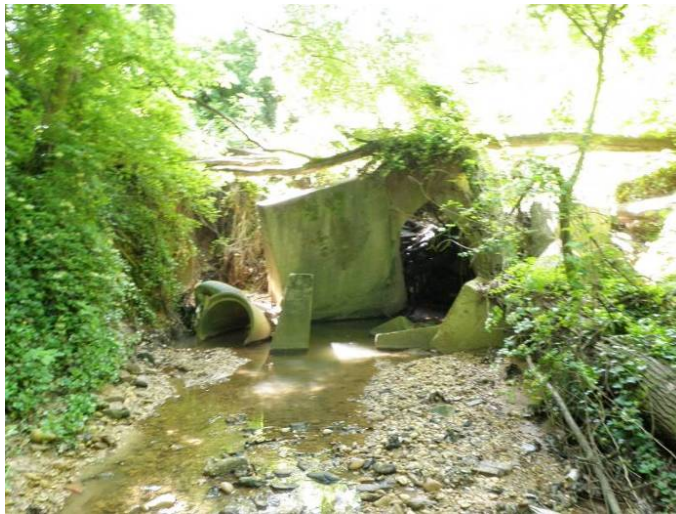
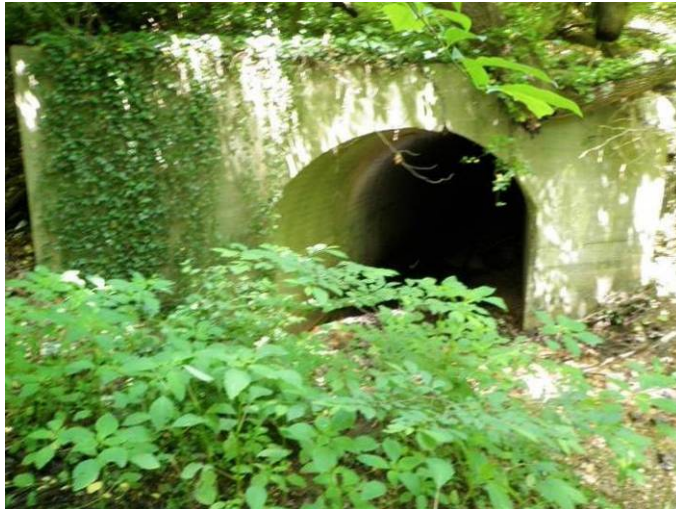
Figure 37a – Candidate Fish Blockage Removal Project

Site Location:	Culvert at the intersection of Branch Avenue SE and Anacostia Road SE, Washington, DC	
Project No.:	PO-L-04-F-1	
ADC Map Book Location:	18 A 5	Map ID: 12
Approximate Upstream Length Open (feet):	400	
Description of Existing Conditions:	The concrete culvert conveying Pope Branch underneath Branch Avenue SE and Anacostia Road SE has collapsed. Both the culvert and the rubble present a complete fish blockage approximately 220 feet long.	
Project Description:	Fish Blockage Removal - Replace the culvert with a design that allows fish passage.
