Anacostia River Watershed Restoration Plan

Pope Branch Subwatershed Provisional Restoration Project Inventory

August 2009

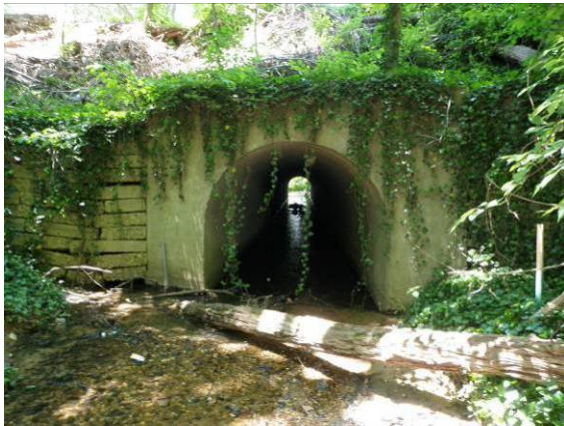
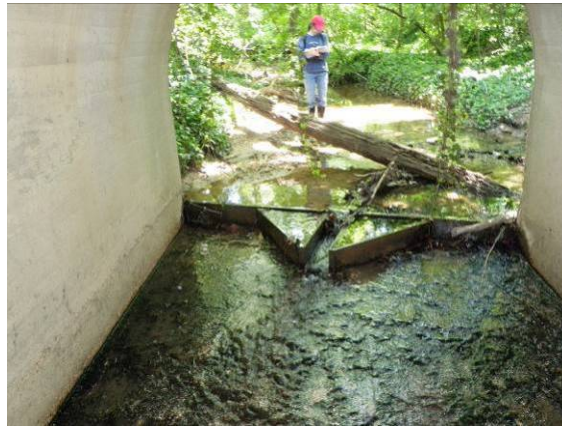
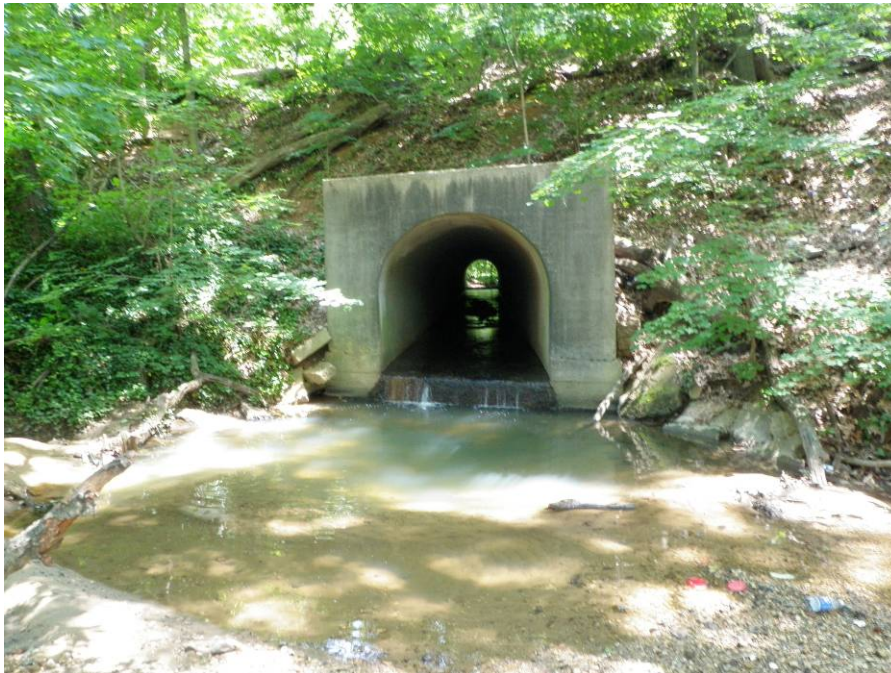
Figure 37b – Candidate Fish Blockage Removal Project

Site Location:	Culvert at Minnesota Avenue SE, Washington, DC	
Project No.:	PO-L-04-F-2	
ADC Map Book Location:	17 K 5	Map ID: 1
Approximate Upstream Length Open (feet):	850	
Description of Existing Conditions:	The culvert consists of a seven-foot-tall arched tunnel with a concrete bed. The upstream end has a small flow restrictor, and the downstream end has a 1.5-foot drop to a large plunge pool.	
Project Description:	Soft Bottom Channel Creation, Fish Blockage Removal - Replace the existing culvert with a soft-bottom design. Install a series of riffle and pool complexes to facilitate fish passage.

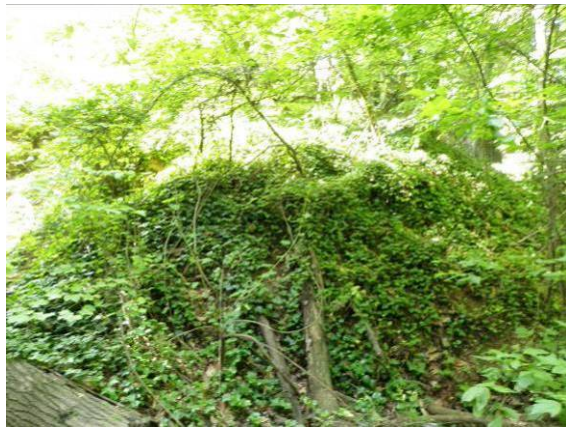
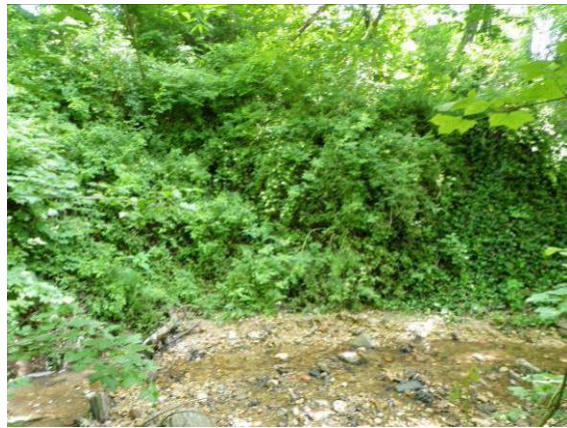
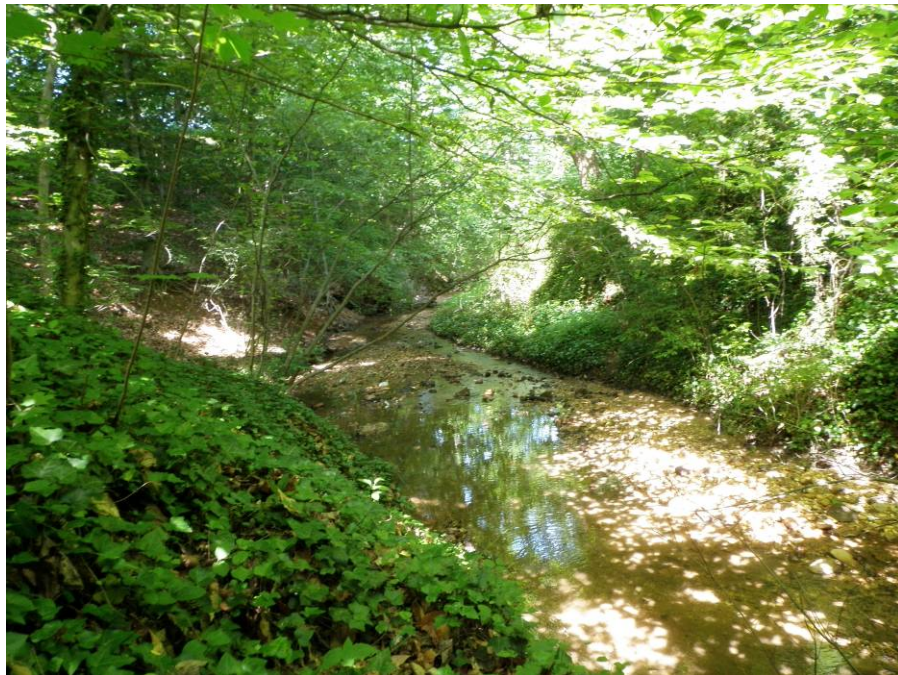
Figure 39a – Candidate Riparian Restoration Project

Site Location:	Riparian area of Pope Branch between Branch Avenue SE and Minnesota Avenue SE, Washington, DC	
Project No.:	PO-L-05-R-1	
ADC Map Book Location:	18 A 5	Map ID: 13
Approximate Acreage (acres):	4.3	
Description of Existing Conditions:	The understory of the riparian area is dominated by the invasive plant species English ivy (<i>Hedera helix</i>), Japanese honeysuckle (<i>Lonicera japonica</i>), multiflora rose (<i>Rosa multiflora</i>), bush honeysuckle (<i>Lonicera maackii</i>), and tree of heaven (<i>Ailanthus altissima</i>).	
Project Description:	Invasive Species Removal - Remove the invasive plant species and revegetate using endemic species.

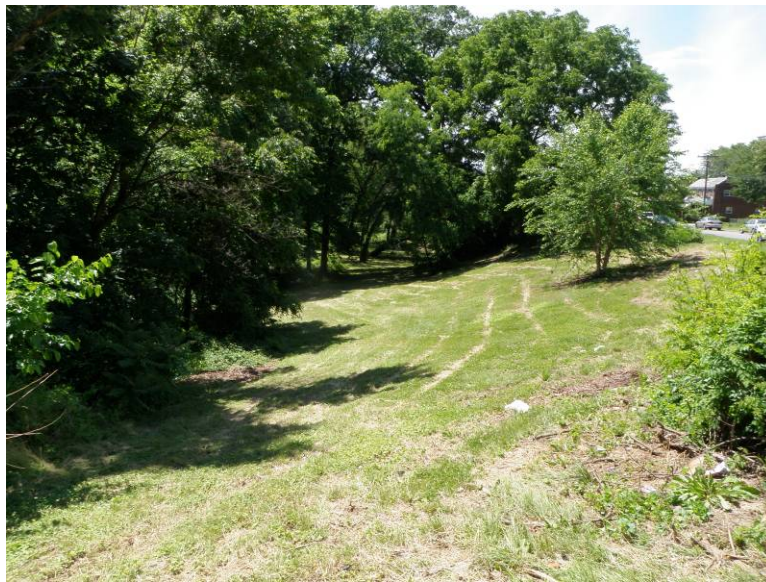
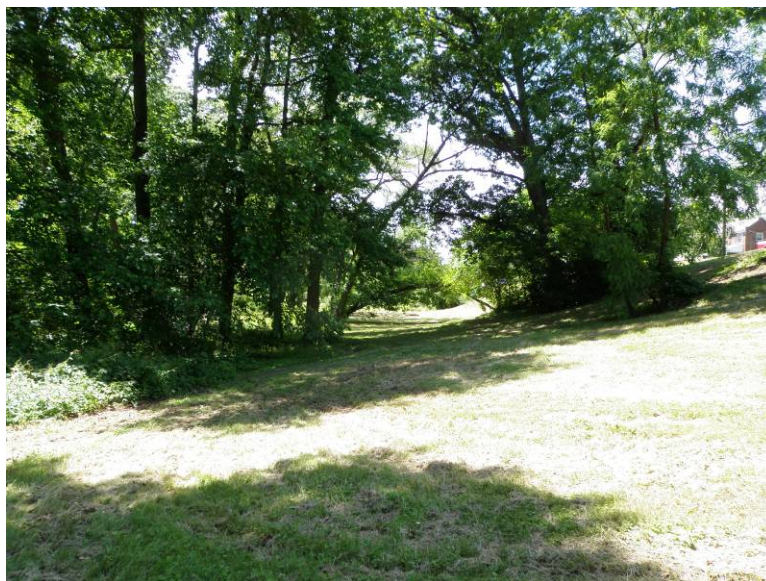
Figure 39b – Candidate Riparian Restoration Project

Site Location:	Grassy field between M Place SE and Pope Branch, west of Minnesota Avenue SE and east of Fairlawn Avenue SE, Washington, DC	
Project No.:	PO-L-05-R-2	
ADC Map Book Location:	17 K 5	Map ID: 11
Approximate Acreage (acres):	0.9	
Description of Existing Conditions:	This site consists of a maintained grassy area between the street and the riparian area of Pope Branch. There are some existing tree plantings adjacent to the street.	
Project Description:	Riparian Reforestation - Reforest the grassy area using endemic trees and shrubs.

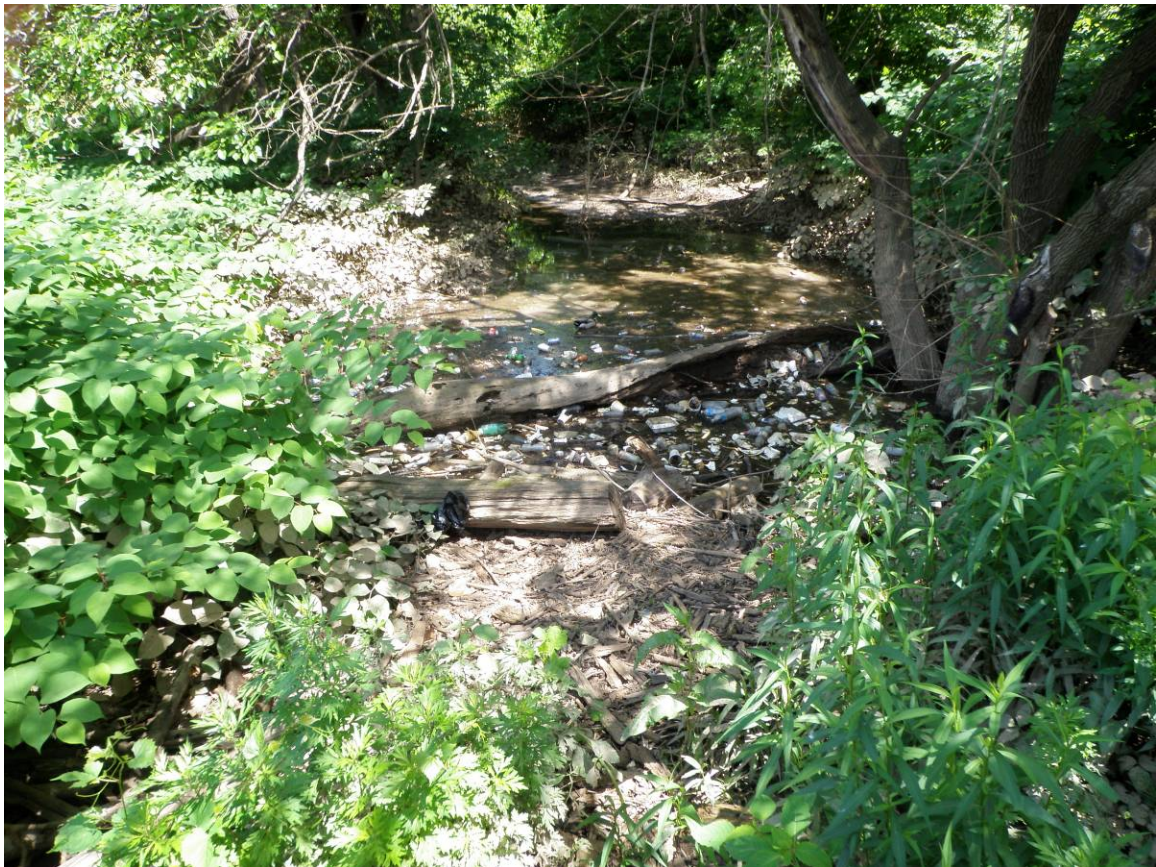
Figure 41a – Candidate Trash Reduction Project

Site Location:	Immediately upstream of the Fairlawn Avenue SE culvert, Washington, DC	
Project No.:	PO-L-06-T-1	
ADC Map Book Location:	17 K 5	Map ID: 4
Approximate Length (miles):	0.05	
Description of Existing Conditions:	A large amount of woody debris and trash has accumulated at the culvert.	
Project Description:	Trash Removal, Trash Net - Remove the accumulated trash and woody debris. Install a trash net at the culvert.
