-FOUNDRY BRANCH- Development of a Dissolved Oxygen (DO) Model Framework MWWCOG Final Report

Prepared For:
District of Columbia
Department of the Environment

Prepared By:
Metropolitan Washington
Council of Governments

September 2011

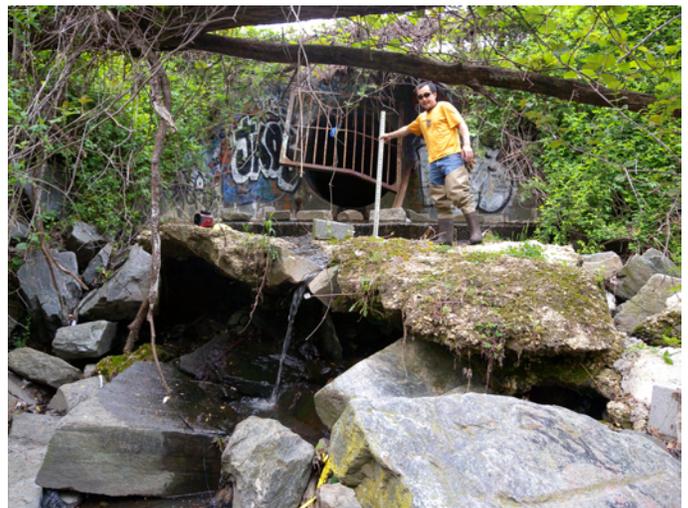
Figure 1. Upper Foundry Branch - 60" RCP outfall and perched concrete pad

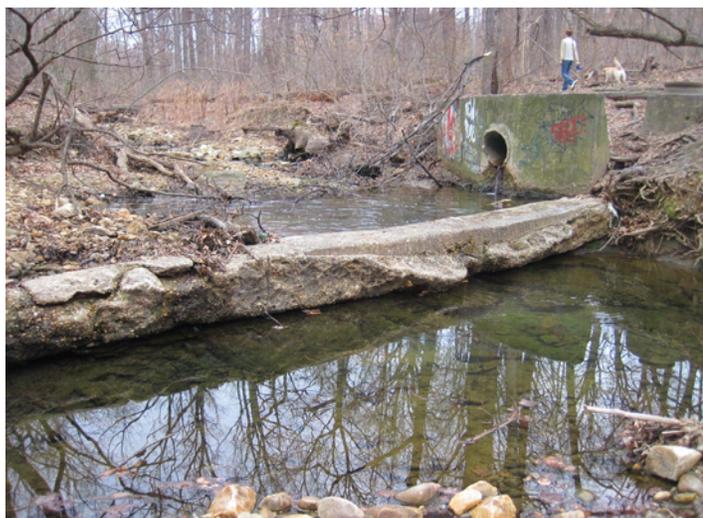
Figure 5. Upper Foundry Branch - Storm Drain #5 - 18" diameter RCP outfall with broken head wall in the center of the stream channel

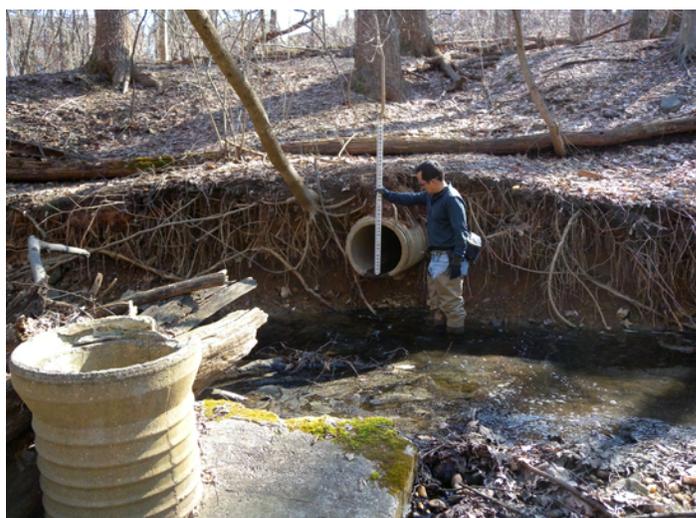
Figure 6. Upper Foundry Branch - Storm Drain #3 - 24" diameter RCP outfall and exposed lateral sewer line crossing (Baseflow flows underneath the sewer line)

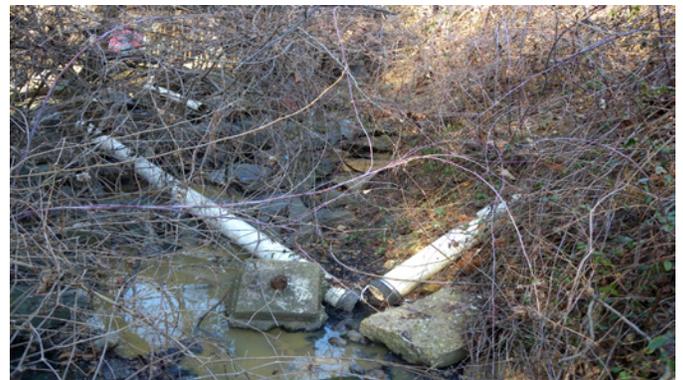
As part of the reconnaissance survey, COG staff documented the presence of both storm drain outfalls (and their associated drainage areas) and sewer line crossing locations within the stream channel, as well as their general condition. On multiple occasions during the study, COG staff reported sewer line breaks and leaks to both DDOE and DC Water for follow up emergency repair (Figure 8).

Figure 8. Upper Foundry Branch - Broken sanitary sewer PVC pipe immediately below the 60" RCP outfall (Repaired in March 2010)

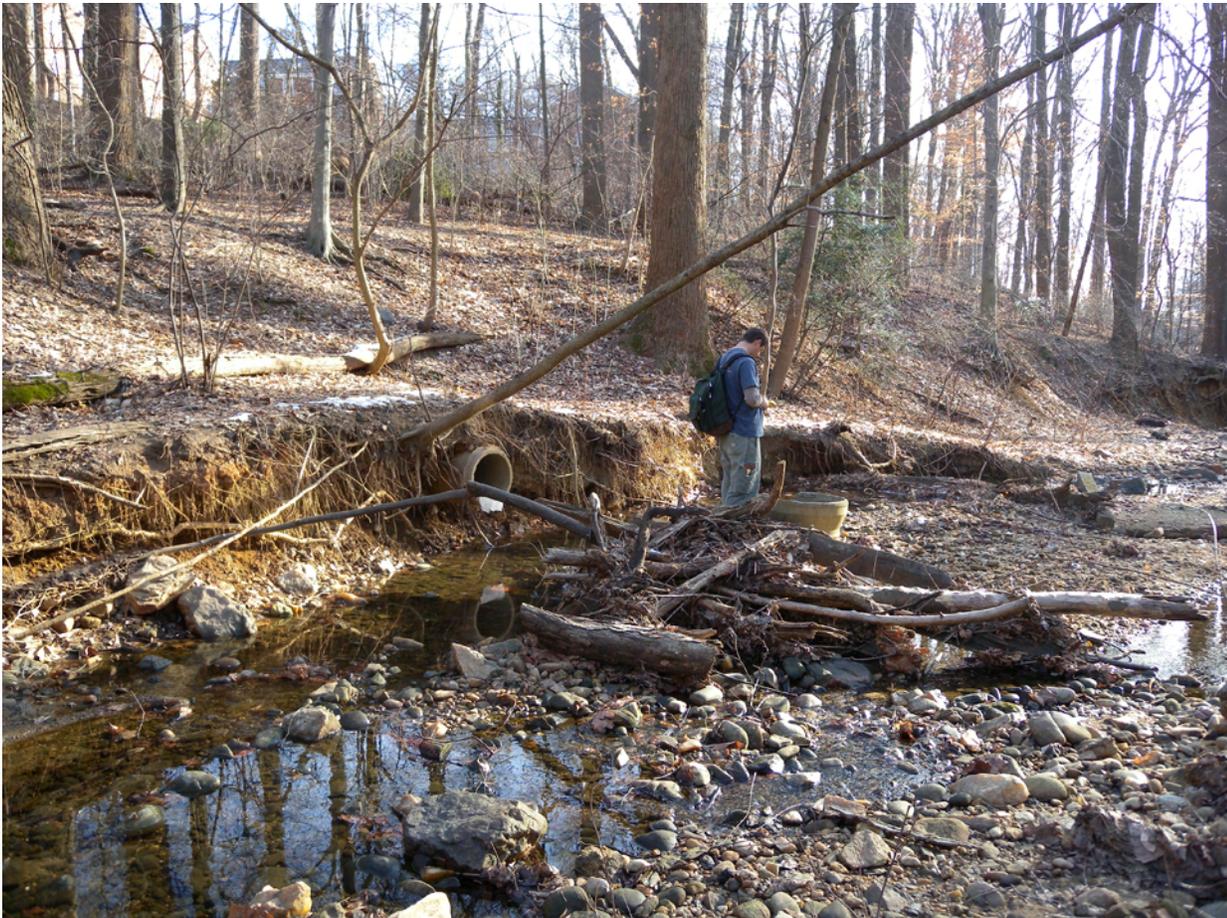
As seen in Table 2, overall upper Foundry Branch bank stability was at the lower end of the good range (i.e., 73.8 percent). Results from the RSAT channel stability survey portion of the study also revealed that out of a total of 2,424 linear feet of stream length, 48.9 linear feet (2.0 percent) exhibited severe stream bank erosion condition. Under the RSAT system, a severe bank erosion designation implies that less than 50 percent of the bank network is stable and that major portions of the banks are unraveling. Furthermore, 77.3 linear feet, representing approximately 3.1 percent of the upper main stem is experiencing moderate/severe bank erosion (Figure 19) (i.e., 50-60 percent of the bank network is stable and that signs of lateral bank erosion are very common). In addition, 448.3 linear feet (18.4 percent) exhibited moderate stream bank erosion conditions (i.e., 61-70 percent of the bank network is stable and signs of lateral bank erosion are common). It should be noted that stream areas experiencing moderate to moderate/severe bank erosion conditions were observed in all Foundry Branch stream channel patterns (i.e., straight, meanders and bends, etc).

Figure 19. Upper Foundry Branch - Moderate/Severe Stream Bank Erosion Condition

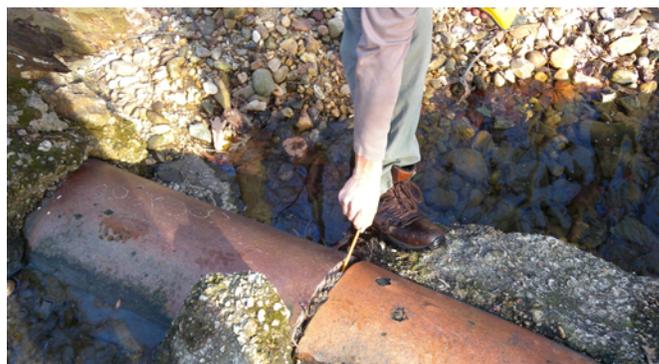
Figure 23. Upper Foundry Branch - Station 2 - Terra cotta sewer line pipe junction without grout, crossing the stream bed (May 2010)

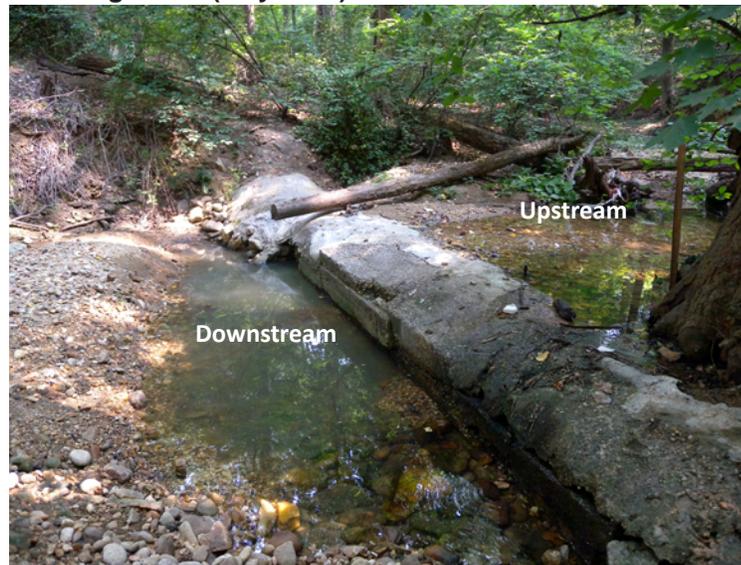
Figure 25. Upper Foundry Branch - Station 3 - Sewer Line Crossing No. 4 (July 2010)

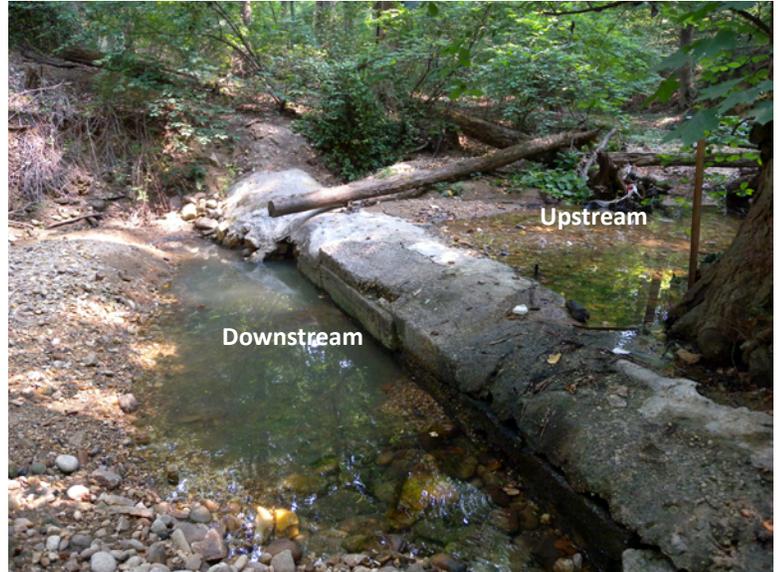
Figure 34. Upper Foundry Branch - Sewer line crossing #4 (Station 3) leaking into the downstream pool (turbid/grey colored water) (July 2010)

- Replace and relocate the sewer manhole stack located in the stream channel (upper Foundry Branch at transect No. 9);
- Replace, or at a minimum rehabilitate, all sewer lines crossing the stream channel, specifically the older vitreous clay pipes, via the employment of an Insituform® or equivalent lining. Subsequently, in-stream grade control structures (such as rock vanes) should be installed to prevent additional streambed downcutting and channel widening; and

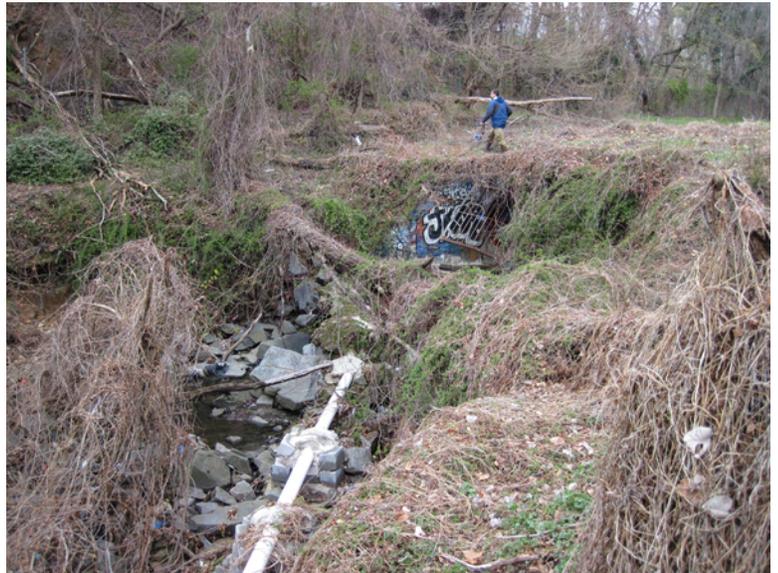
- Current in stream location (Figure 35) of the recent, temporary repair of the six inch PVC lateral line (located in the upper Foundry Branch, immediately downstream of the 60" RCP outfall) is anticipated to again break under higher stormflow conditions. It is strongly recommended that this pipe be replaced and relocated out of this high velocity area as soon as possible;
- Replace and relocate the sewer manhole stack located in the stream channel (upper Foundry Branch at transect No. 9);

Figure 35. Upper Foundry Branch - Repaired six inch PVC sanitary lateral line located in the stream channel downstream of 60" RCP outfall

- The six inch PVC lateral line (located in the upper Foundry Branch, immediately downstream of the 60" RCP outfall) is anticipated to again break under higher stormflow conditions. Therefore, it is strongly recommended that this pipe be replaced and relocated out of this high velocity area as soon as possible;

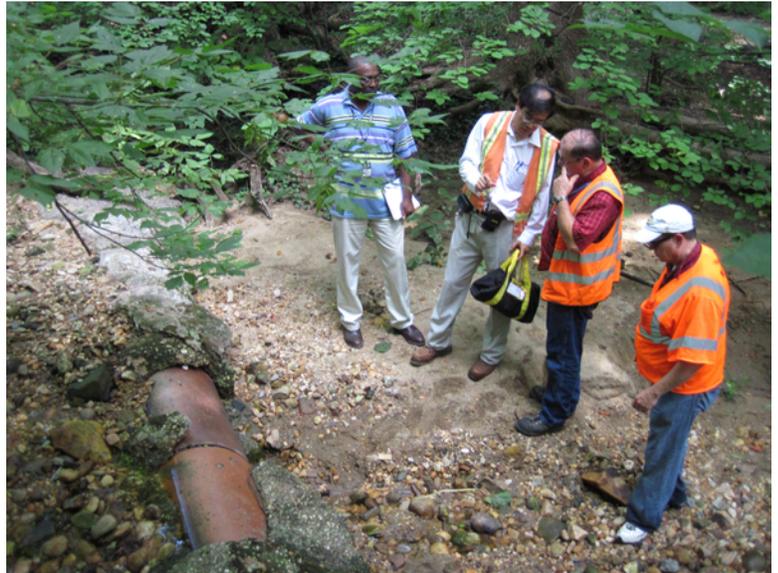
Figure 36. Upper Foundry Branch - DC Water staff inspecting a VCP sewer line with missing grout crossing upper Foundry Branch main stem

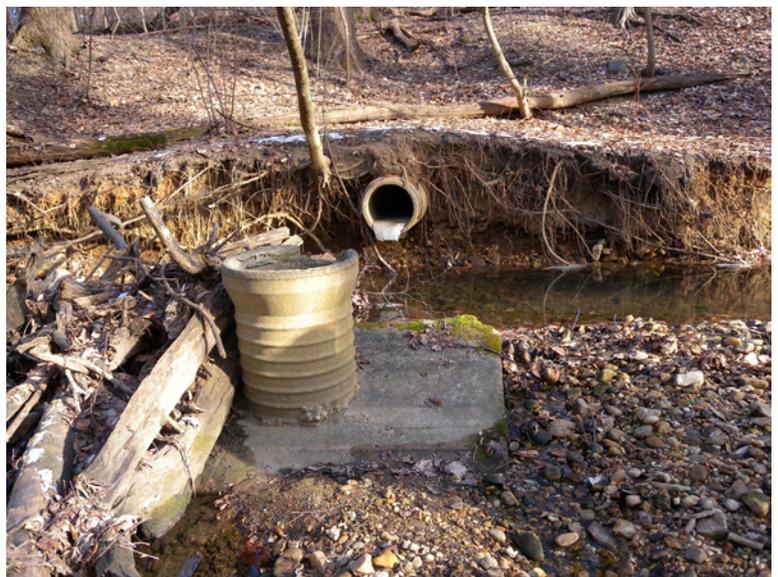
Figure 37. Upper Foundry Branch - Storm drain outfall # 5 with broken headwall lying within the stream channel

4. Given the major technical, institutional and financial challenges associated with the implementation of subwatershed-wide stormwater management controls (which significantly reduce runoff volumes entering Foundry Branch), a Rosgen-based main stem stream channel restoration project for the entire length of open channel (i.e., approximately 1.6 miles) is recommended. This would include the repair (Figure 37) and/or the installation of more effective velocity dissipation features at the preceding four storm drain outfall locations (No.s 1, 2, 3, and 5).
