GOVERNMENT OF THE DISTRICT OF COLUMBIA Department of Energy and Environment Environmental Services Administration

Underground Storage Tank Branch

LUST Cleanup Success Story

Site Name:	Maintenance and Repair Facility
Site Old Address: 54 Hanover Place, NW, Washington, DC 20001	
Site New Address:	57 N Street, NW, Washington, DC 20001
Ward #:	5
Facility ID:	9000281
LUST Case No.:	2015023
Square / Lots:	0617 / 0214 and 0215
Size:	34,256SF
Property Owner:	Mr. Kamlesh Gulati
Remediating Party:	W-G 57 N, LLC

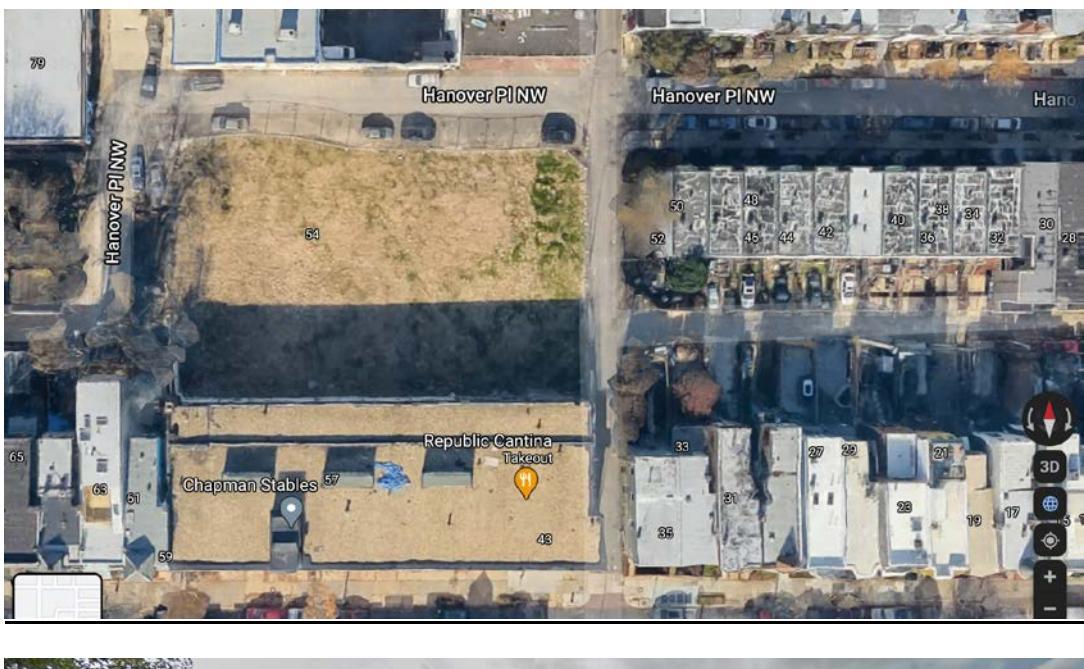
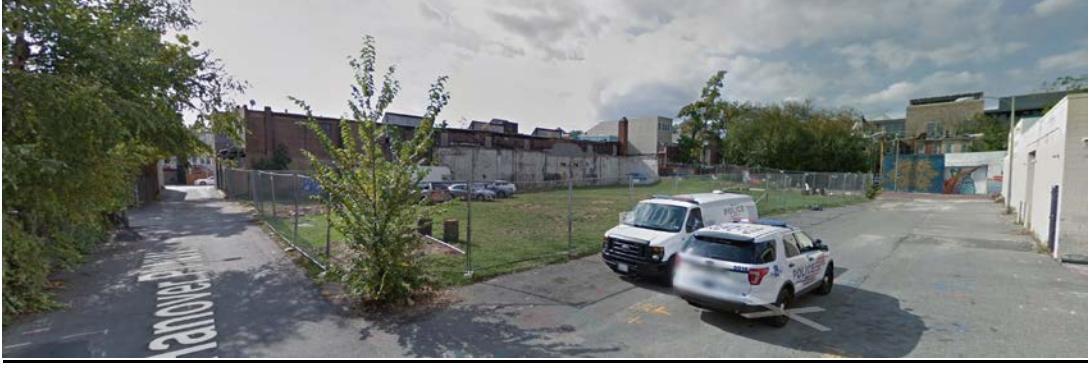
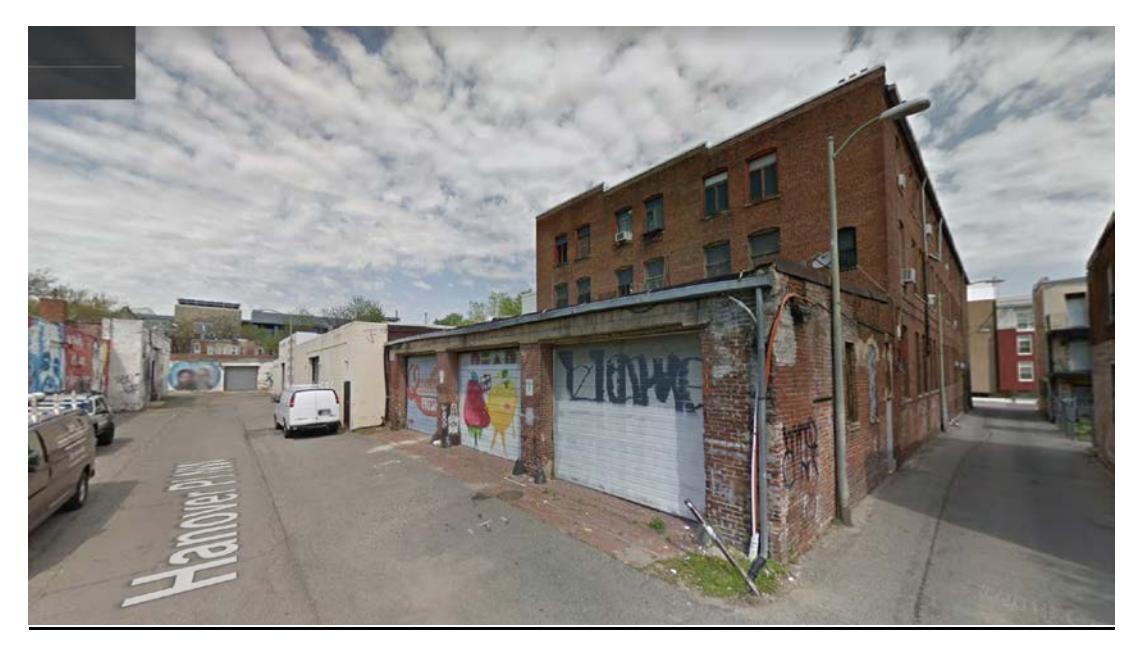
<u>PHOTOS [Before Development]:</u>

The development started in early 2015. During and before development several underground storage tanks were discovered and removed. The 2,000-gallon UST contained diesel fuel and the two 1,000-gallon USTs were believed to have contained gasoline and kerosene.

- 1. Petroleum contaminated soil and groundwater were identified in 2015 during an environmental investigation completed by the property owner. Based on the history of the Site, it is assumed that underground storage tanks historically located on the property were the source of the original release.
- 2. No surface water bodies are in the vicinity of the subject site, and groundwater is not used for potable purposes in the District of Columbia. The Site is surrounded by retail, commercial, and residential properties.
- 3. The average depth to groundwater at the Site is approximately at 28 feet below grade.
- 4. Currently, the Site has a multistory building including a basement community hall with parking and residential apartments/condominiums.

Excavation and remediation were completed at the site in accordance with a DOEE approved workplan. Post remediation soil and groundwater concentrations at the Site are below the Tier 1 RBSLs and do not pose a significant threat to human health and/or the environment.

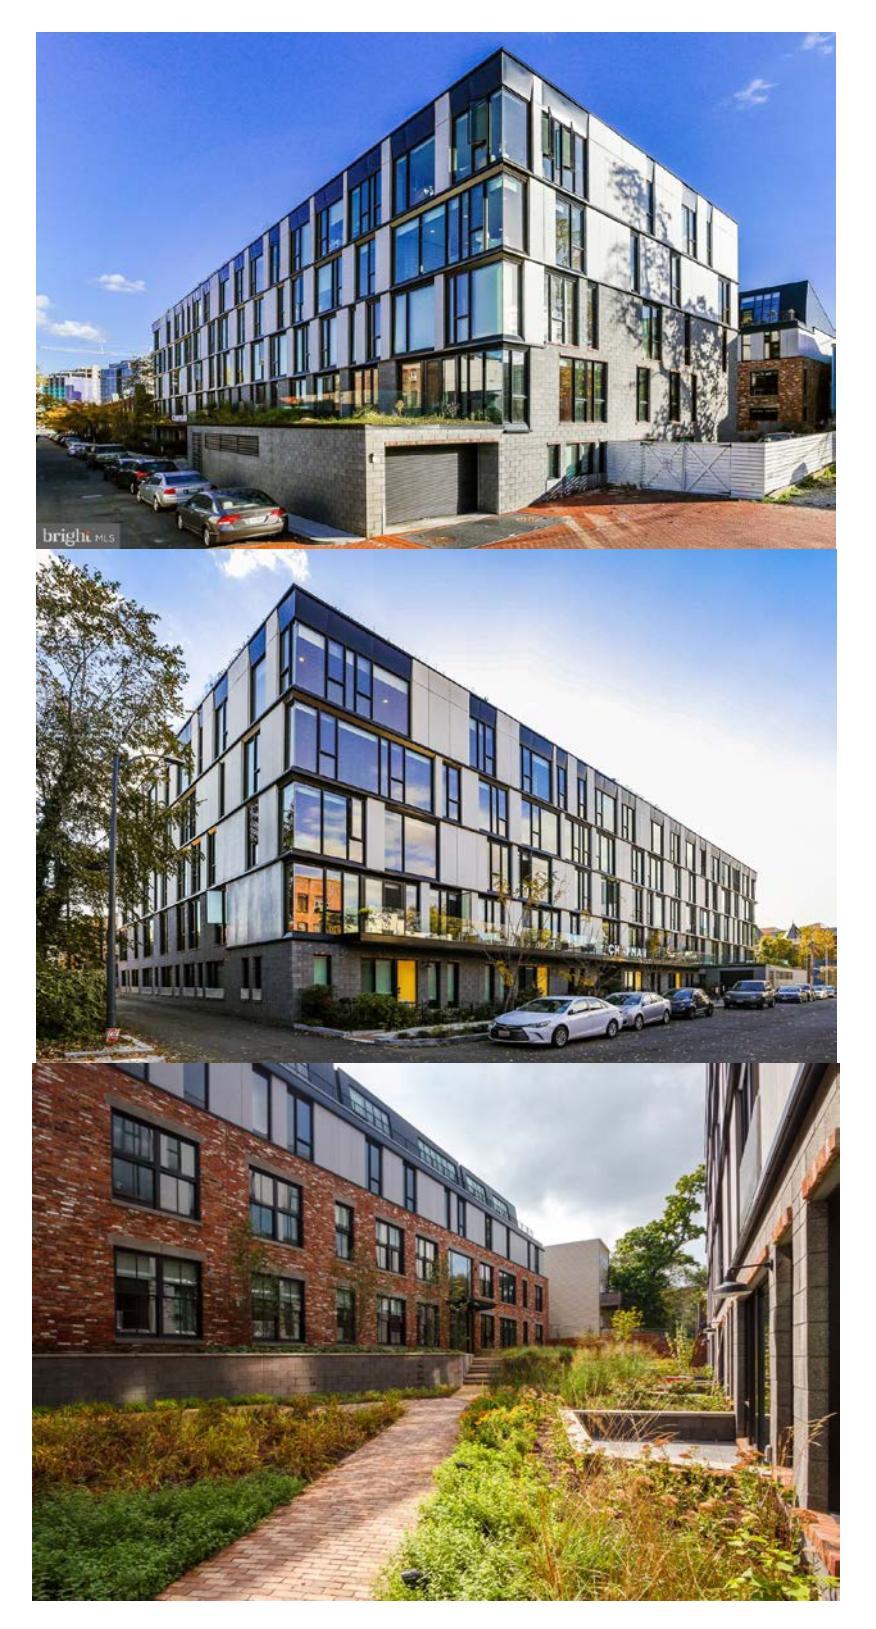
PHOTOS [After Development]:

Currently, the site is comprised of five-story high-rise building as shown on the photographs below. The building contains residential apartments and condominium.
