Stream Restoration Monitoring Protocol:

Photo Documentation Guide

GOVERNMENT OF THE DISTRICT OF COLUMBIA
Department of Energy and Environment

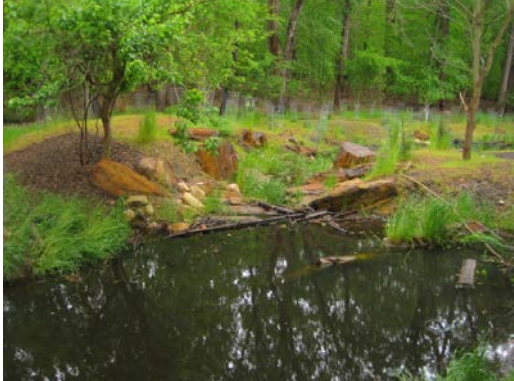
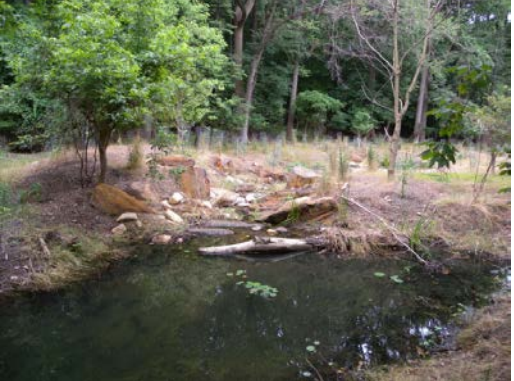
Station	Feature	Comments	Corrective Action Needed		
				March 2012	August 2012
0+10	Pool #1	<ul style="list-style-type: none"> • Deep wide pool • Water lily • Aquatic grasses appear healthy • Clear water 	None

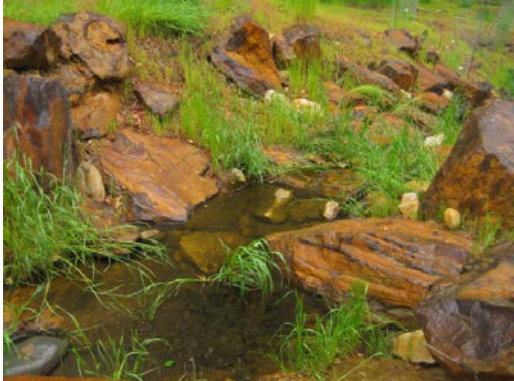
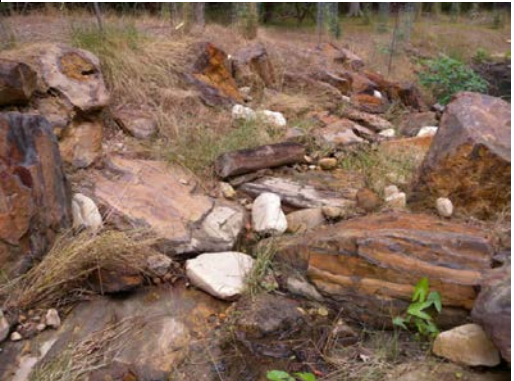
0+24	Weir #1	<ul style="list-style-type: none"> • Large stable boulders • Good riffle cascade into downstream pool • New large woody debris • New lily vegetation • Healthy riparian growth 	None; monitor vegetative groundcover to ensure plant growth

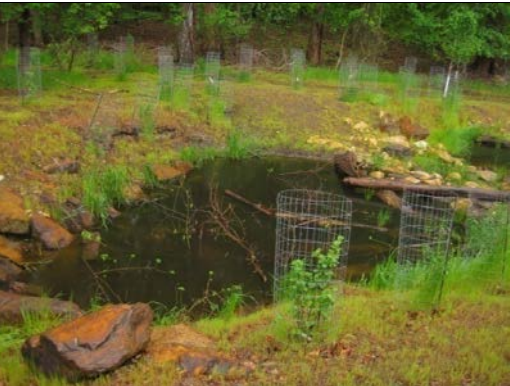
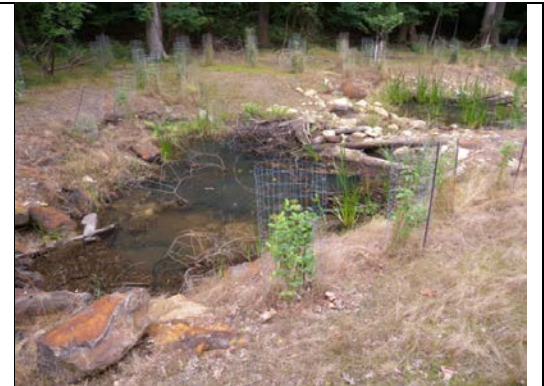
Pool #2	<ul style="list-style-type: none"> • Good stable pool • Vegetation within and outside • Clear water 	None; monitor vegetation

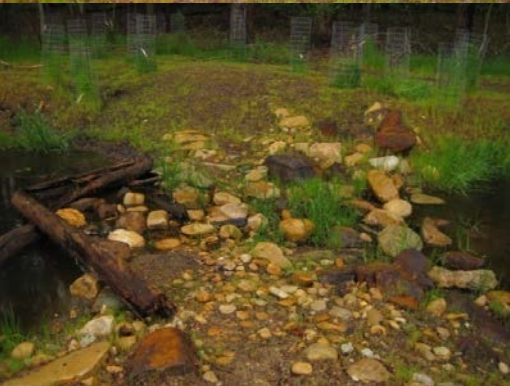
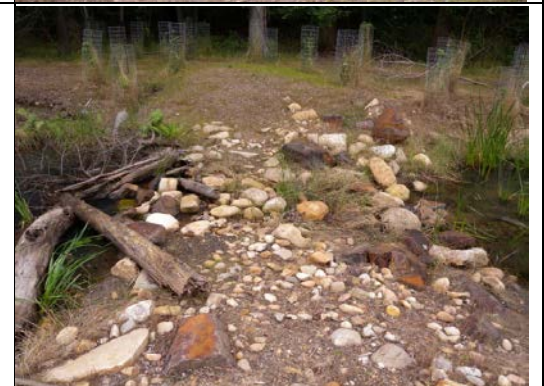
Weir #2	<ul style="list-style-type: none"> • Good stable condition • Low to no flow over weir 	None; monitor vegetation
