DEPARTMENT OF ENERGY & ENVIRONMENT Fort Stevens Recreation Center

Design Report, August 2021 DPR II – Design and Build 4 LID Sites Contract Number CW712222

Prepared by Natural Resources Design Christopher Sonne, P.E., SITES AP Barbara Neal, ISA #4283B, RCA#428 Lauren Wheeler, LEED AP, SITES AP Sylvan Kaufman, PhD

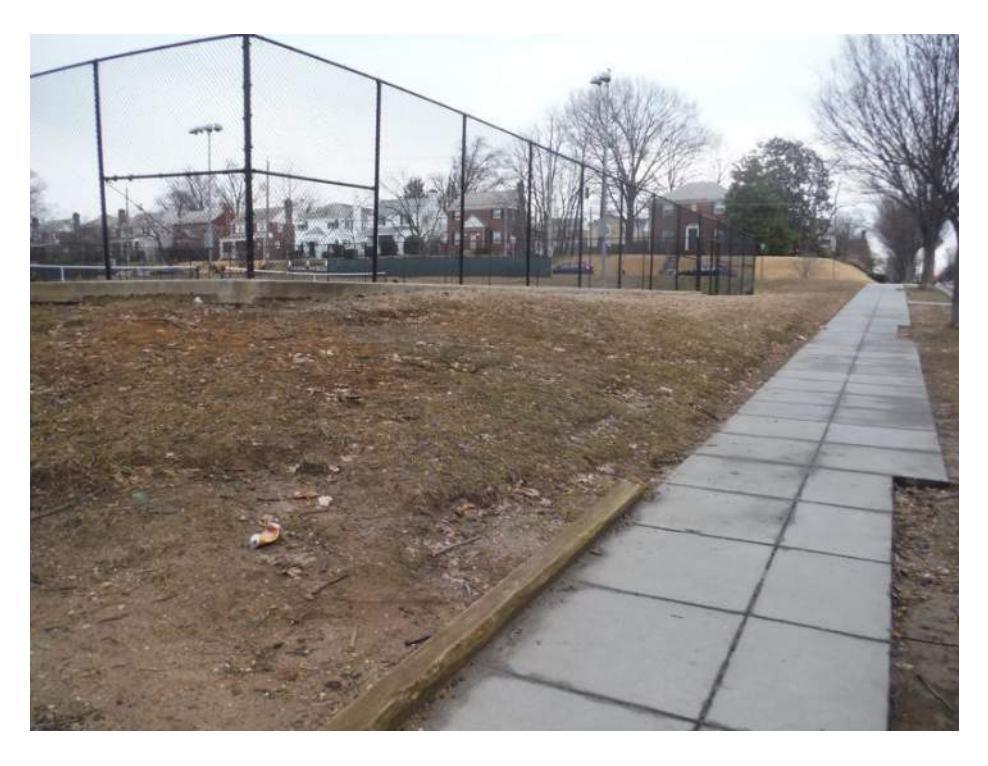
The majority of this erosion appears to be due to large volumes of runoff from the tennis courts overflowing the adjacent curbing and scouring the soils on the steep slopes below (Figure 1). During the field inspection, we noted that the drain inlet for the tennis courts has been fitted with a mesh screen which is clogged and causing these overflow conditions (Figure 2).

Figure 1 - Erosion below southeast corner of the tennis court area located along Van Buren Street.

Tennis courts (southern end) – The existing drainage structure has been fitted with a mesh grate cover to prevent tennis balls from entering. This mesh cover plugs and causes the system to overflow. This mesh will be removed and the basin will be fenced out of the tennis court play area. Reducing the overflow conditions will lessen downstream soil erosion.

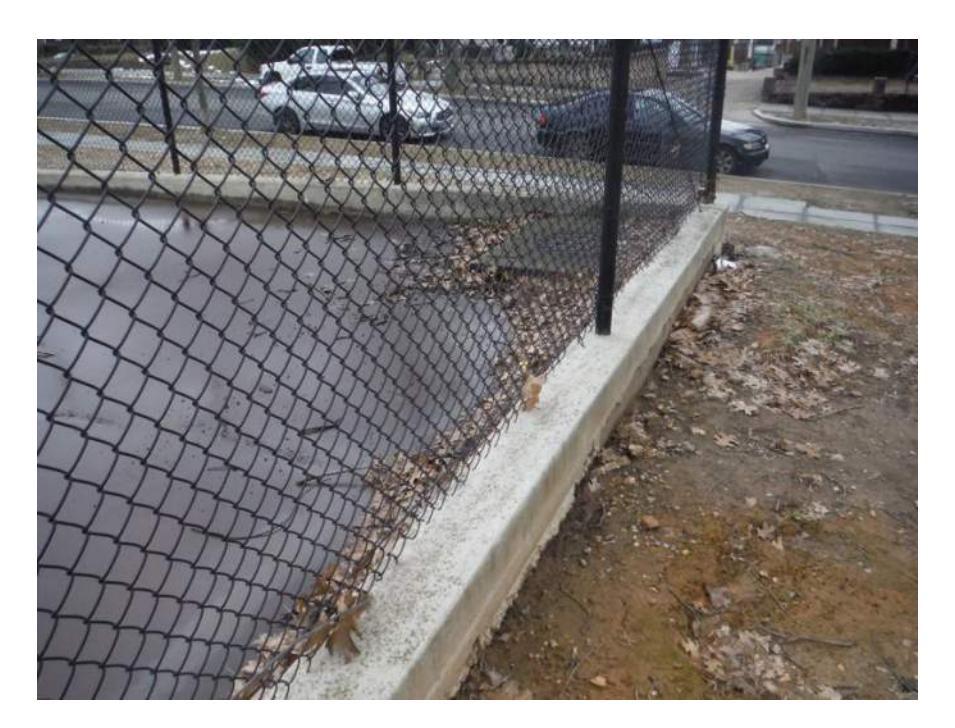
Figure 2 - Plugged inlet at southeast corner of tennis court area

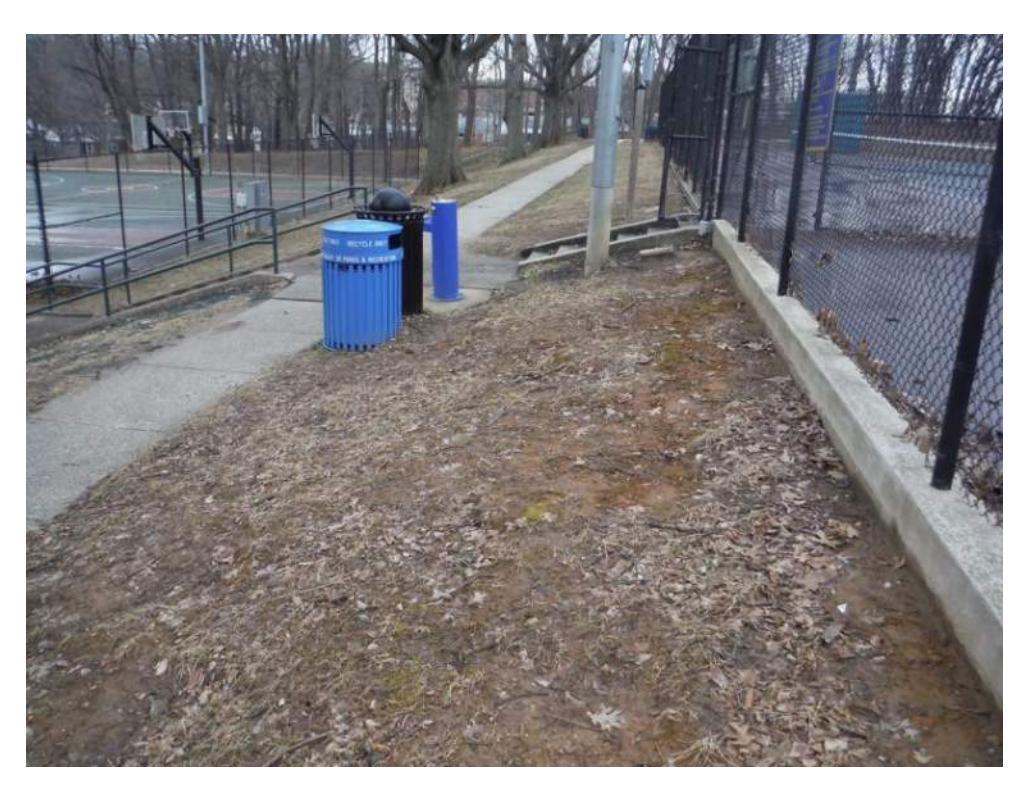
Additional erosion resulting from tennis court runoff occurs as stormwater flows over the shallow curbing at the northwest end of the courts and down the steps to the fenced tennis court area (Figures 3 and 4). A protective soil matting has been installed on the slopes around the existing oak trees, but it is not clear if this is providing the required degree of soil and tree protection.

Figure 3 - Erosion below tennis courts

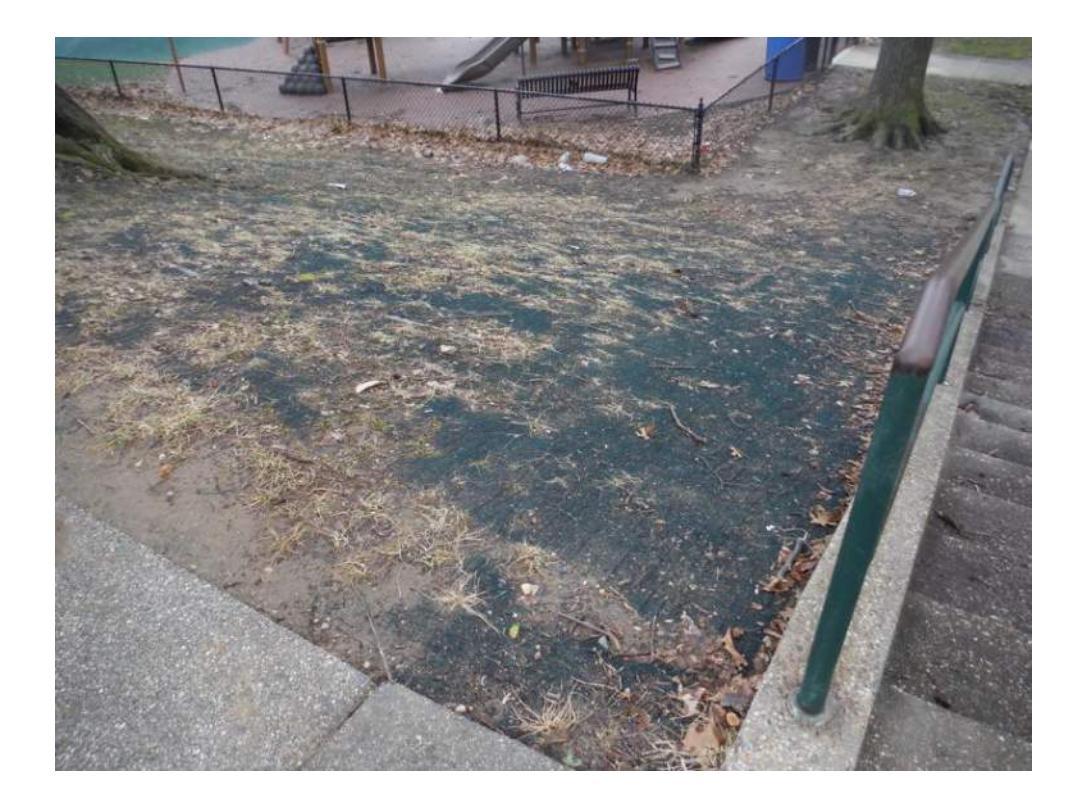
Figure 4 - Eroded bank below the sidewalk that abuts the tennis courts (with soil protection matting)

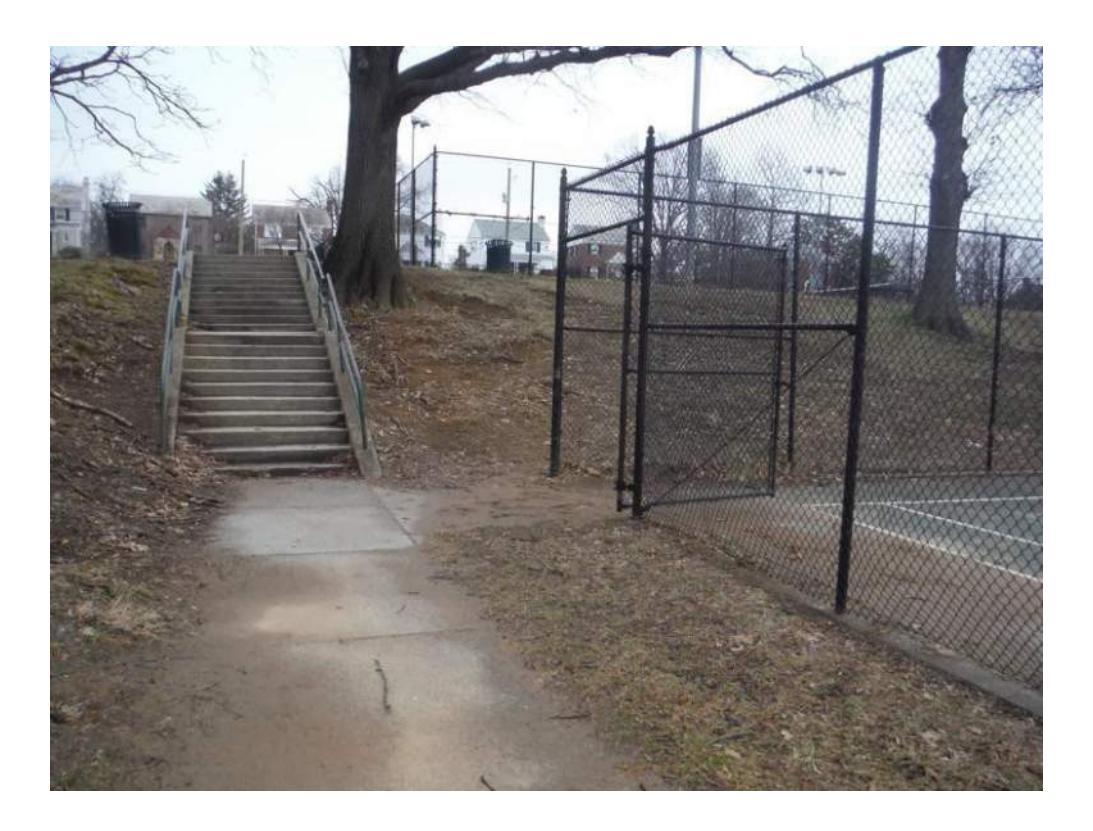
Eroded soil washes down the slopes and onto the sidewalk and upper entrance to the basketball courts. (Figure 5).

Figure 5 - Erosion above basketball court area

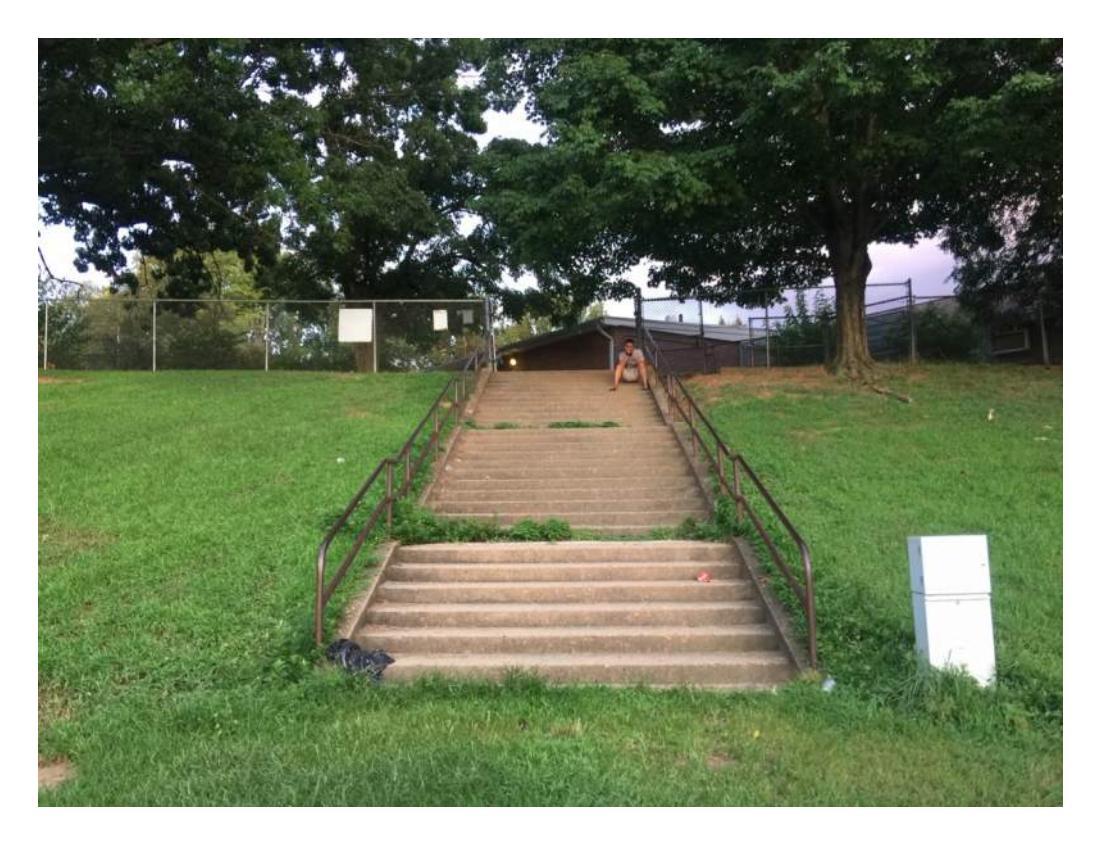
During heavy rain events, it appears concentrated stormwater from the area around the Community Center bypasses the existing storm swale and runs down the steep slope to the soccer fields. This has caused significant erosion adjacent to the existing concrete steps (Figure 6).

Figure 5 - Erosion seen on the right of the upper portion on the steps.

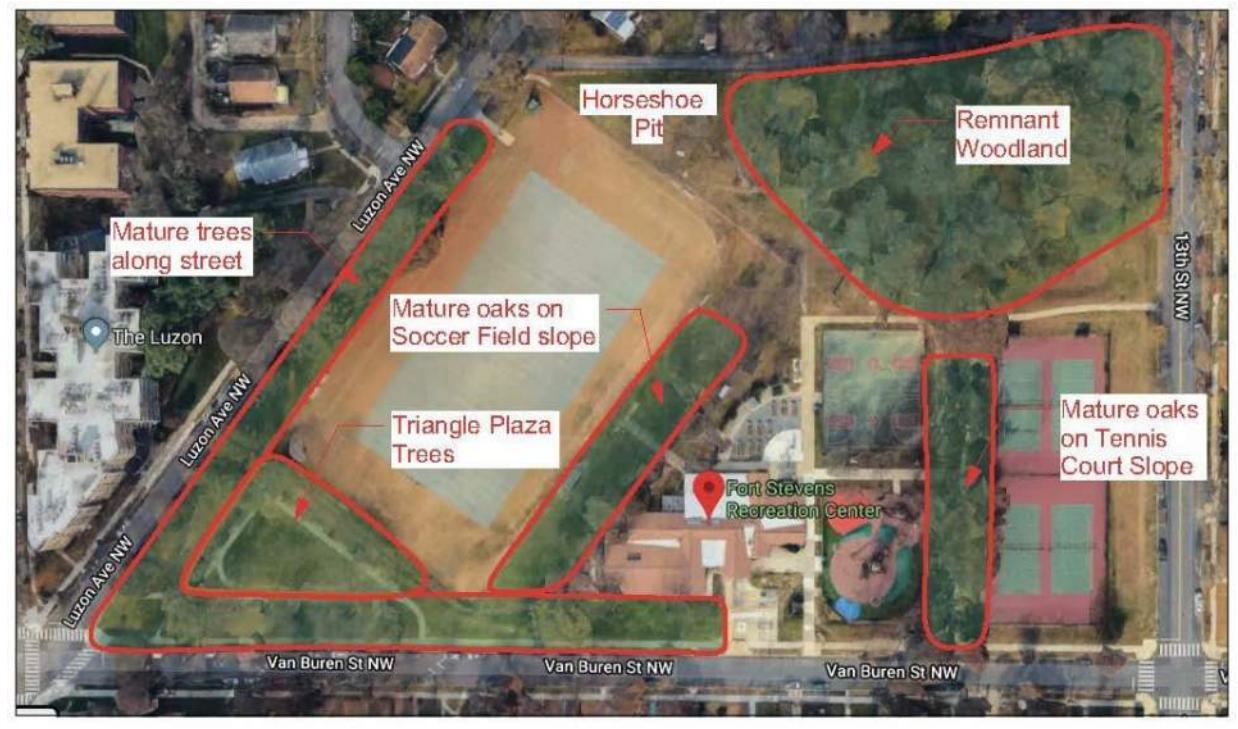
Figure 6 – Existing Vegetation

The existing vegetation on site (Figure 6) can be divided in two areas. The "developed" area which dominates the site and is located on the southern portion of the park. This area largely consists of very mature trees located on the steep slopes between the tennis courts and playground, and between the Community Center and the soccer field. It also includes a row of trees along Luzon Avenue and mature trees that surround a seating area that abut the Triangle Turf Plaza. There are limited foundation plantings around the recreation center building, a community garden and shrubs on the north side of the Community Center, and some shrubs and perennials in a bioretention cell located at the corner of the splash park.

The "wooded area" consists of a remnant woodland is located at the northern side of the park. It is a combination of mature trees and understory plants with a heavy infestation of invasive plants. Though it should be noted that the management of the vegetation of this area is not within the project scope.

The predominate groundcover plant on the site is turf. Between the tennis courts and 14th Street is a turf strip in good to fair condition. The turf located underneath the shade trees between the tennis courts and playground and by the recreation center and soccer field, is in poor condition due to the shade cast by the mature oaks. The Triangle Turf Plaza is in good condition and the turf located in the tree lawns along the streets is in good to fair condition.
