Prepared for:
Pepco and Pepco Energy Services
Washington, D.C.

Prepared by:
AECOM
Beltsville, Maryland
September 2016

TECHNICAL MEMORANDUM #1 CONCEPTUAL SITE MODEL

Benning Road Facility
3400 Benning Road, NE
Washington, DC 20019

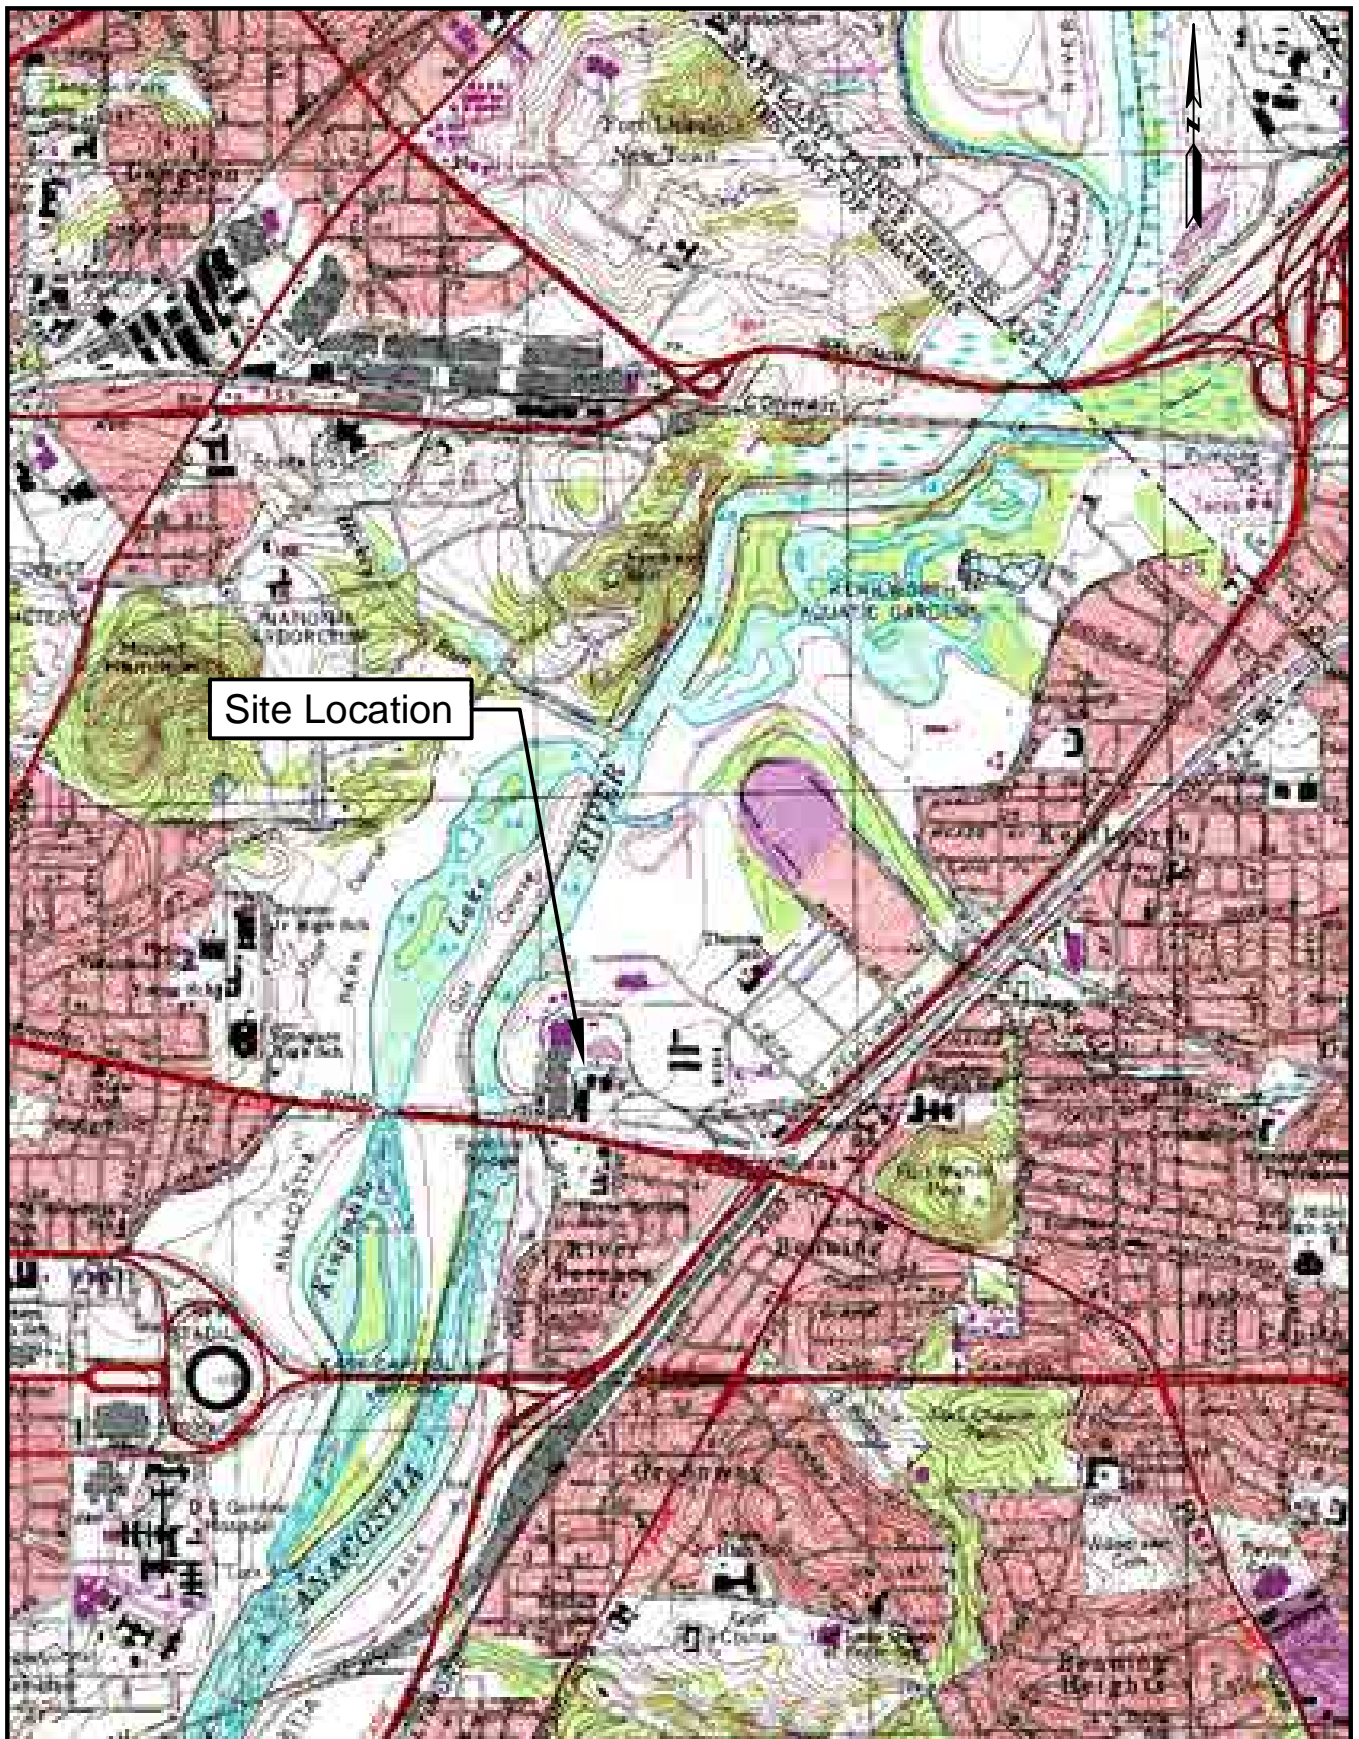
FIGURE 1-1

Source:
USGS 7.5 Minute Topographic Map
Washington East Quadrangle

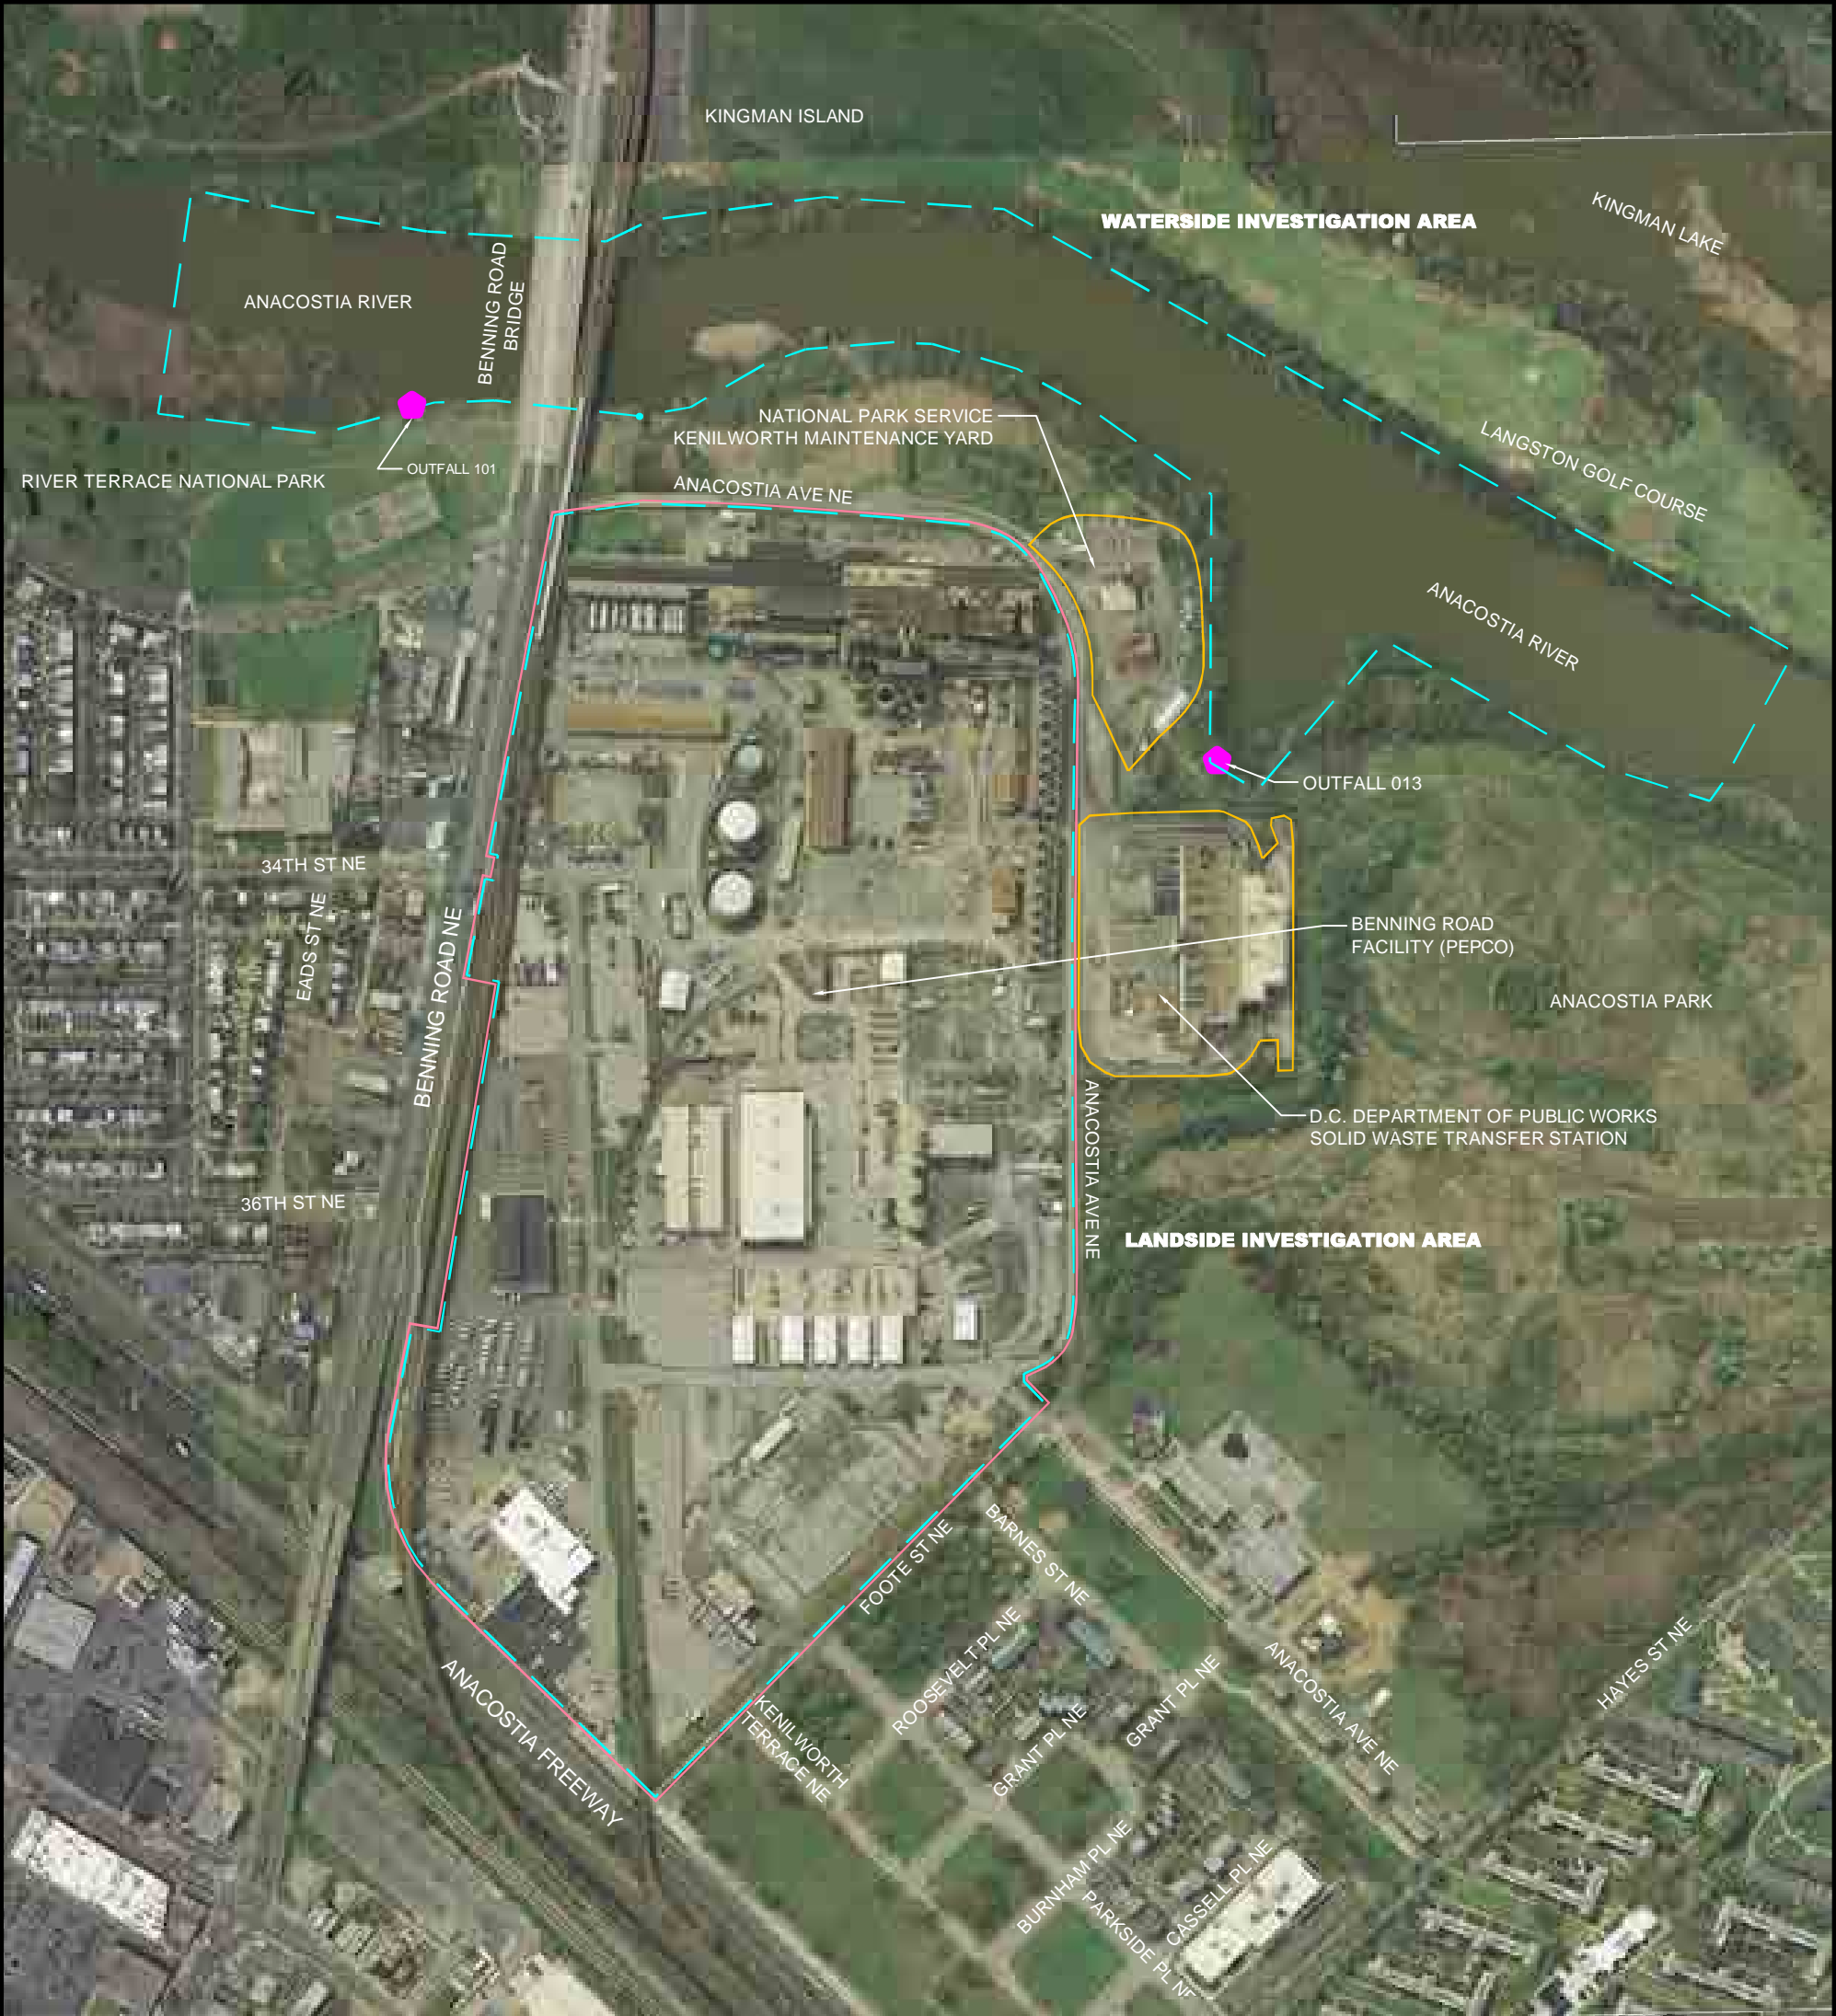
Benning Road Facility RI/FS Project 3400 Benning Rd., NE Washington, DC 20019			Site Plan And Investigation Areas (Pre-Power Plant Demolition)	
	DATE: 09/21/2016	DRAWN BY: LAD	CHECKED BY: RD	FIGURE 1-2

- INVESTIGATION AREA
- BENNING ROAD FACILITY PROPERTY BOUNDARY
- PROPERTY BOUNDARY

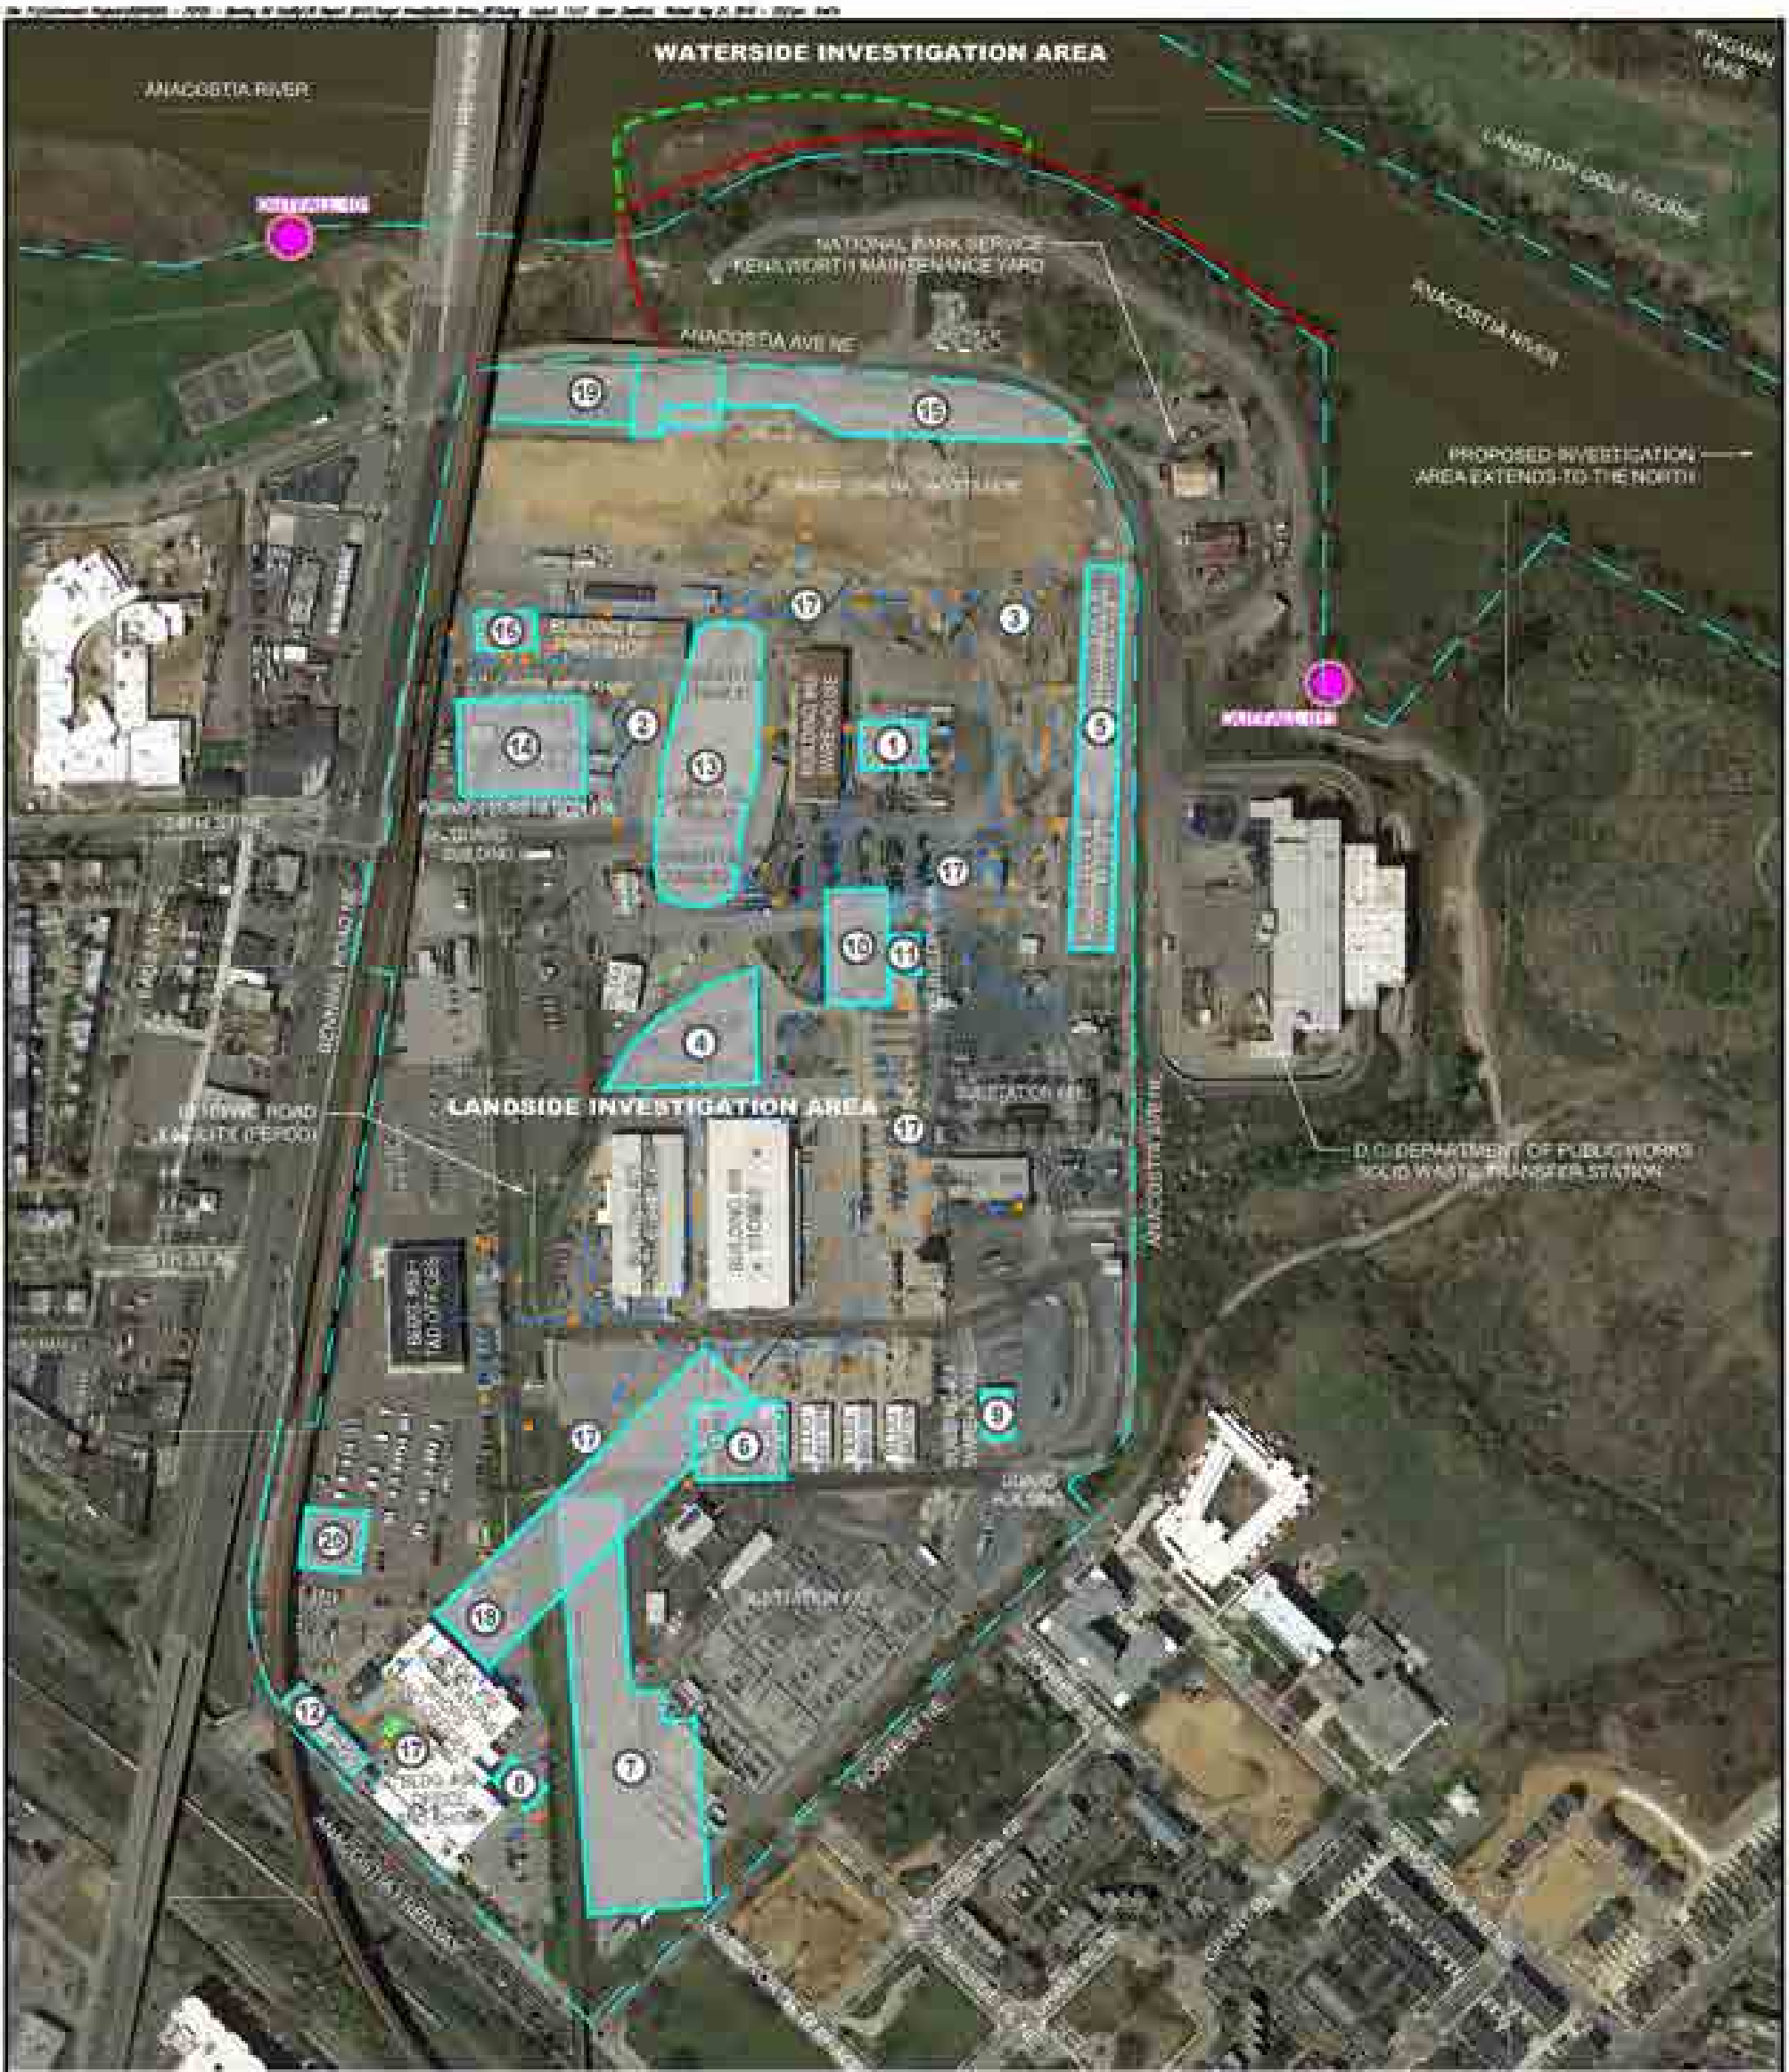
FIGURE 1-3

- 18 TARGET AREA #
- TARGET AREA
- NPDES OUTFALL TO ANACOSTIA RIVER
- INVESTIGATION AREA
- STORM WATER UTILITY
- APPROXIMATE FORMER CONSTRUCTED WETLANDS BOUNDARY
- APPROXIMATE LOCATION OF SEA WALL
- 15,000 GALLON TRANSFORMER OIL UST

Target Investigation Areas
(Current Site Plan)

There are three active underground storage tanks (USTs) at the Site. One is a 15,000-gallon double-walled steel and fiberglass tank installed in 1988 to hold new non-PCB transformer oil. The 15,000-gallon double-walled new transformer oil UST is located within the paved yard surrounded by Buildings 54, 56 and 57. A 20,000-gallon fiberglass tank, installed in 1975, contains gasoline, and a second 20,000-gallon double-walled tank, installed in 1991, holds diesel fuel. All three tanks have leak detection monitoring devices which test the tanks and underground piping for leaks on a monthly basis. These tanks are registered with the District Department of Energy & Environment (DOEE) and are operated in compliance with the District's UST regulations. The locations of these USTs are shown on **Figure 1-3**.

According to the 1999 URS ESA, the Former Railroad Switchyard located east of Building 32 contained deactivated transformers, outdoor metal switchgear, oil-filled circuit breakers, and a battery storage area, some of which appeared to be in disrepair. Staining was observed on the stone beneath one of the existing transformers and also near a transformer that had been removed. The location of the former railroad switchyard is shown on **Figure 1-4**.

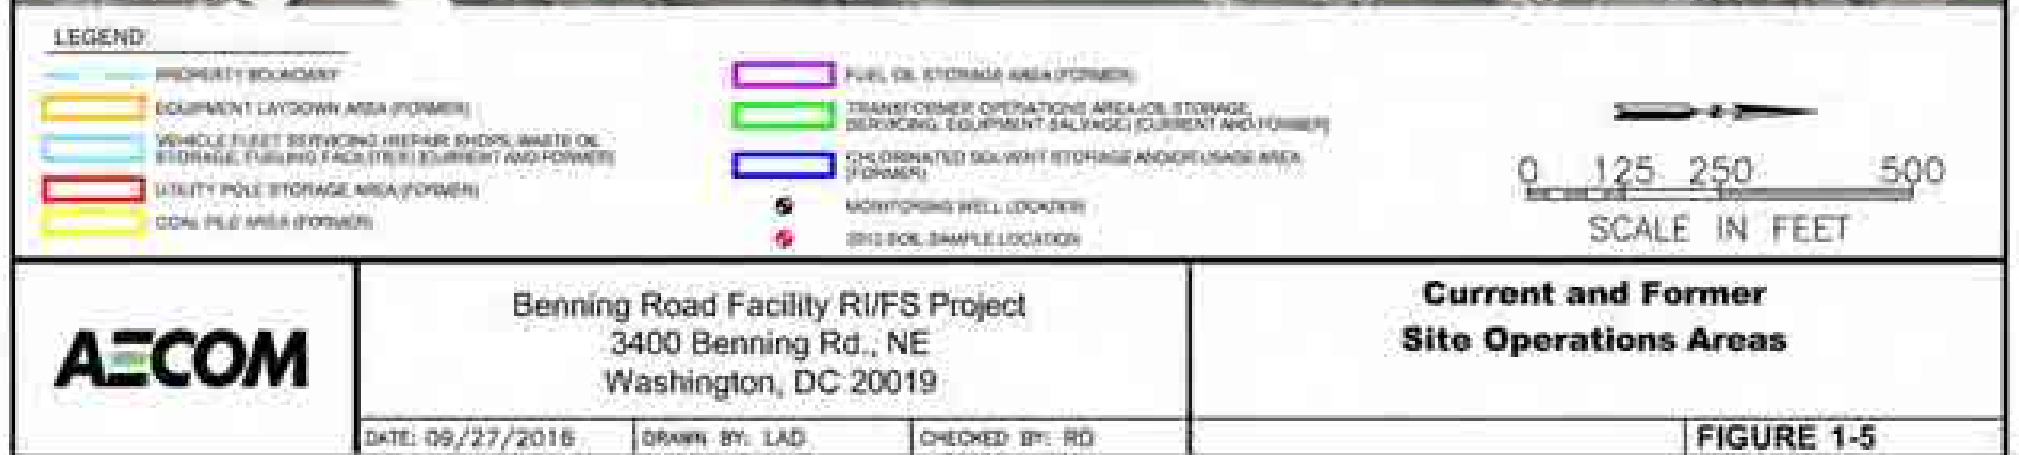
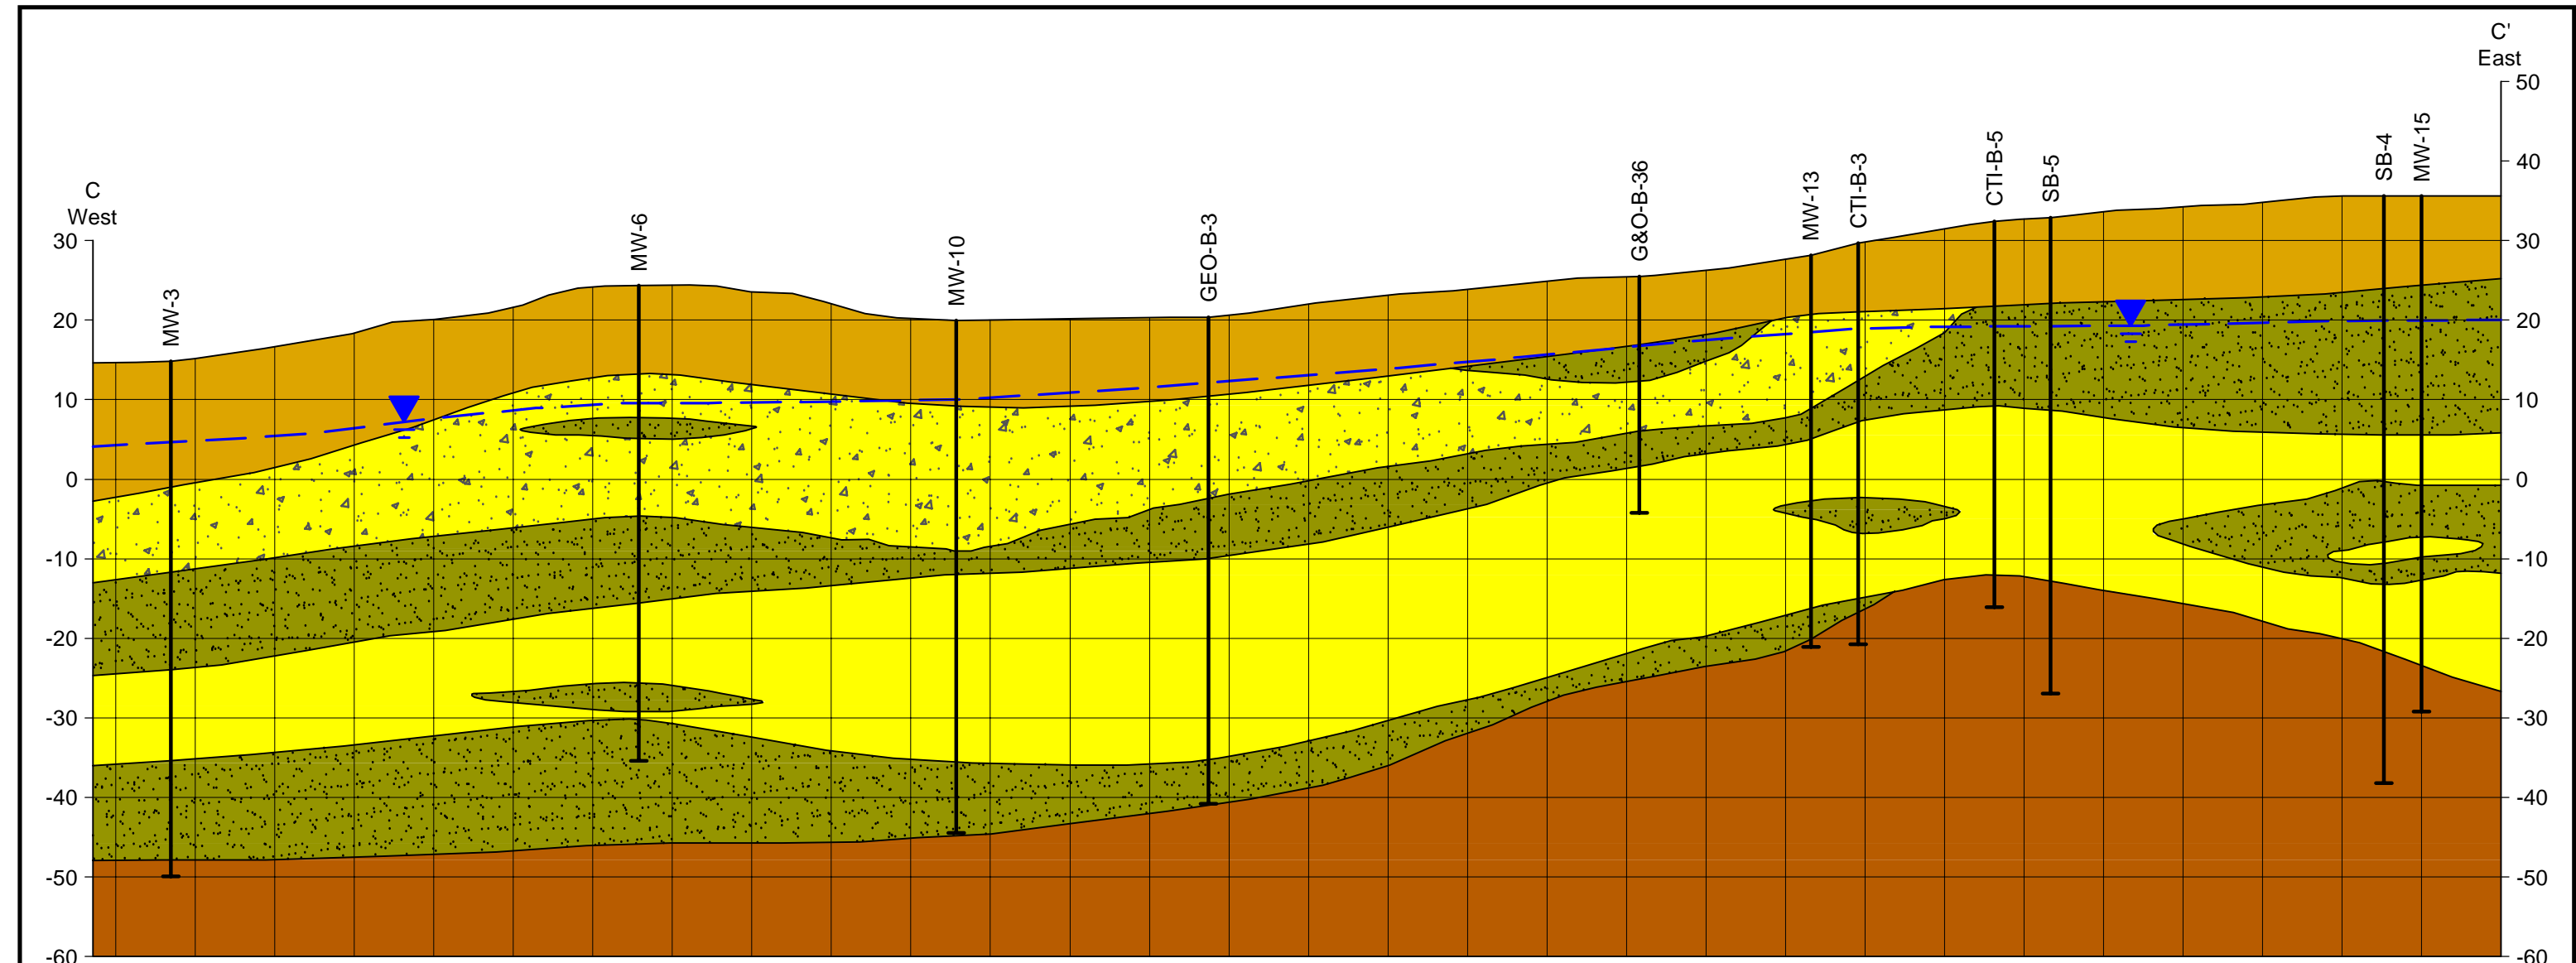
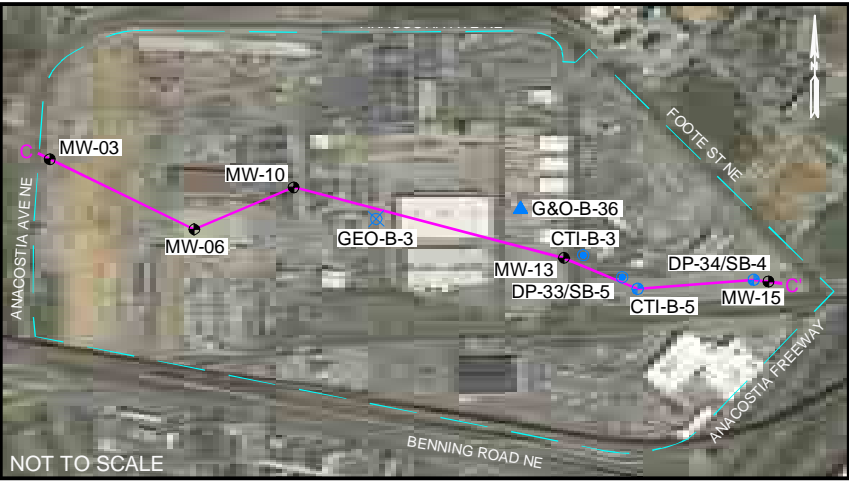
Benning Road Facility RI/FS Project 3400 Benning Rd., NE Washington, DC 20019			Geologic Cross Section C-C'	
DATE: 03/14/2016	DRAWN BY: LAD	CHECKED BY: RD	FIGURE 3-1

Cross Section C-C'

- Boring Location And ID
- Alluvium/Fill
- Sand
- Sand/Gravel
- Clay, Silt, and Sand Intermixed
- Arundel Clay
- Inferred Lithology
- NAVD88 North American Vertical Datum of 1988
- Depth To Water (Encountered during drilling.)
- Approximate Water Table

NOTE: GEOLOGIC CROSS-SECTIONS ARE GENERALIZED

Underlying the Patapsco Formation is the Arundel Clay, a distinct regional confining layer, comprised of very stiff, fat, mottled maroon and dark grey clay. The Arundel Clay underlies the Site at a depth of between 45 and 85 ft bgs, and generally dips toward the west. The thickness of the Arundel Clay varies, but has been observed to be as much as 100 feet thick (USGS, 2002).

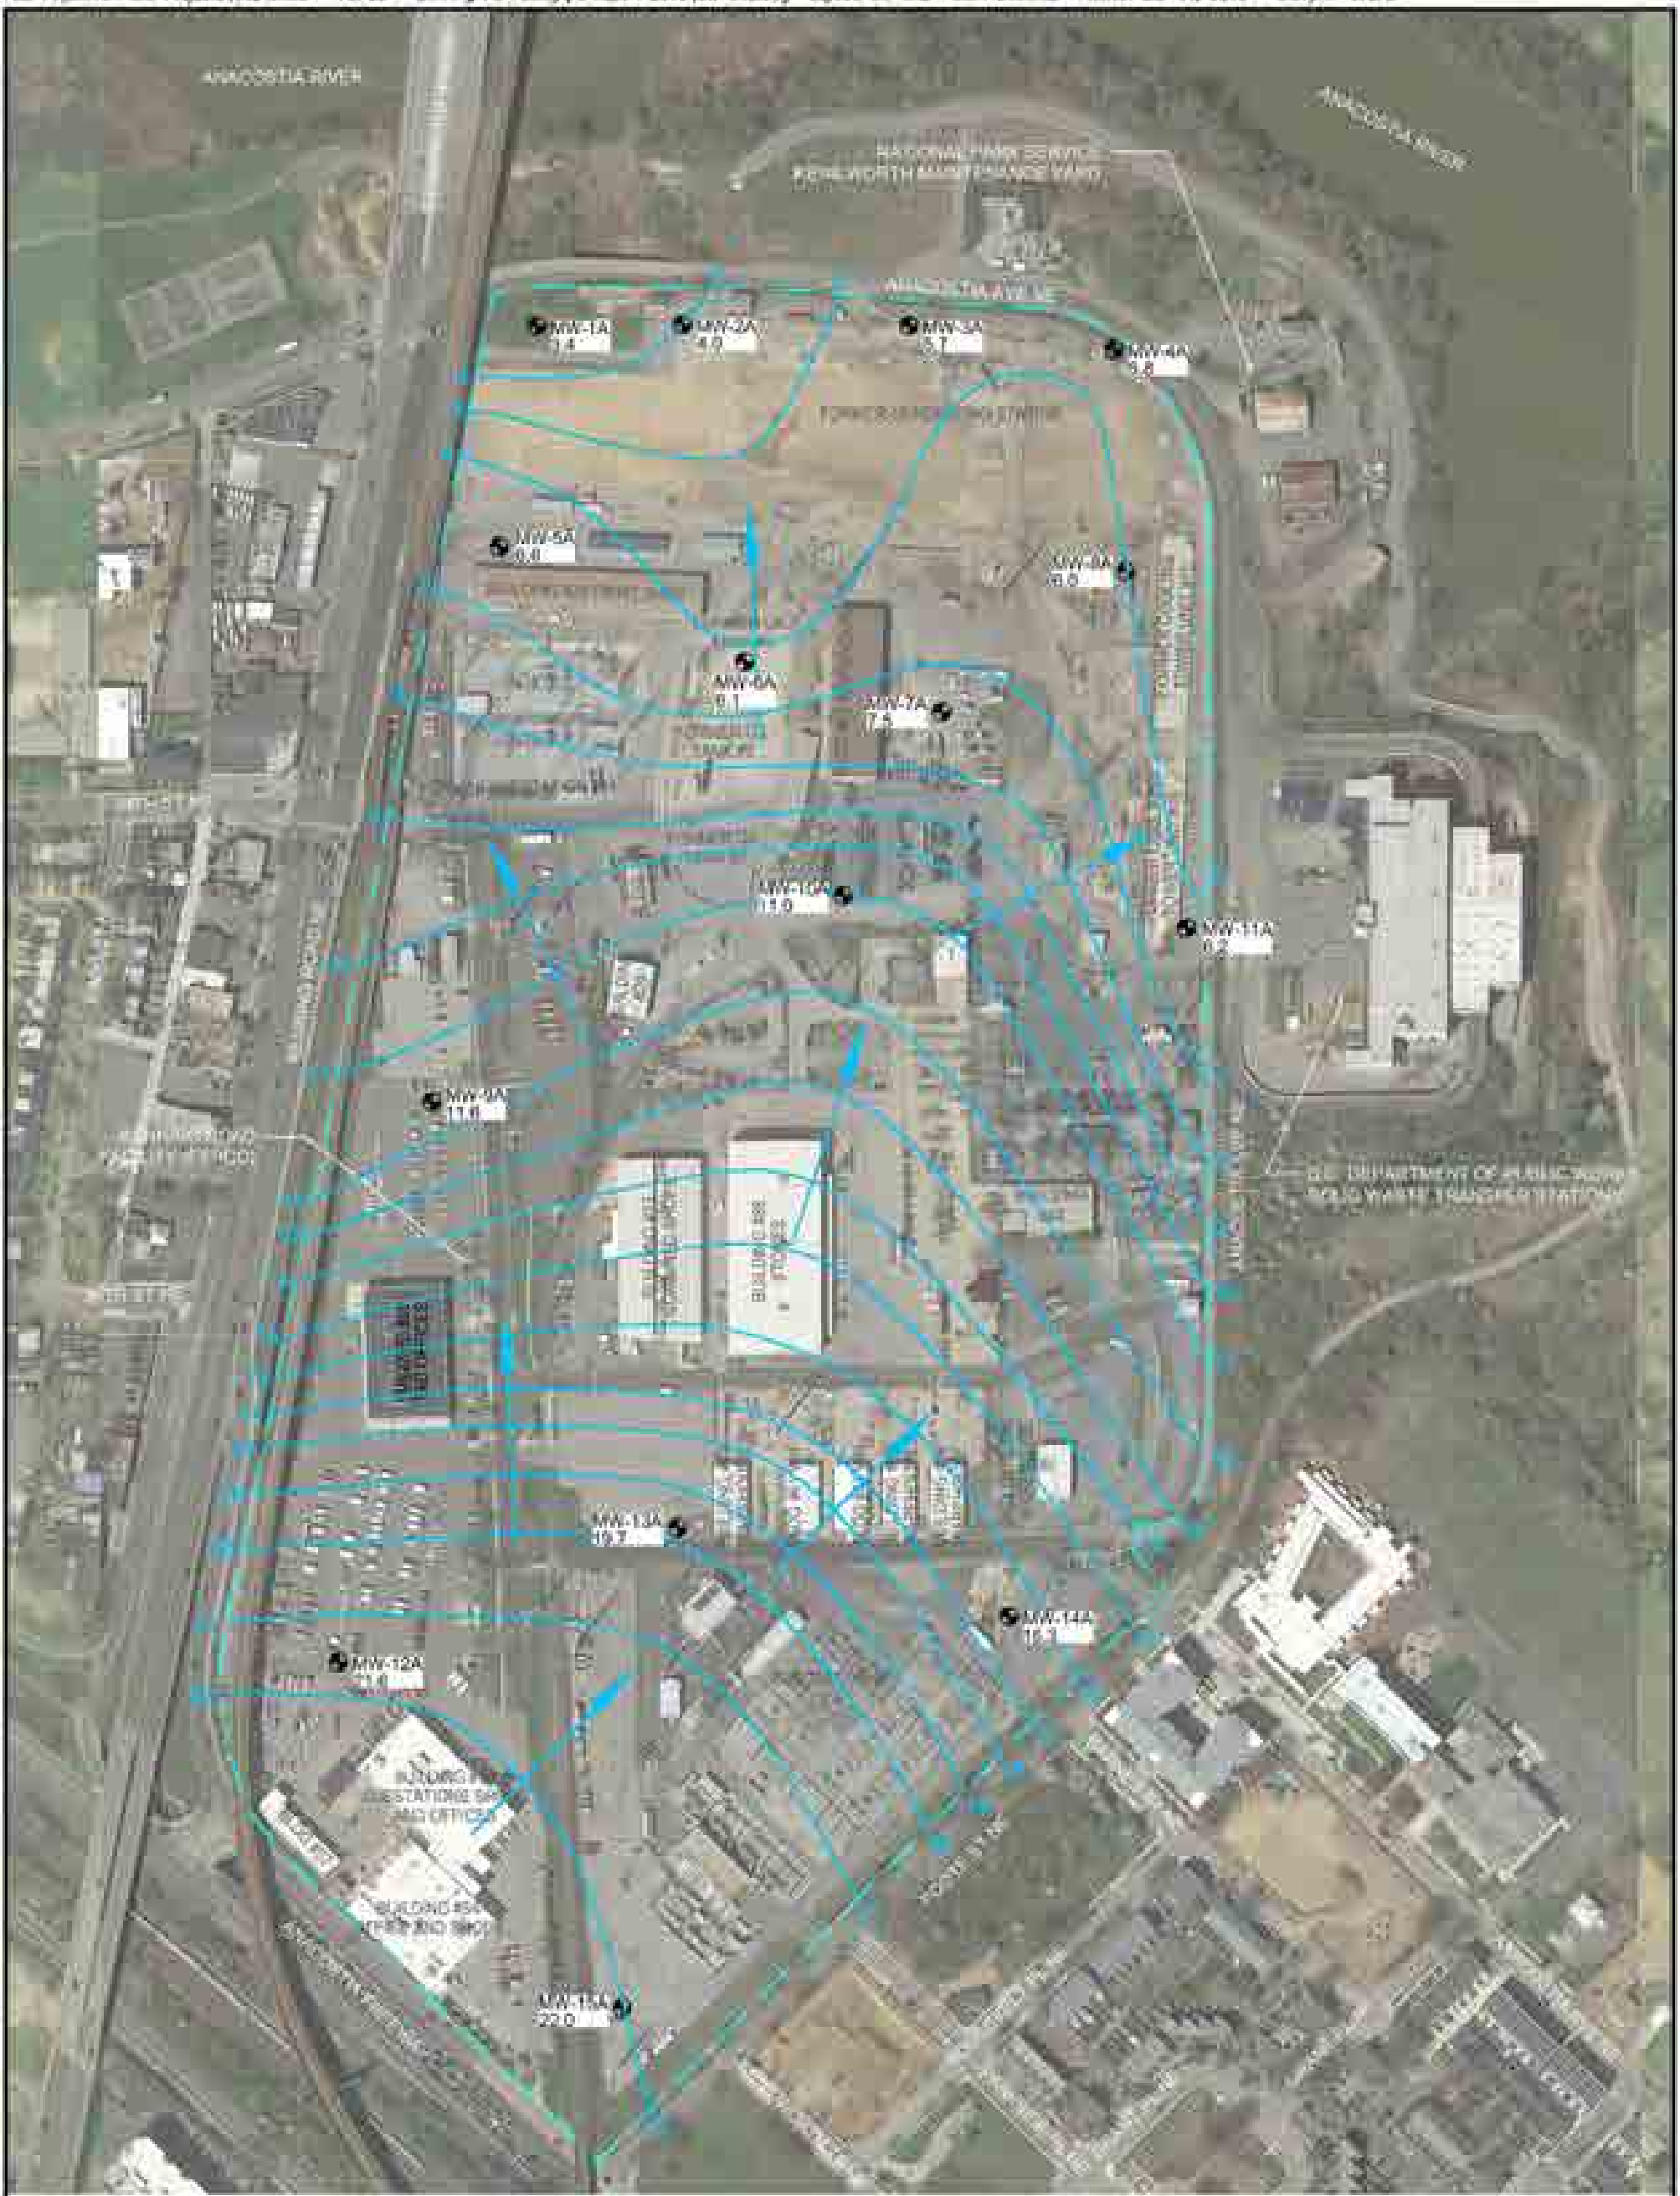
Upper Water-Bearing Zone
Groundwater Contour Map

- MW-12 21.6 MONITORING WELL LOCATION, ID, AND GROUNDWATER ELEVATION IN FEET
- GROUNDWATER CONTOUR
- DIRECTION OF GROUNDWATER FLOW
- SITE BOUNDARY

Groundwater contour maps have been prepared for average (mid-tide) groundwater levels in the UWZ and LWZ (**Figures 3-2** and **3-3**, respectively). Mid-tide groundwater levels were computed from gaging measurements collected during mid-tide conditions in the Anacostia River. Based on the results of the tidal study, there is little variation in water levels (1-3 inches) across much of the Site (excluding the southwest corner near the dredged inlet [MW-01]) between low and high tides. The direction of groundwater flow in both aquifers is generally toward the River to the west. In both aquifers, groundwater flow in the northern and eastern portions of the Site is toward the northwest, while groundwater flow in the western and southern portions of the Site is toward the west or southwest. In both the UWZ and LWZ, horizontal hydraulic gradients become shallower nearer the River. During high tide conditions, hydraulic

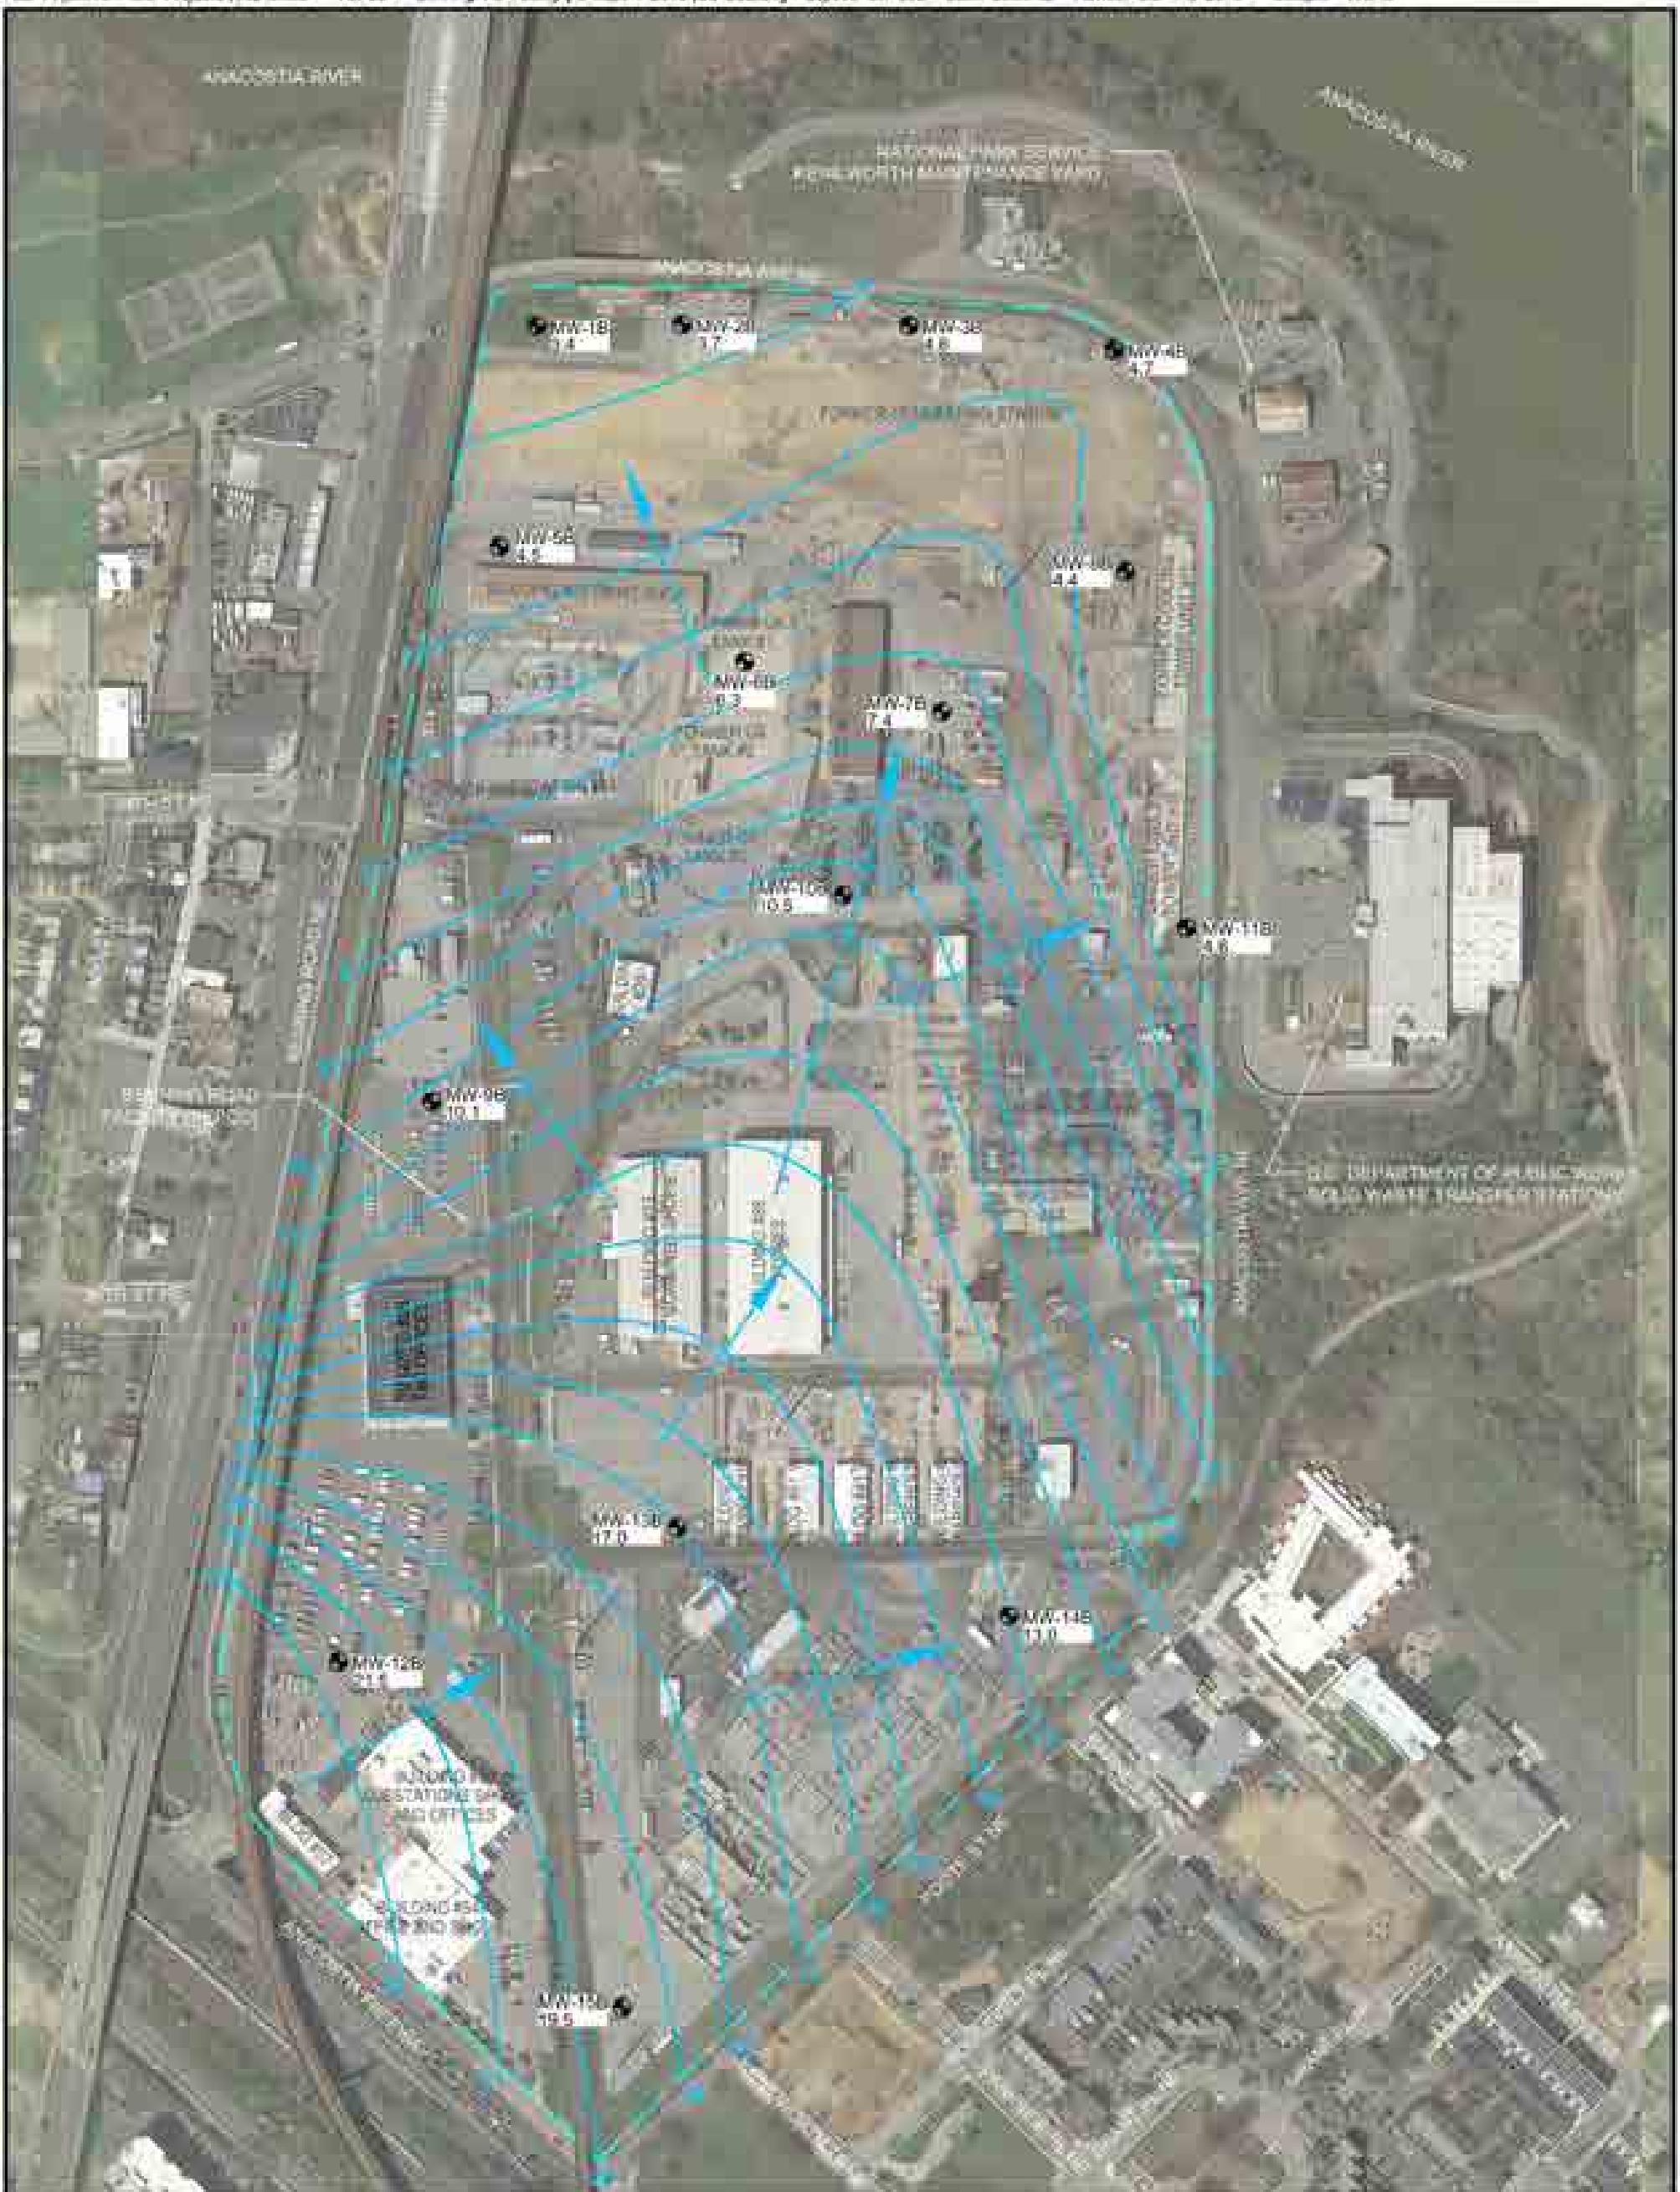
Lower Water-Bearing Zone
Groundwater Contour Map

- MW-12 21.5 MONITORING WELL LOCATION, ID, AND GROUNDWATER ELEVATION IN FEET
- GROUNDWATER CONTOUR
- DIRECTION OF GROUNDWATER FLOW
- SITE BOUNDARY
