Prepared for:
Pepco and Pepco Energy Services
Washington, D.C.

Prepared by:
AECOM
Beltsville, Maryland
September 2016

TECHNICAL MEMORANDUM #1 CONCEPTUAL SITE MODEL

Benning Road Facility
3400 Benning Road, NE
Washington, DC 20019

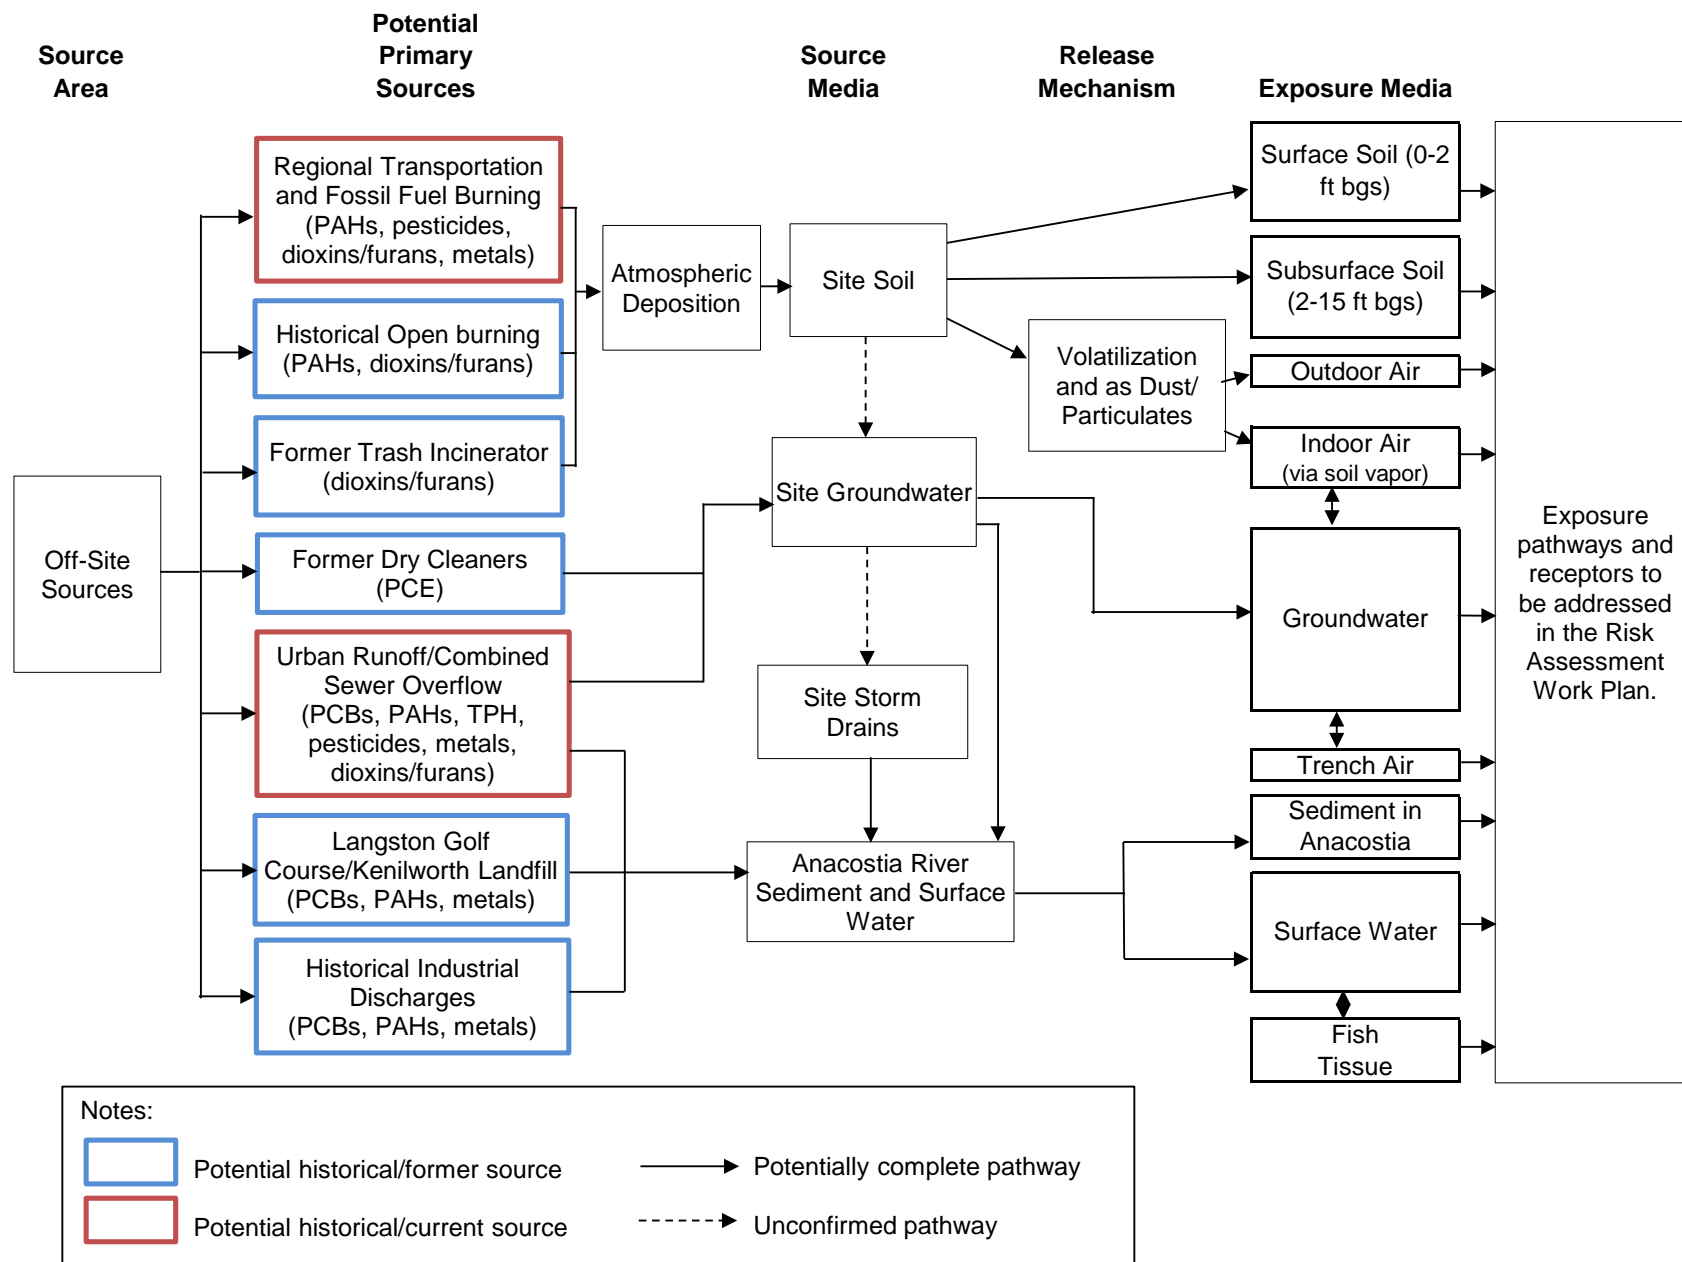
Figure 6-2
Preliminary Conceptual Site Model - Off-Site Sources
Benning Road Facility RI/FS Project

-----> Unconfirmed pathway

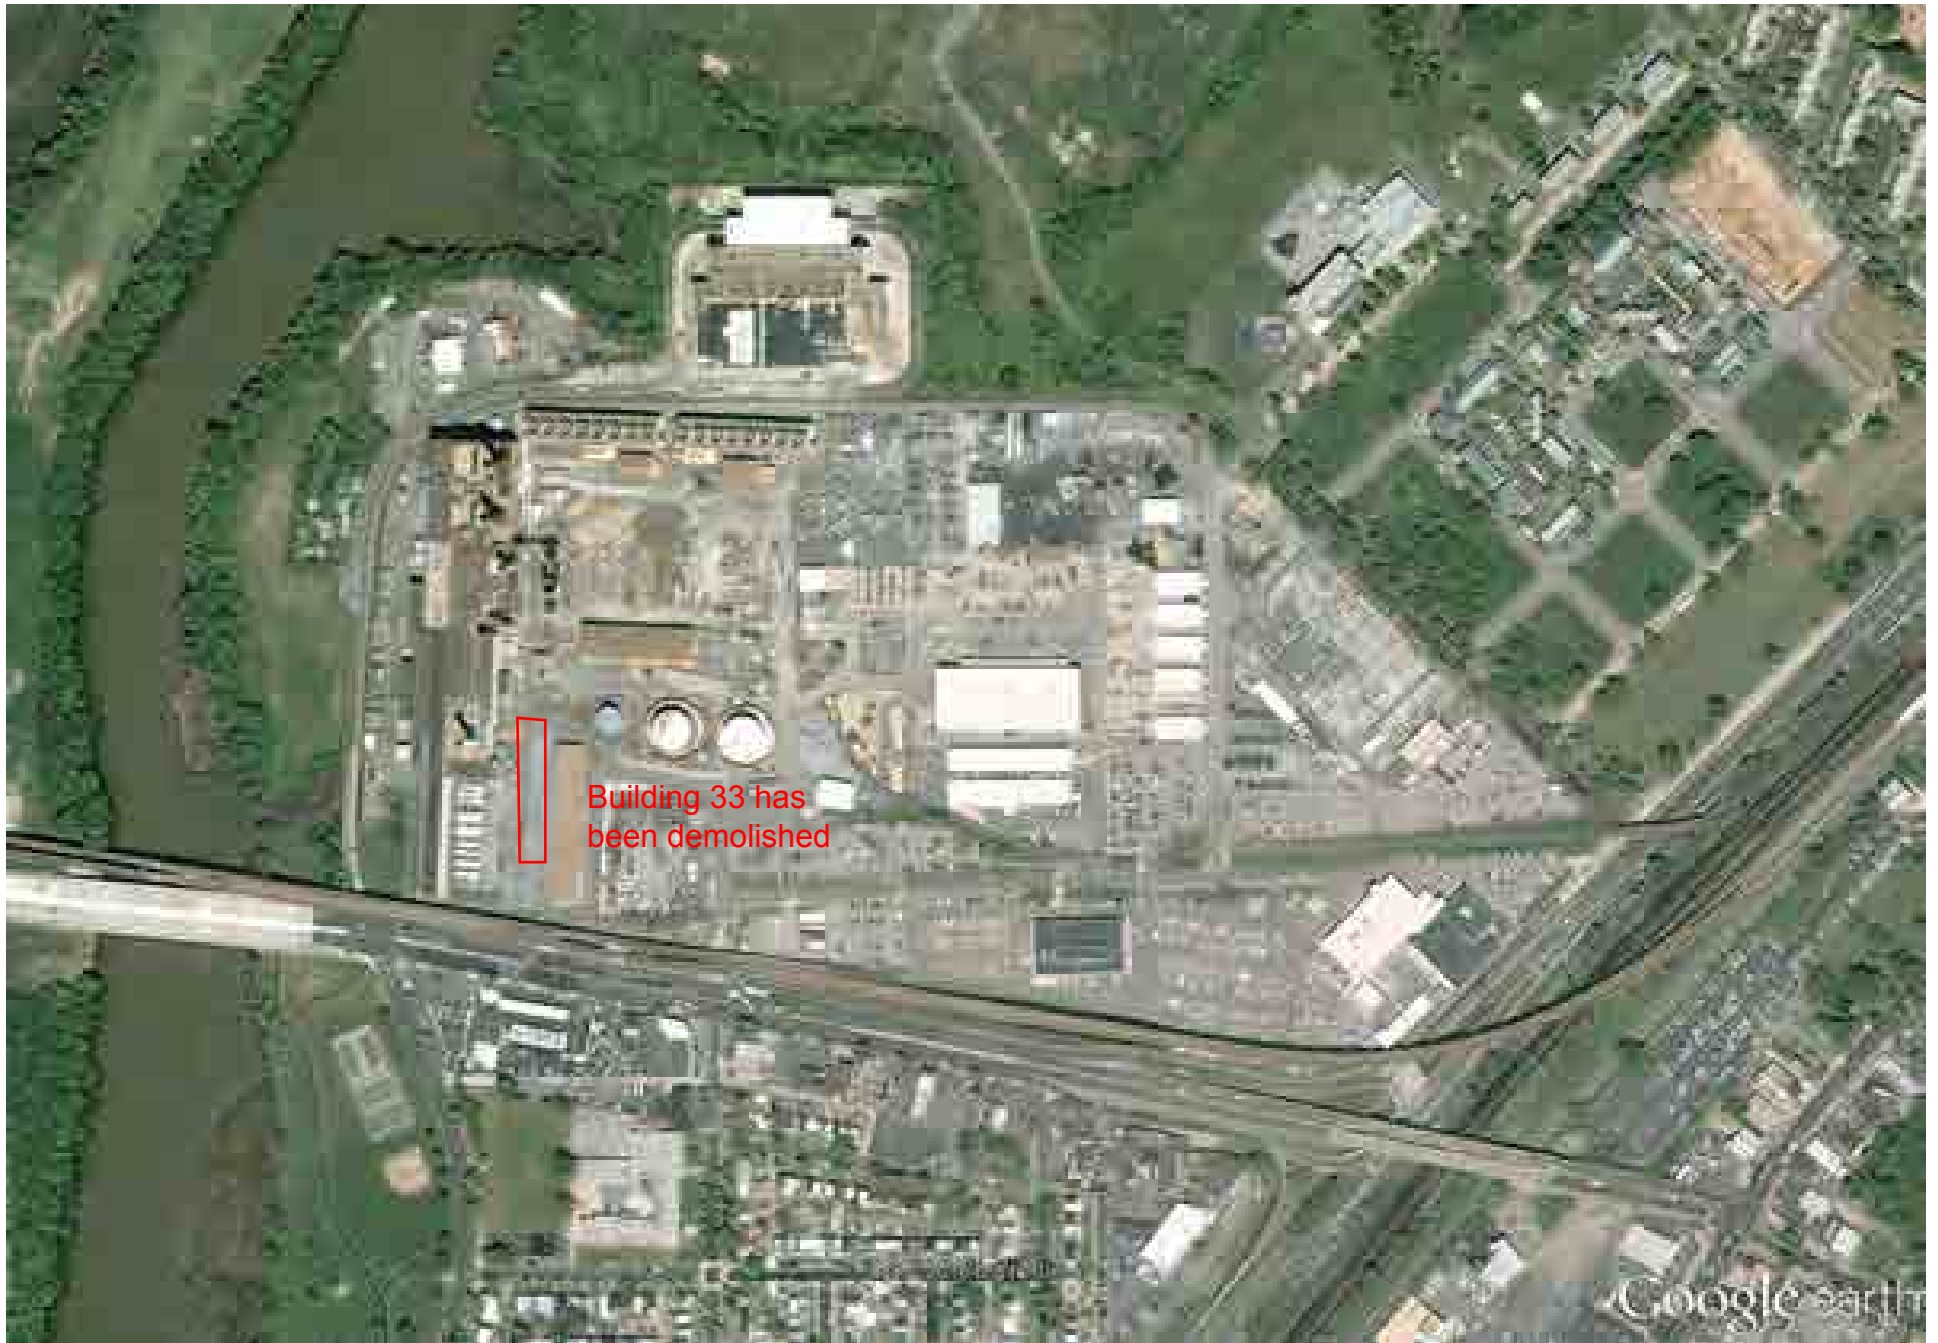
Building 33 has
been demolished

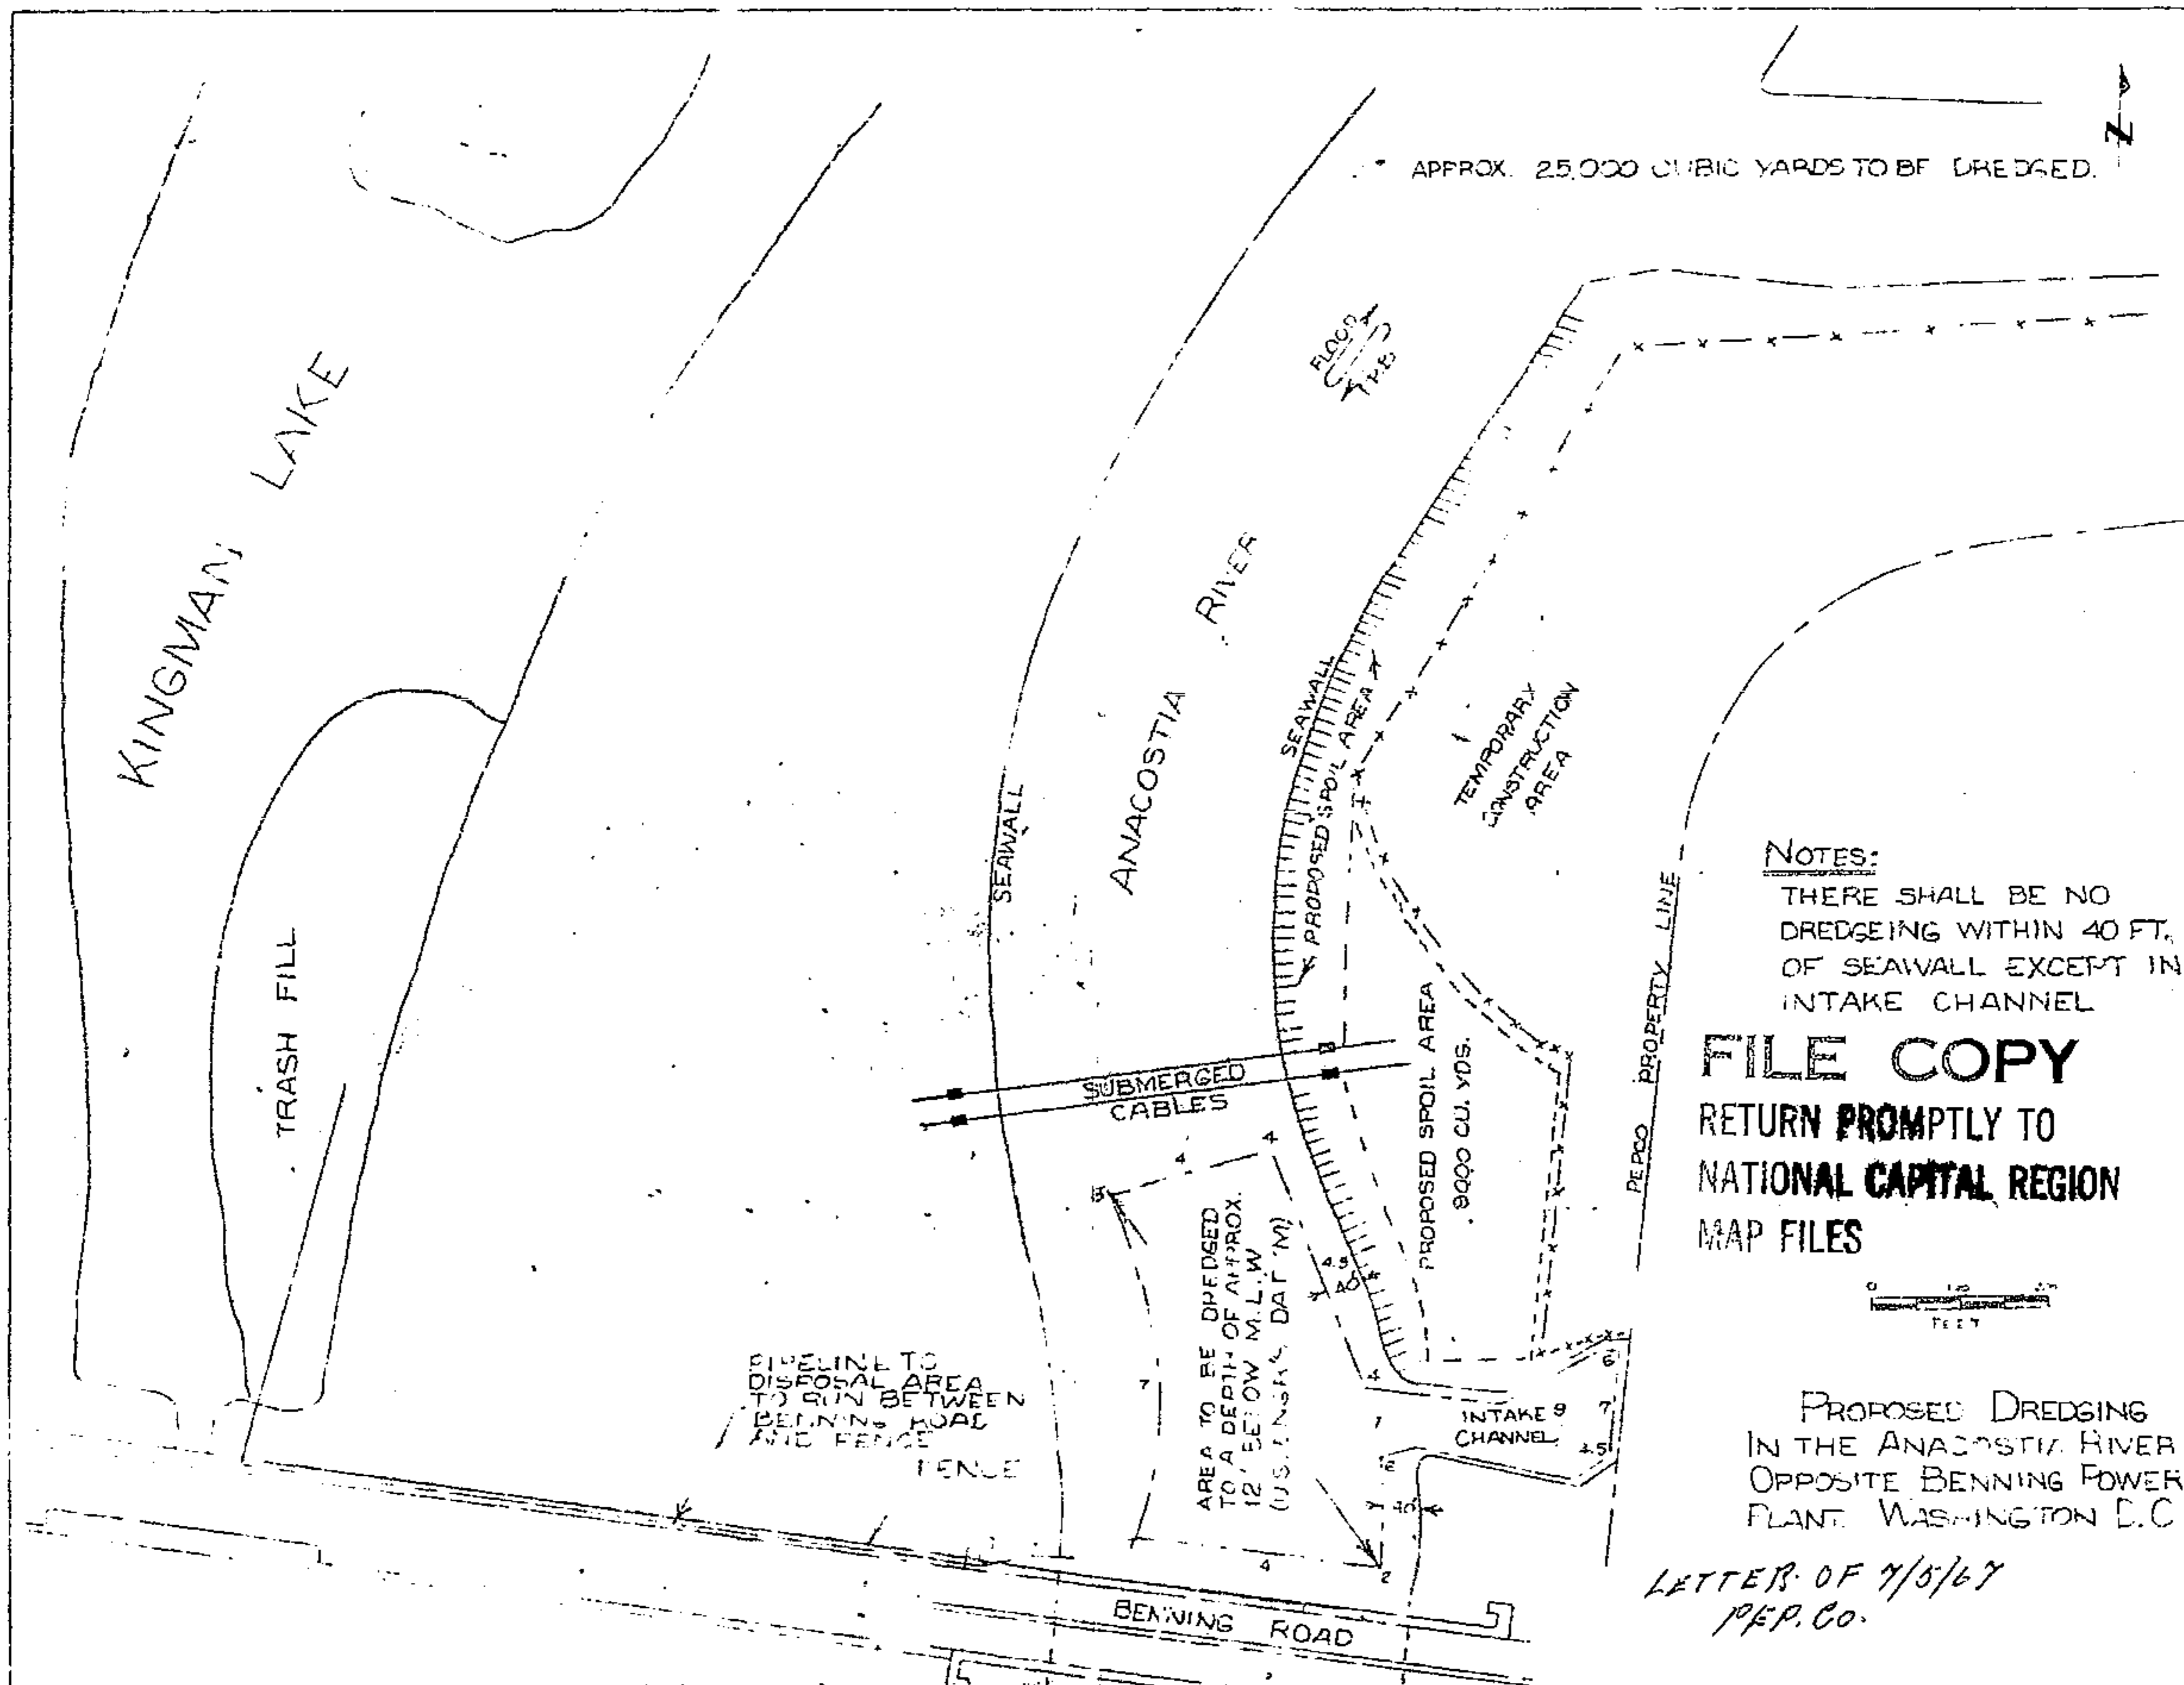
Proposed 1967 Dredge Spoils Area Figures

THERE SHALL BE NO DREDGING WITHIN 40 FT. OF SEAWALL EXCEPT IN INTAKE CHANNEL
