District Department of the Environment <u>APPLICATION FOR</u> VOLUNTARY CLEANUP PROGRAM

I. Property			
Property Name 309-311 Pennsylvania Avenue, SE			
Address 309-311 Pennsylvania Avenue, SE			
City Washington QuadrantSE Zip Code20003 Ward6			
Square # <u>0790</u> Lot # <u>0018</u> Acreage <u>0.042</u>			
Has the site had any prior involvement with District or Federal environmental regulatory programs including notices of violation, orders, consent orders, enforcement actions, or environmental permits? (Y/N)Y			
Is the property listed on the National Priority List pursuant to the Comprehensive Environmental Response, Compensation, and Liability Act of 1980, 42 U.S.C. 9601 <i>et seq</i> .? (Y/N)N			
Is the property subject of a current cleanup action by the Environmental Protection Agency or the DDOE? $(Y/N)N$			
Please include:			
Permit numbers, dates, name(s) of program(s), name of regulated entity and any other information known to the Applicant, and current pictures of the site.

Page 2 Preliminary Sub-Slab Soil and Soil Gas Testing Report 309 Pennsylvania Avenue, S.E. August 26, 2015

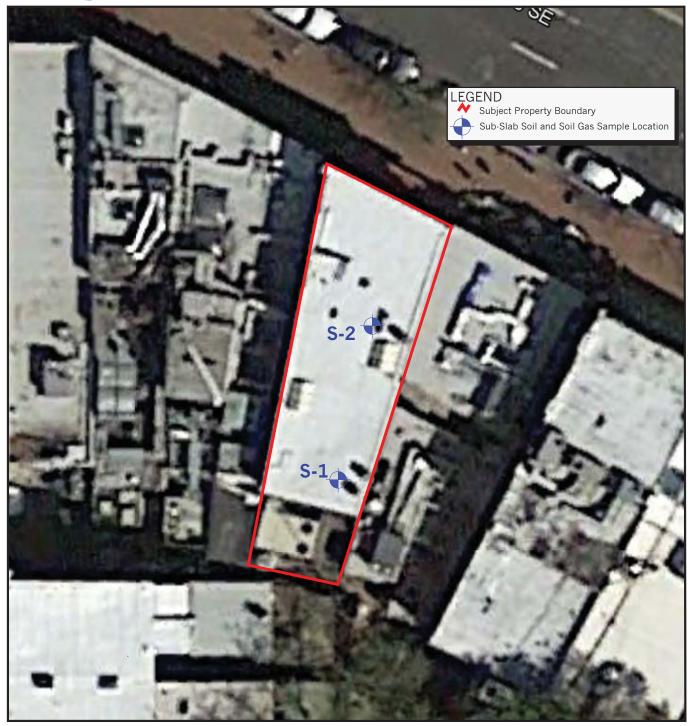
FIGURE 1

ECC observe two soil gas sampling points installed on the east side of the basement floor by ECC in August 2015. No other obvious penetrations or significant cracks were observed in the basement floor slab.

TITLE: SITE PLAN	DATE: 08/26/15	NOT TO	SCALE	OCC.
	DRAWN BY: NRA	1101 10	SCALL	Environmental
309 PENNSYLVANIA AVENUE, S.E. WASHINGTON, DISTRICT OF COLUMBIA	APPROVED BY: TMH		REGULATORY CASE NUMBER:	Consultants and Contractors, Inc.

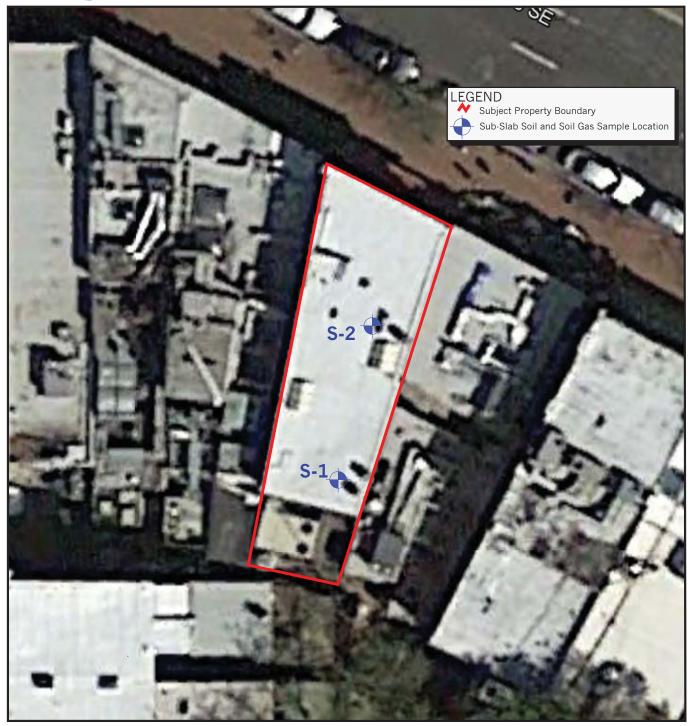
FIGURE 1

TITLE: SITE PLAN	DATE: 08/26/15	NOT TO SCALE		OCC.
	DRAWN BY:	1101 10	Environmental	
309 PENNSYLVANIA AVENUE, S.E. WASHINGTON, DISTRICT OF COLUMBIA	APPROVED BY: TMH		REGULATORY CASE NUMBER:	Consultants and Contractors, Inc.

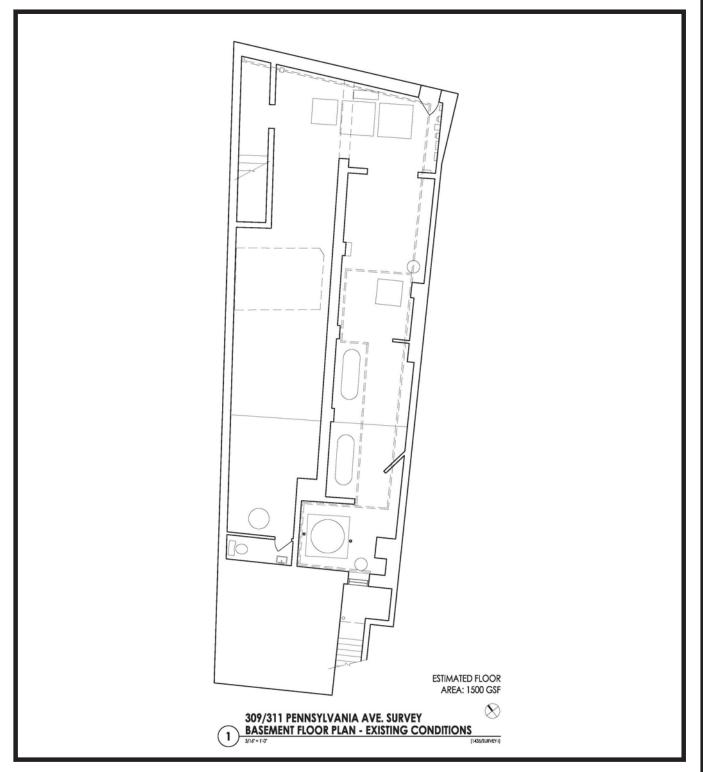
SITE PLAN - EXISTING SURVEY PLAN (1 OF 4)	DATE: 12/26/15	NOT TO	OCC.	
PROJECT:	DRAWN BY: LSA NOT TO SCALE		Environmental	
309 PENNSYLVANIA AVENUE, S.E. WASHINGTON, DISTRICT OF COLUMBIA	APPROVED BY: TMH	PROJECT NUMBER: 15-12037	REGULATORY CASE NUMBER: N/A	Consultants and Contractors, Inc.

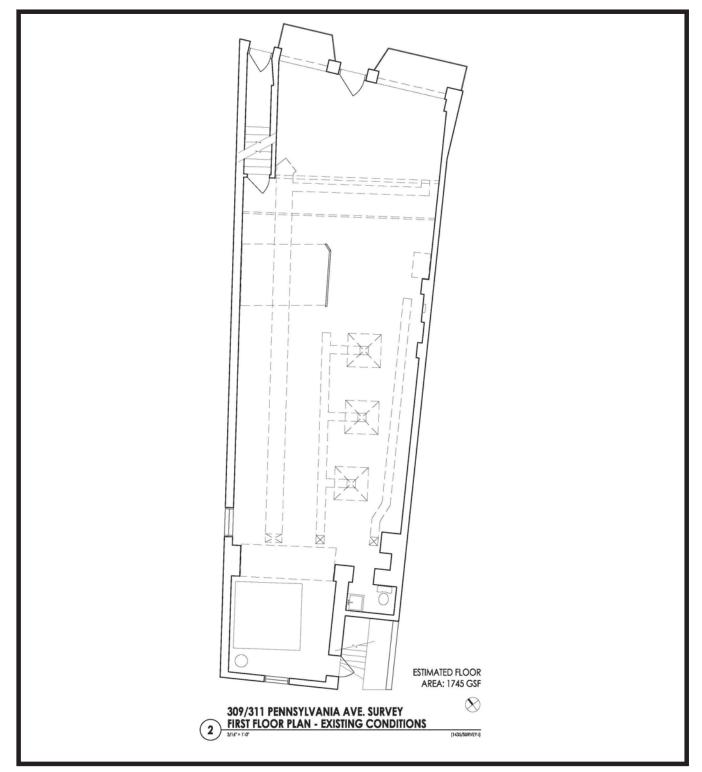
SITE PLAN - EXISTING SURVEY PLAN (2 OF 4)	DATE: 12/26/15	NOT TO	SCALE	OCC.
	DRAWN BY: LSA	NOT TO SCALE		Environmental
309 PENNSYLVANIA AVENUE, S.E. WASHINGTON, DISTRICT OF COLUMBIA	APPROVED BY: TMH	PROJECT NUMBER: 15-12037	REGULATORY CASE NUMBER:	Consultants and Contractors, Inc.

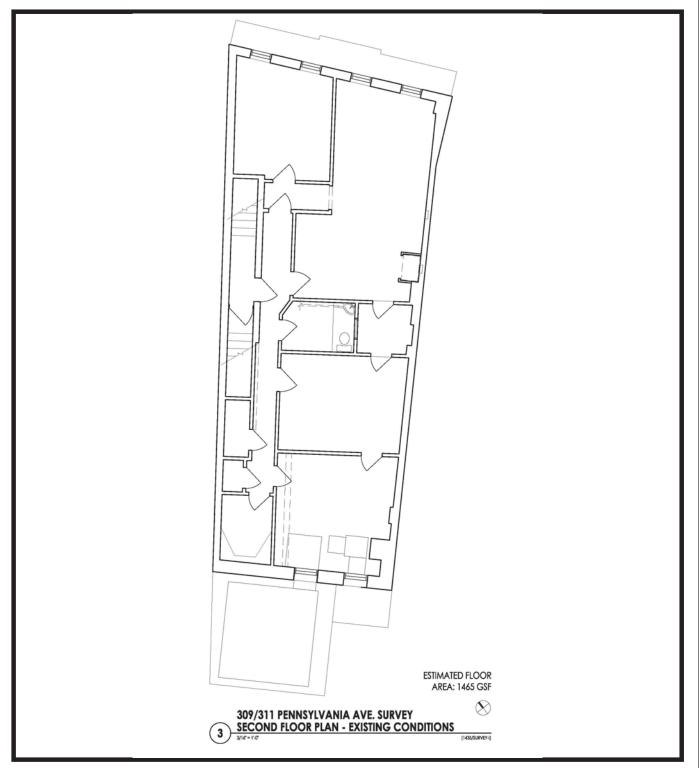
SITE PLAN - EXISTING SURVEY PLAN (3 OF 4)	DATE: 12/26/15	NOT TO	OCC.	
PROJECT:	DRAWN BY: LSA		Environmental	
309 PENNSYLVANIA AVENUE, S.E. WASHINGTON, DISTRICT OF COLUMBIA	APPROVED BY: TMH	PROJECT NUMBER: 15-12037	REGULATORY CASE NUMBER:	Consultants and Contractors, Inc.

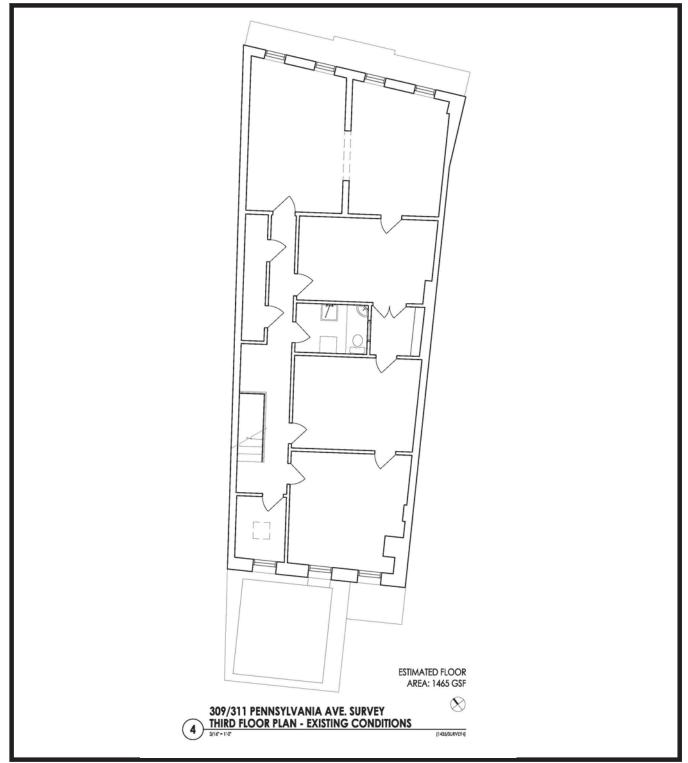
SITE PLAN - EXISTING SURVEY PLAN (4 OF 4)	DATE: 12/26/15	NOT TO	OCC.	
PROJECT:	DRAWN BY: LSA	NOT TO	Environmental	
309 PENNSYLVANIA AVENUE, S.E. WASHINGTON, DISTRICT OF COLUMBIA	APPROVED BY: TMH	PROJECT NUMBER: 15-12037	REGULATORY CASE NUMBER:	Consultants and Contractors, Inc.
