DISTRICT DEPARTMENT OF THE ENVIRONMENT

Underground Storage Tank Branch Leaking Underground Storage Tank (LUST) Contaminated Sites LUST Cleanup Success Story

Site Name: Washington Post Building
Site Address: 1150 15th St, NW, Washington DC 20005
LUST ID #: 91-065
Facility ID: 9-000754
Property Owner: 1100 15TH STREET LLC (c/o CARR Properties)
Remediating Party: Graham Holdings Company

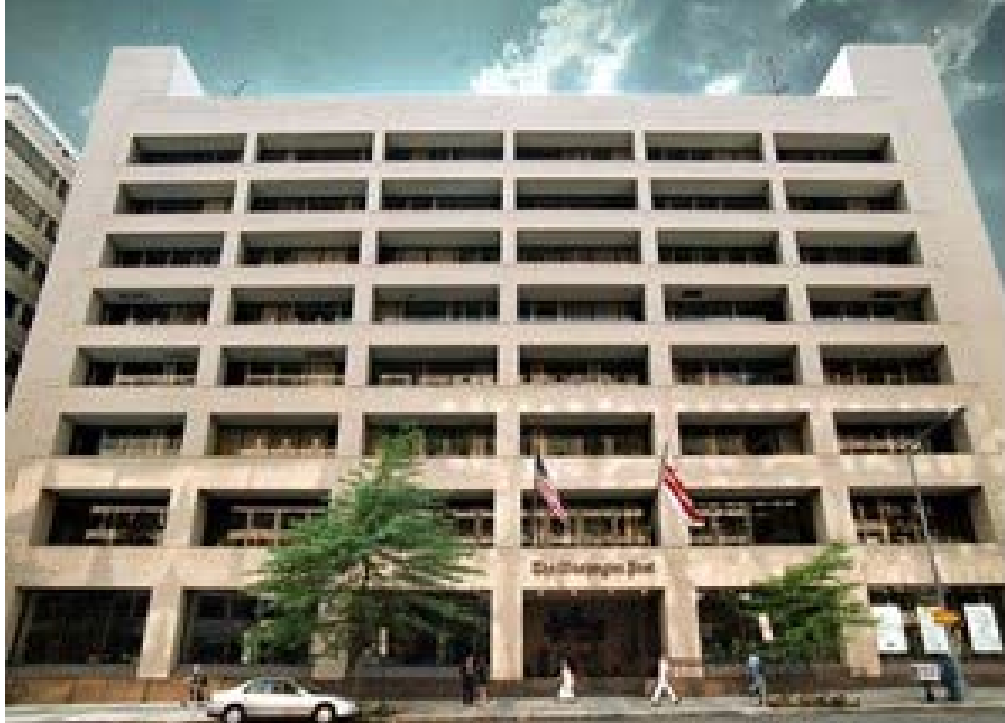
Site before development - showing the old Washington Post Building - 2005

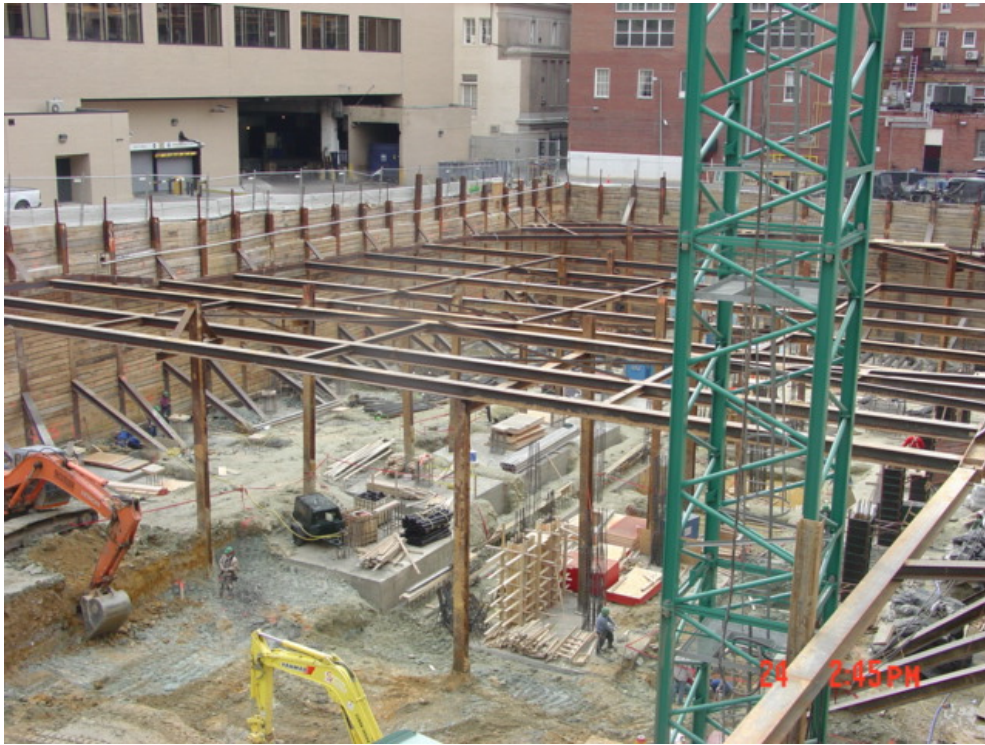
Site during development -2018

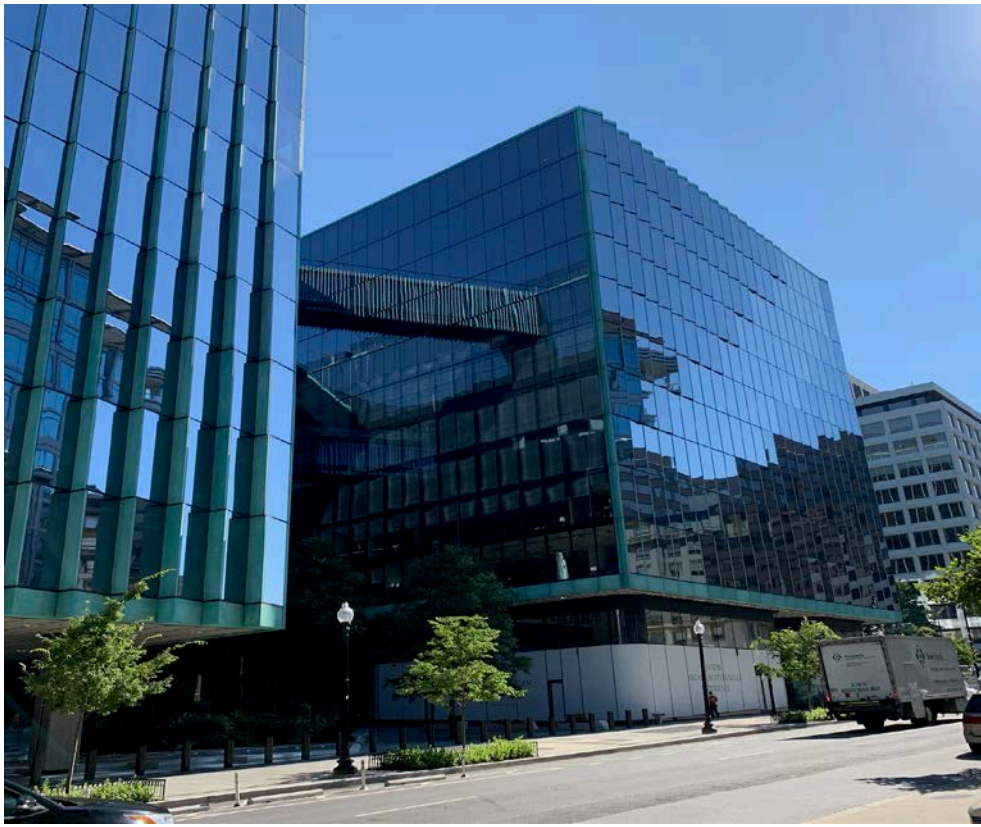
Site after development - 2020
