# SOIL PILE SITE INVESTIGATION REPORT

*Kingman Island, Washington, DC*

*Department of Energy and the Environment  
Government of the District of Columbia*

March 29 2016

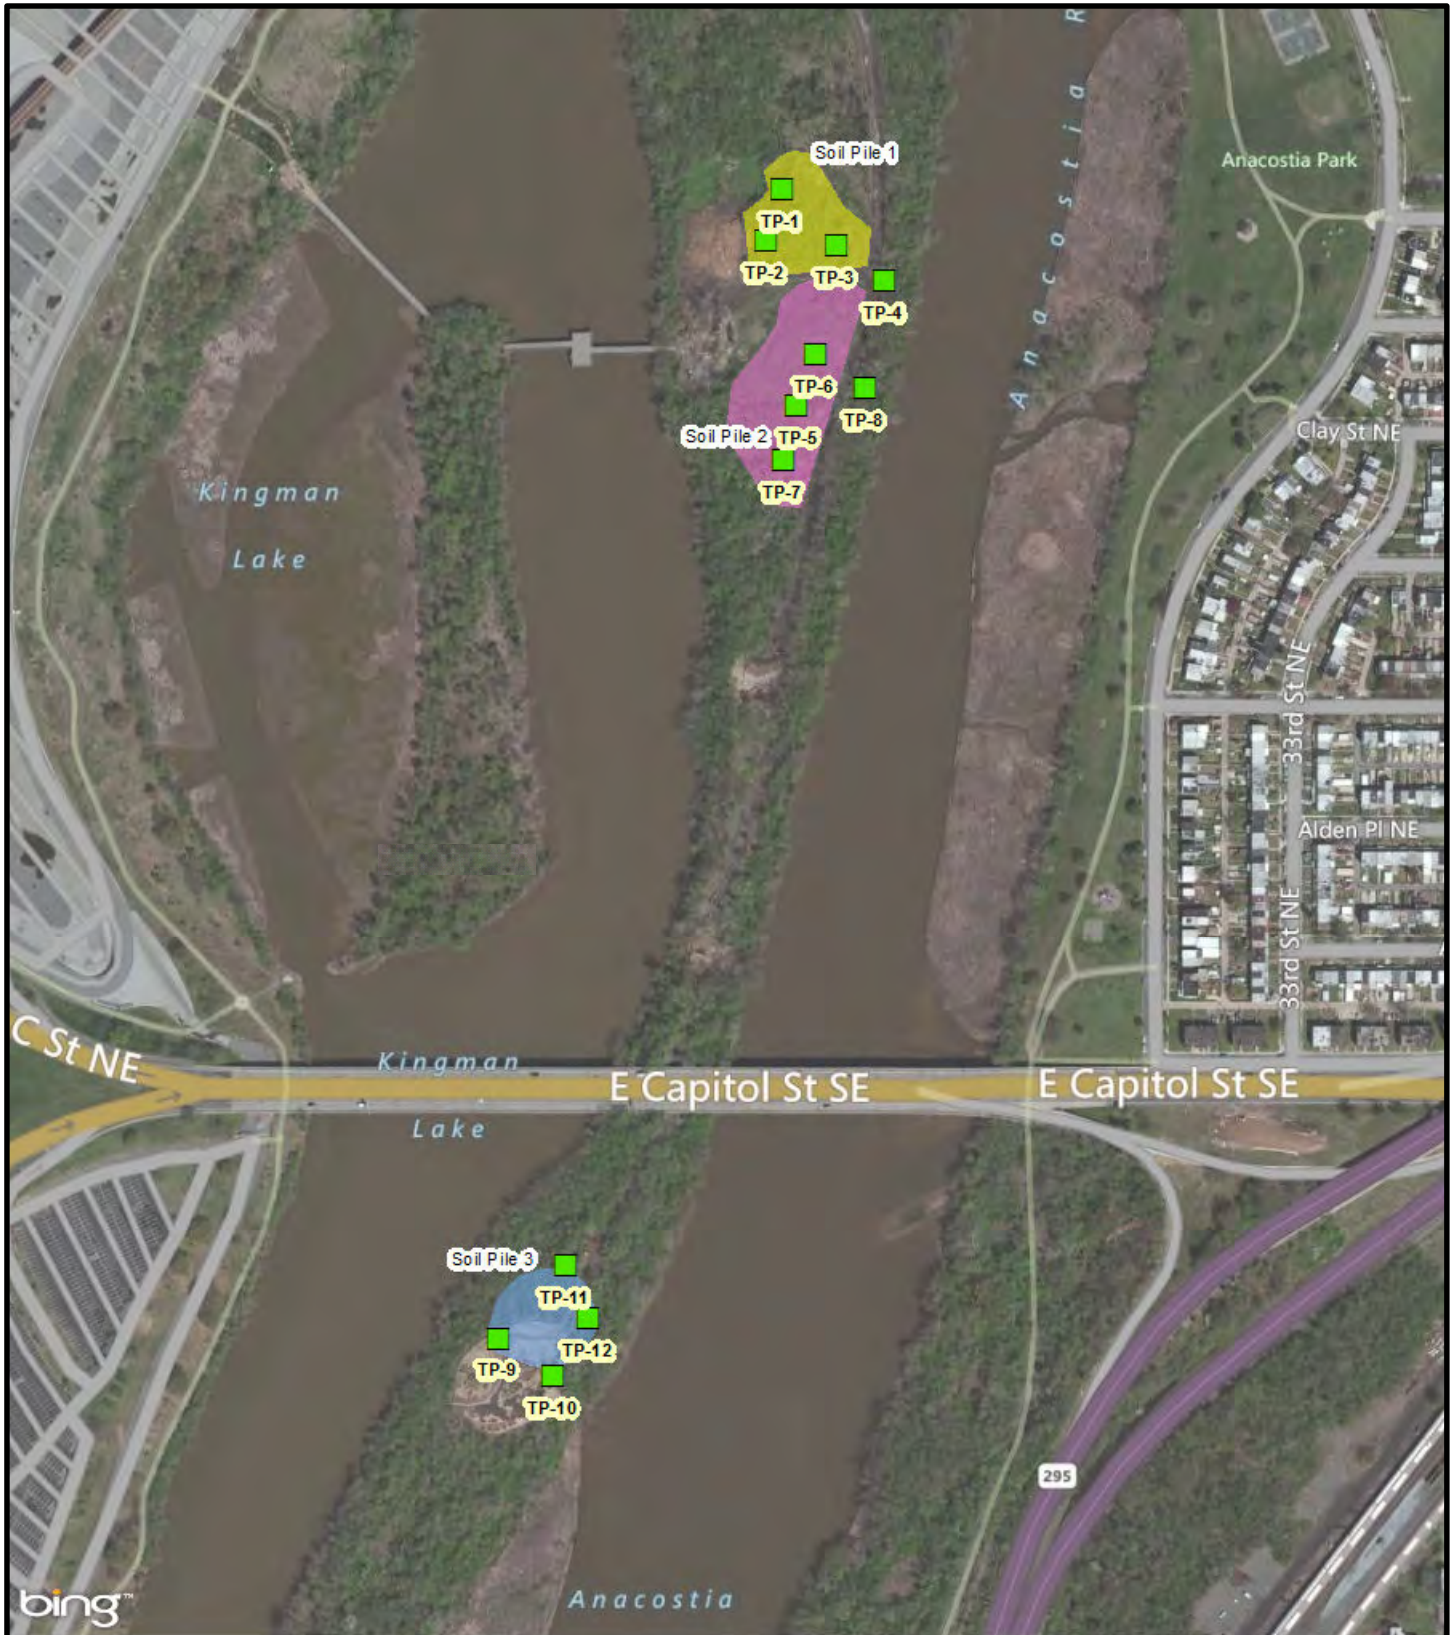
FIGURE 3  
TEST PIT LOCATIONS

To further evaluate the material present within the soil piles, Tetra Tech conducted test pits within, or in the vicinity of each of the known soil piles to depths between 10 to 25 feet bgs. On November 9, 2015 through November 12, 2015, a total of twelve (12) test pits, four (4) in the vicinity of each of the three soil piles was excavated with a Komatsu PC160LC-8 excavator operated by Miller Environmental Group of Baltimore, Maryland. The final location of the test pits was based on the excavator accessibility, while prioritizing the spatial distribution of the test pits within each soil pile. Two total test pits were conducted outside of the known extent of each of the soil piles in areas where surface debris was observed. Horizontal coordinates of the corners of each test pit were collected with a hand-held GPS unit to document the test pit location. The location of the test pits is shown on **Figure 3 of Attachment 1**. The detailed location of the test pits in the vicinity of Soil Piles 1 and 2 is shown on **Figure 4 of Attachment 1**. The detailed location of the test pits in the vicinity of Soil Pile 3 is shown on **Figure 5 of Attachment 1**.
