ATTACHMENT 3. TEST PIT FIELD FORMS

Kingman Island Investigation

Test Pit ID: TP-1

Project Number: 103S3636.014.03

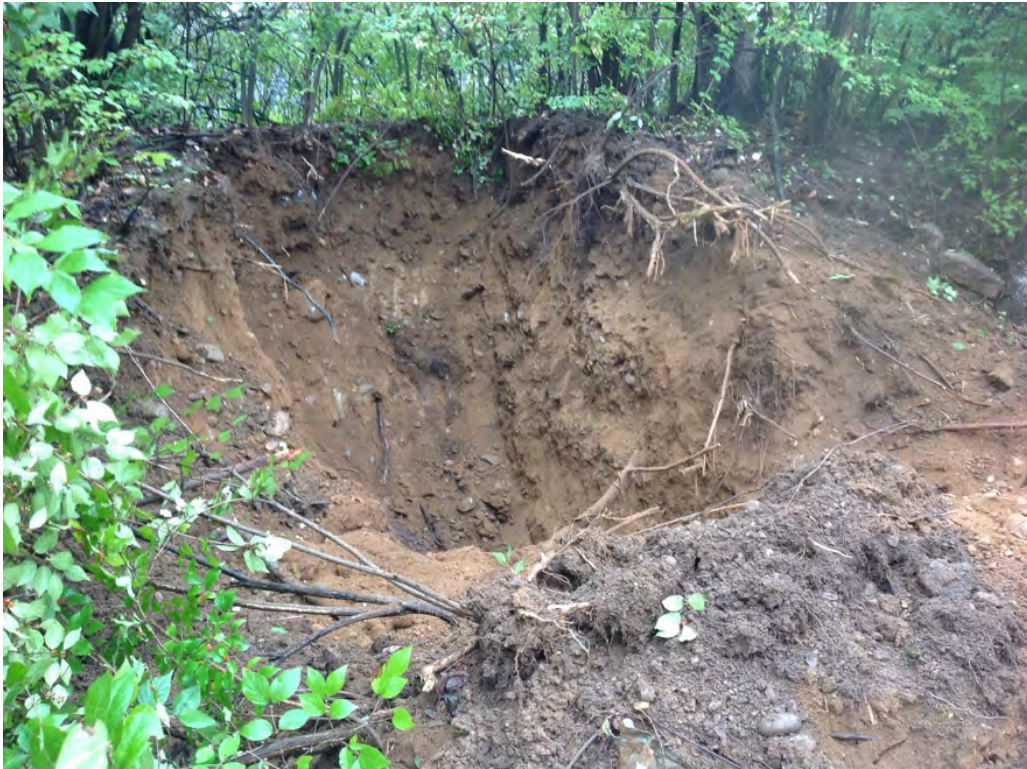
Photo 1:

Overall view of Test Pit 1.

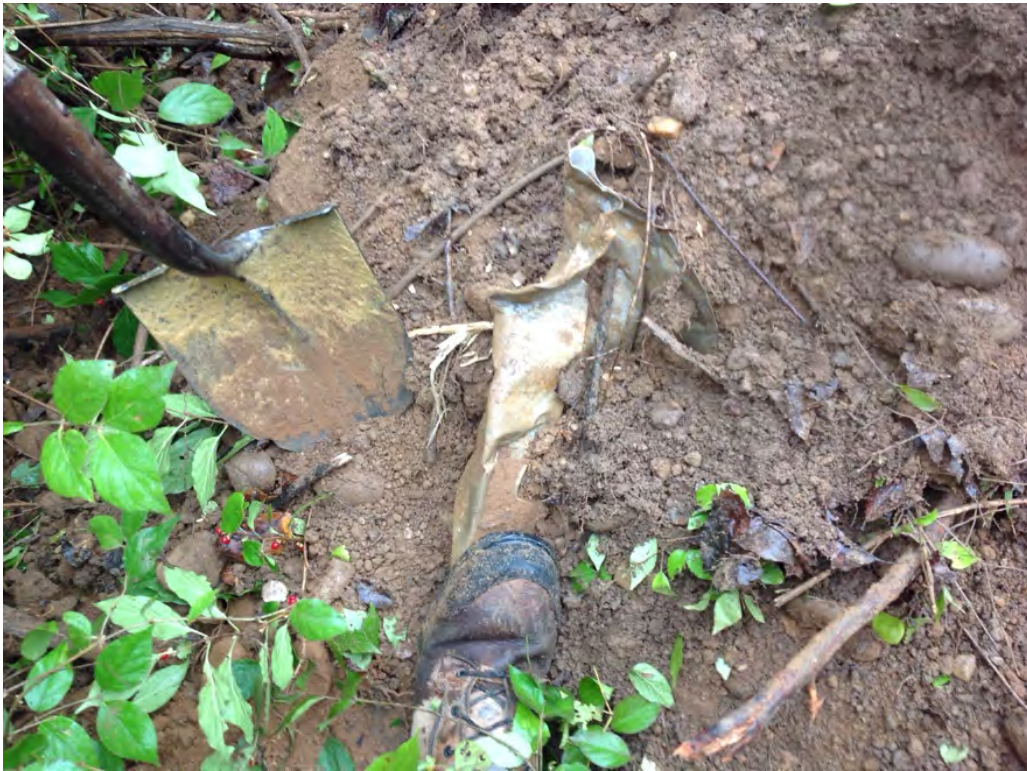
Photo 2:

Metal debris within two feet of surface.

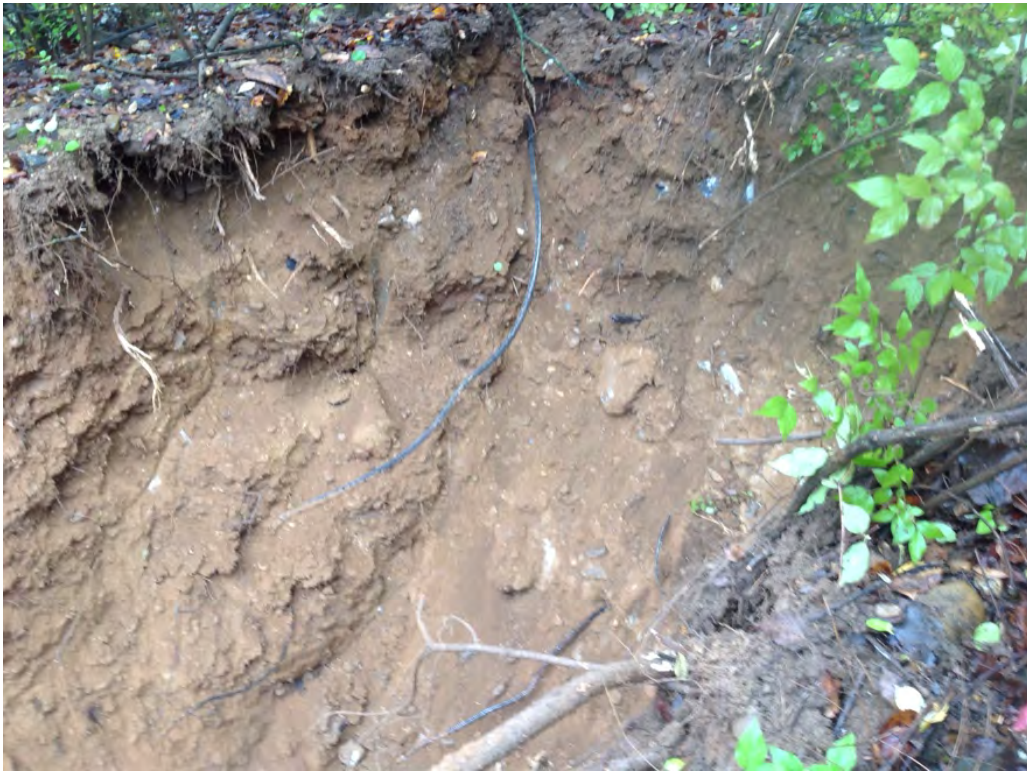
Photo 4:

Primarily medium brown silty sand with large well rounded gravel. Steel rebar noted on northern wall at 1 foot in depth. Additional rebar noted at 7 feet in depth.

Rebar noted at two feet and seven feet in depth.

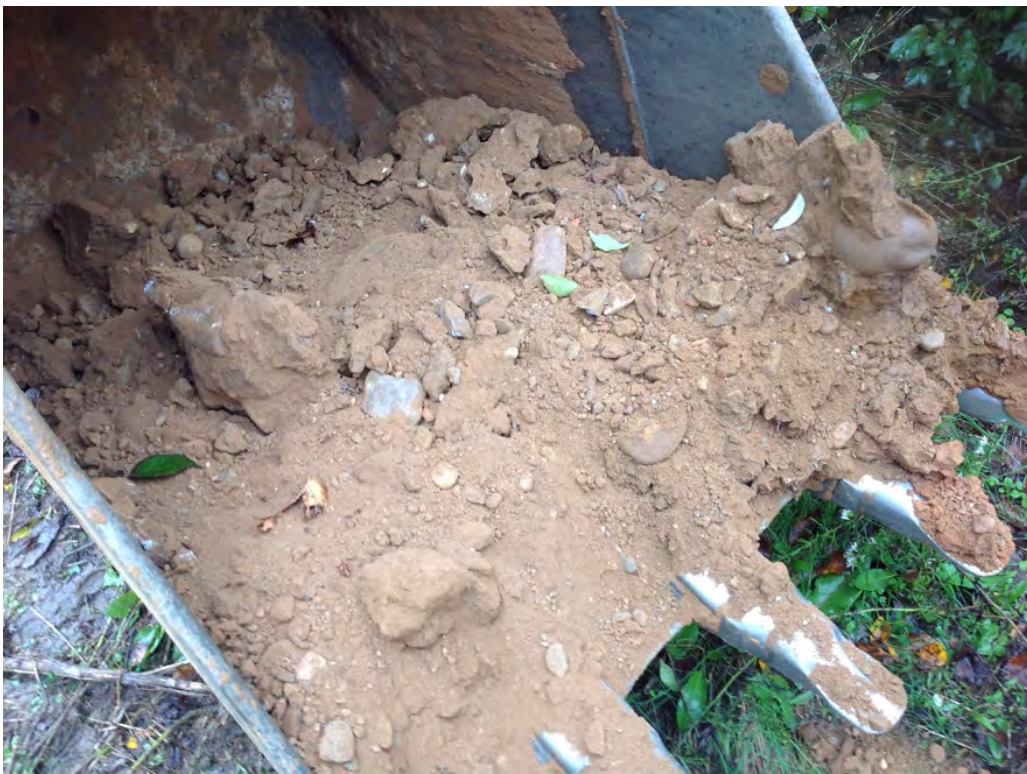
Photo 6:

Typical material encountered.

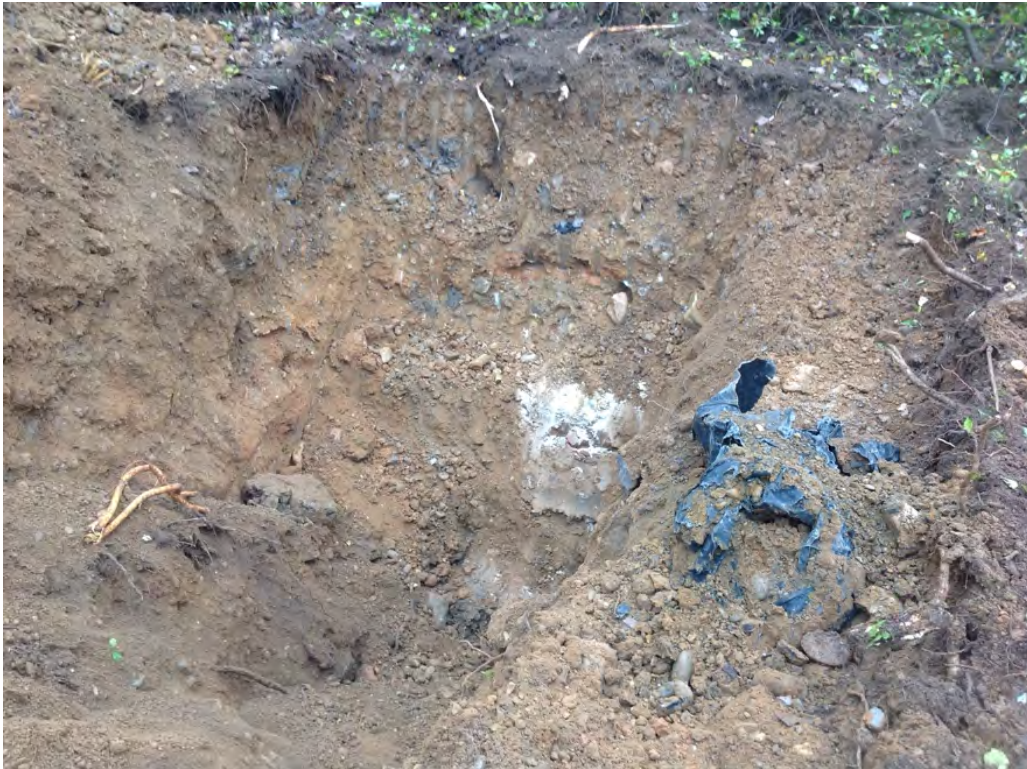
Photo 1:

East wall consists of medium brown silty clay with well rounded cobbles and some large boulders. Asphalt pieces at 3 to 5 feet. Concrete and rebar noted from 5 to 10 feet.

Eastern wall.

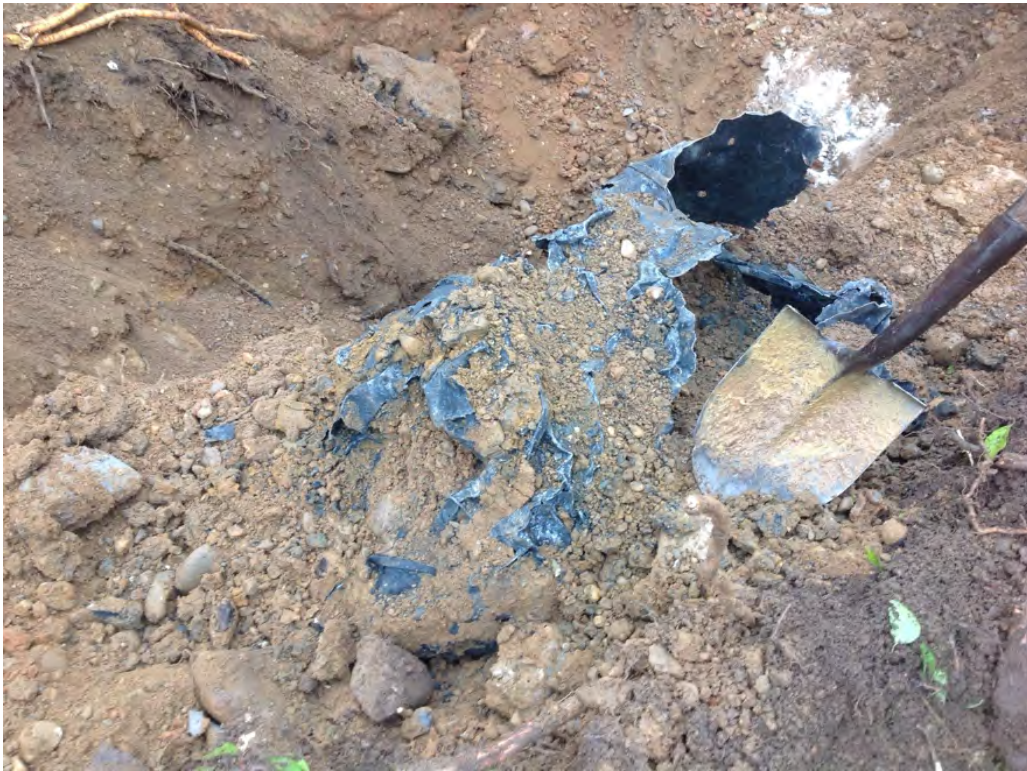
Photo 2:

Similar material as above, with increasing wood and concrete debris beginning at 4 feet in depth. Corrugated metal debris noted at approximately 8 feet.

Corrugated metal debris at 8 feet in depth.

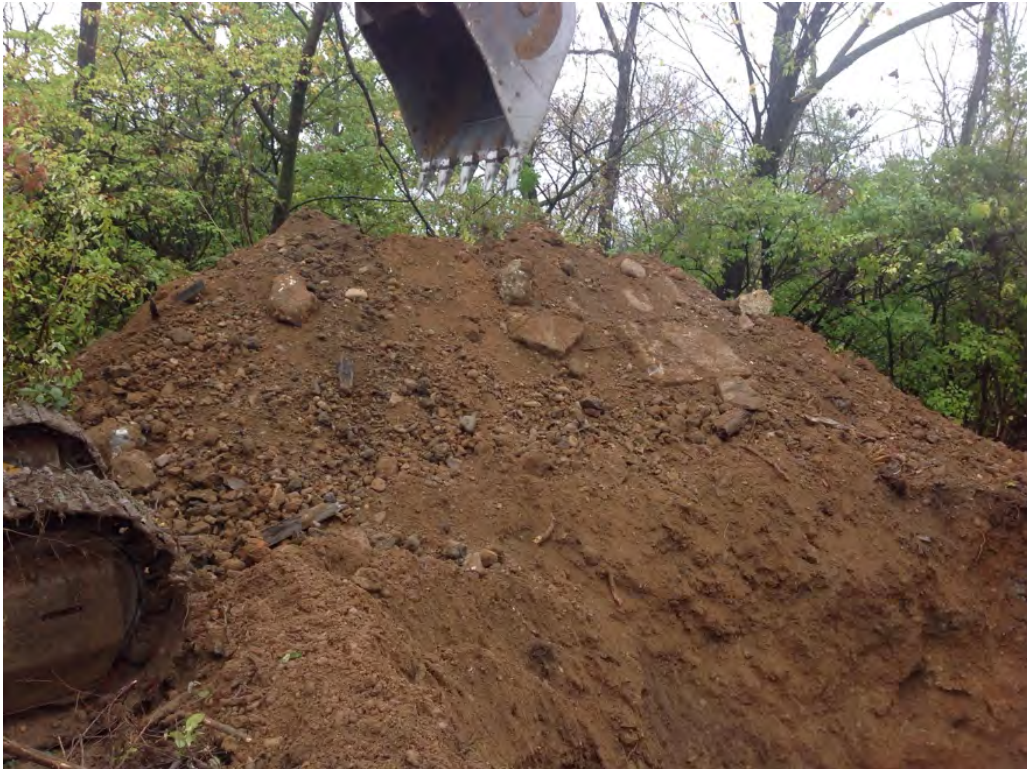
Photo 3:

Excavated material has wood, asphalt, and concrete.

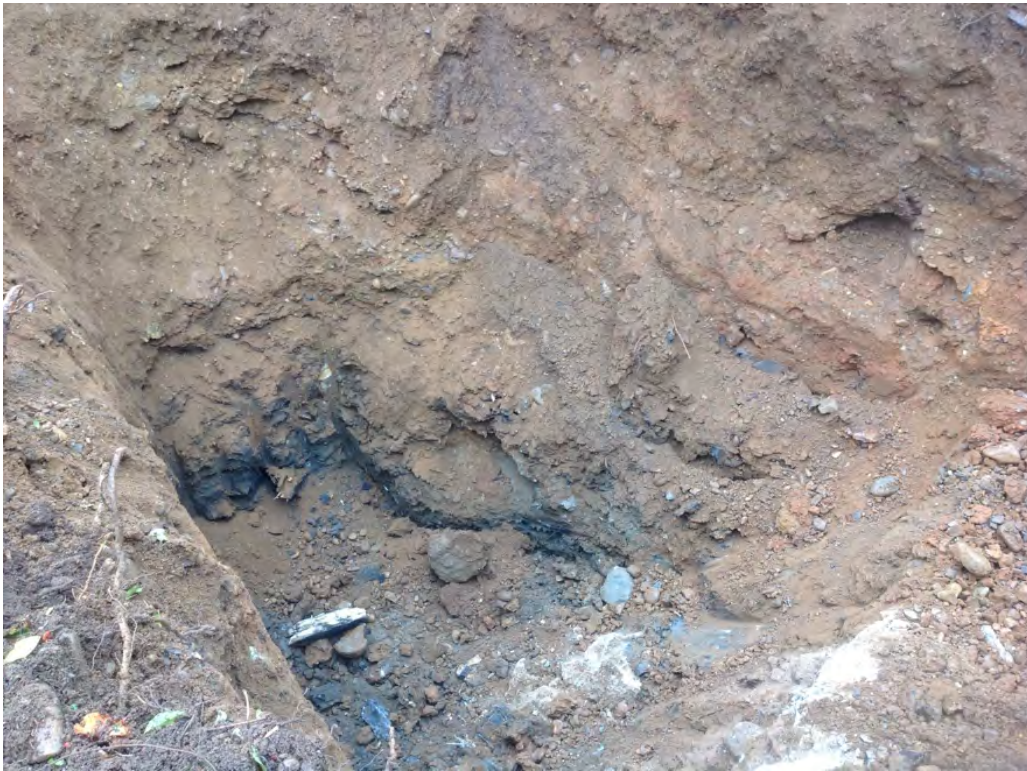
Photo 4:

Bottom of the pit at approximately 14 feet showed signs of dark staining. Material consisted of light grey silty clay with slight petrochemical odor and slight PID reading.

Grey staining begins at 10 feet and down to 14 feet.

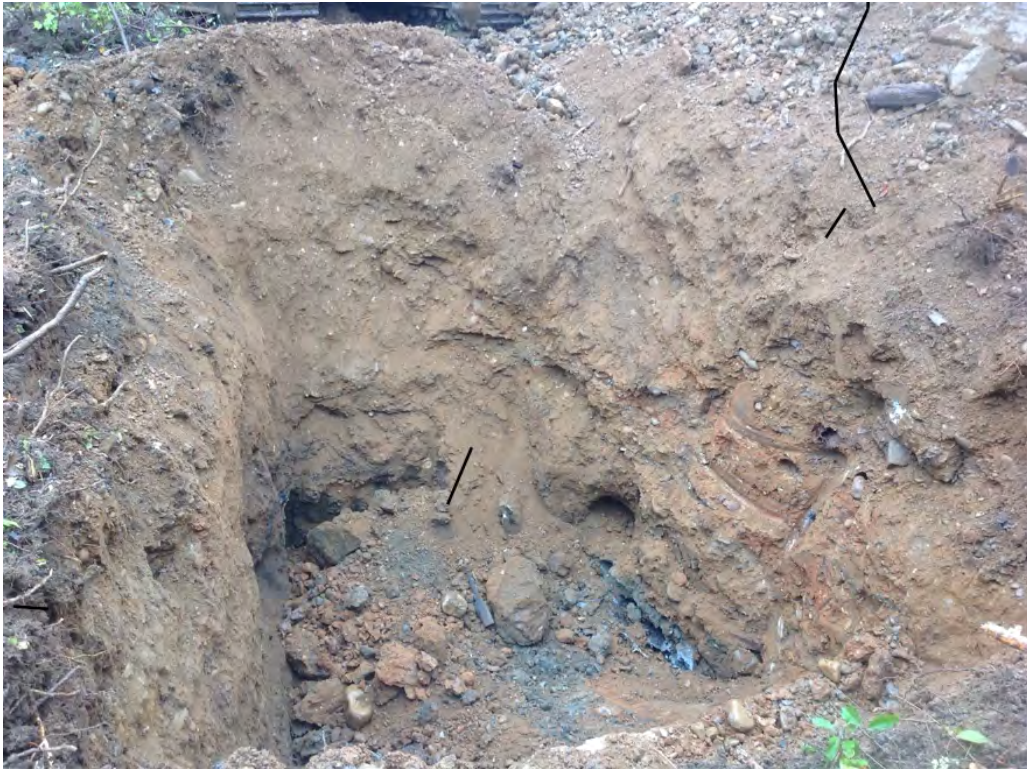
Photo 5:

West wall showing asphalt and concrete
beginning at 10 feet.

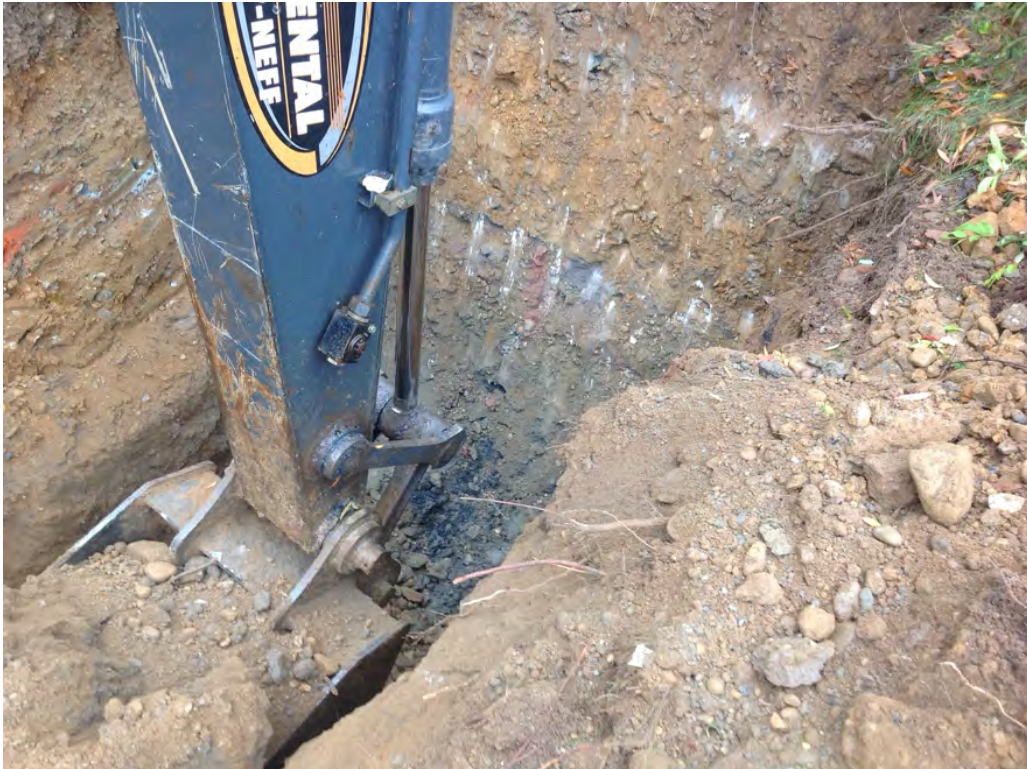
Photo 1:

Surface to 3 feet consists of medium brown silty clay with well rounded cobbles. Debris including concrete pieces, brick, wood, and asphalt noted beginning at 3 feet in depth.

Debris noted beginning at about 5 feet.

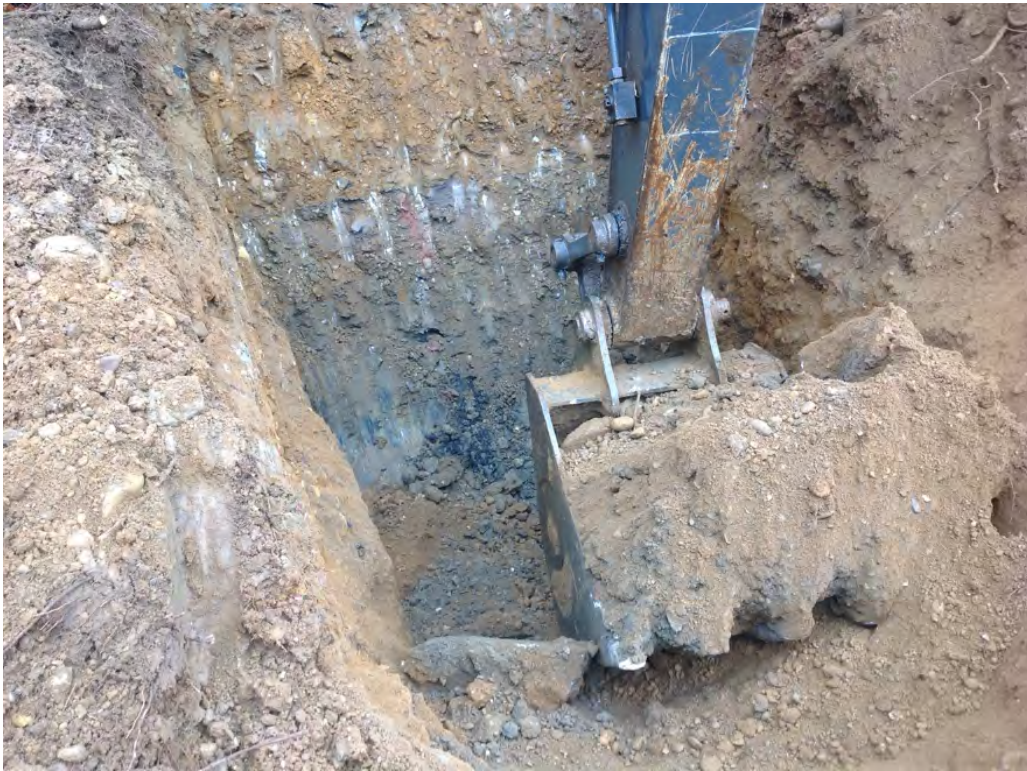
Photo 2:

Dark staining noted at about 5 feet in depth.

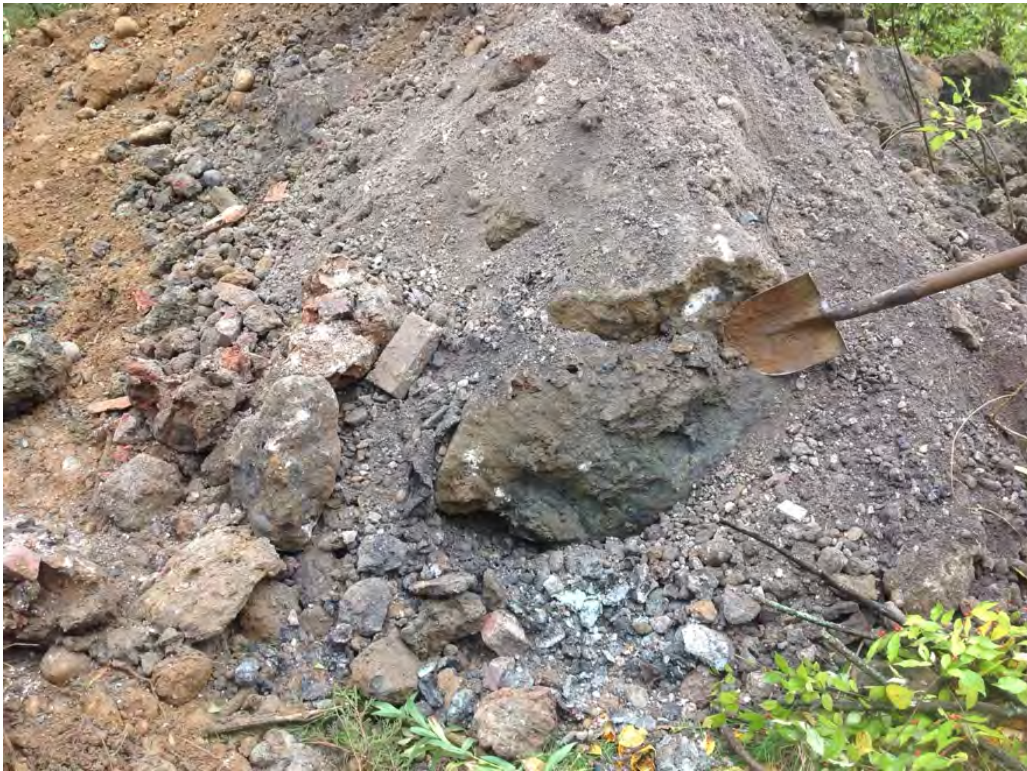
Photo 6:

Debris removed from pit.

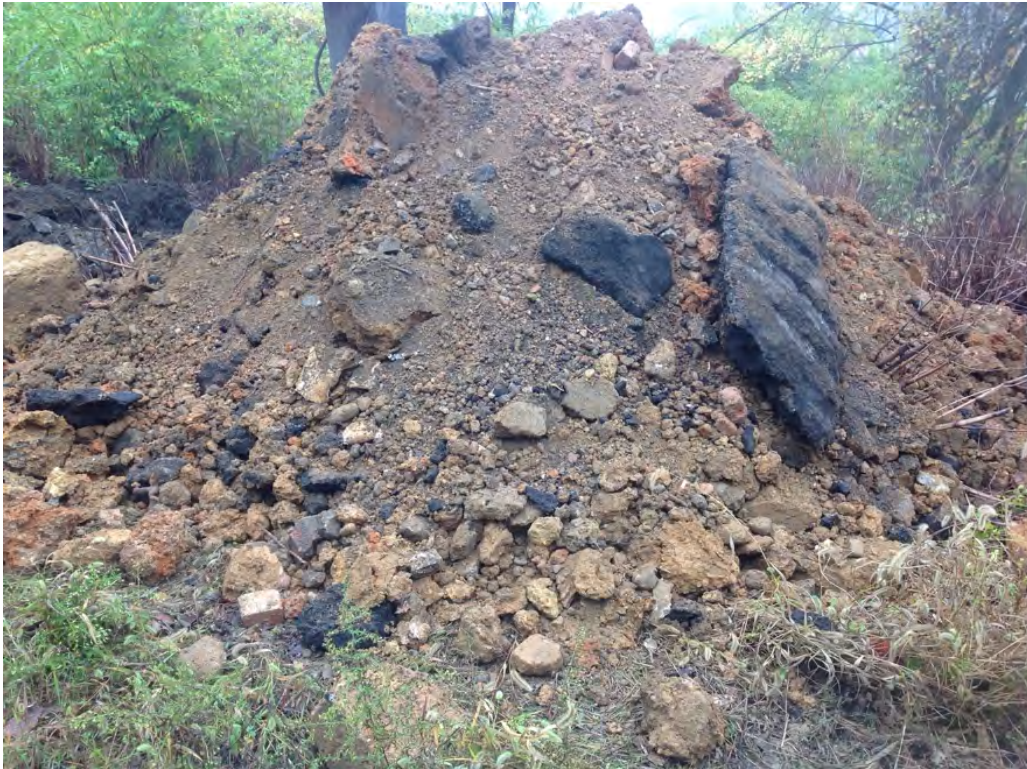
Photo 1:

Concrete brick and asphalt throughout.

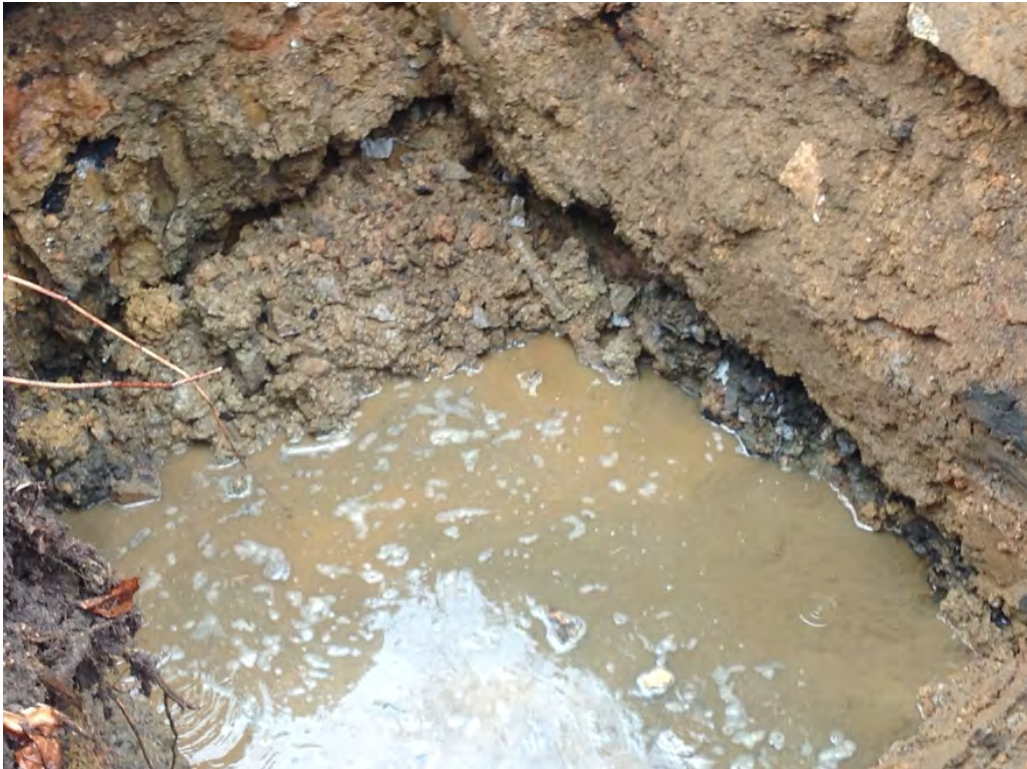
Photo 5:

Water flowing into excavation below 10 feet. Material removed below glass layer has petrochemical odor and slight staining. Consists of light to medium grey silty clay with well rounded cobbles and brick. End of test pit at 13 feet in depth.

Water flowing into excavation below 10 feet.

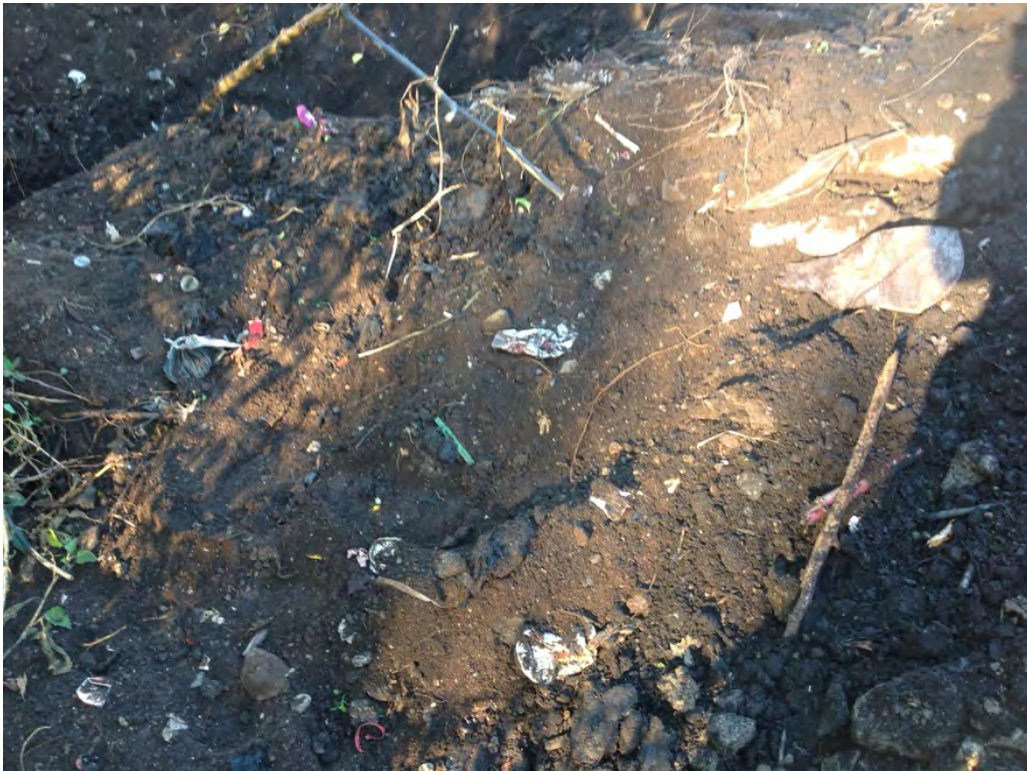
Photo 6:

Excavated material showing common trash and plastic debris.

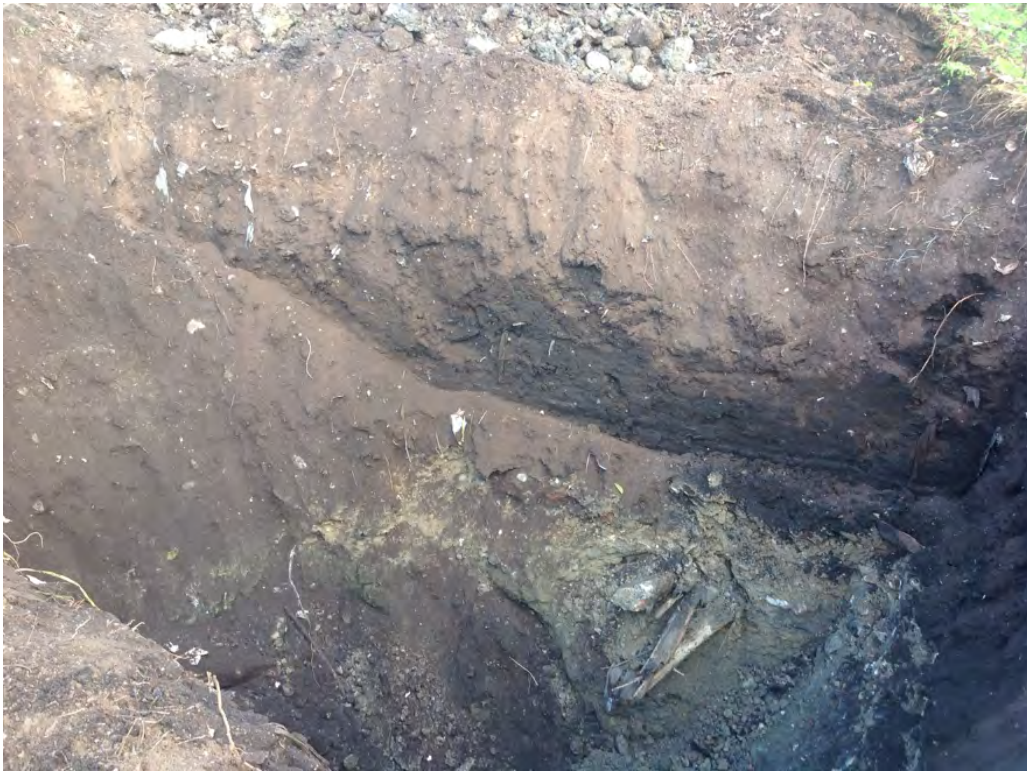
Photo 2:

North wall showing organics interface with construction debris.

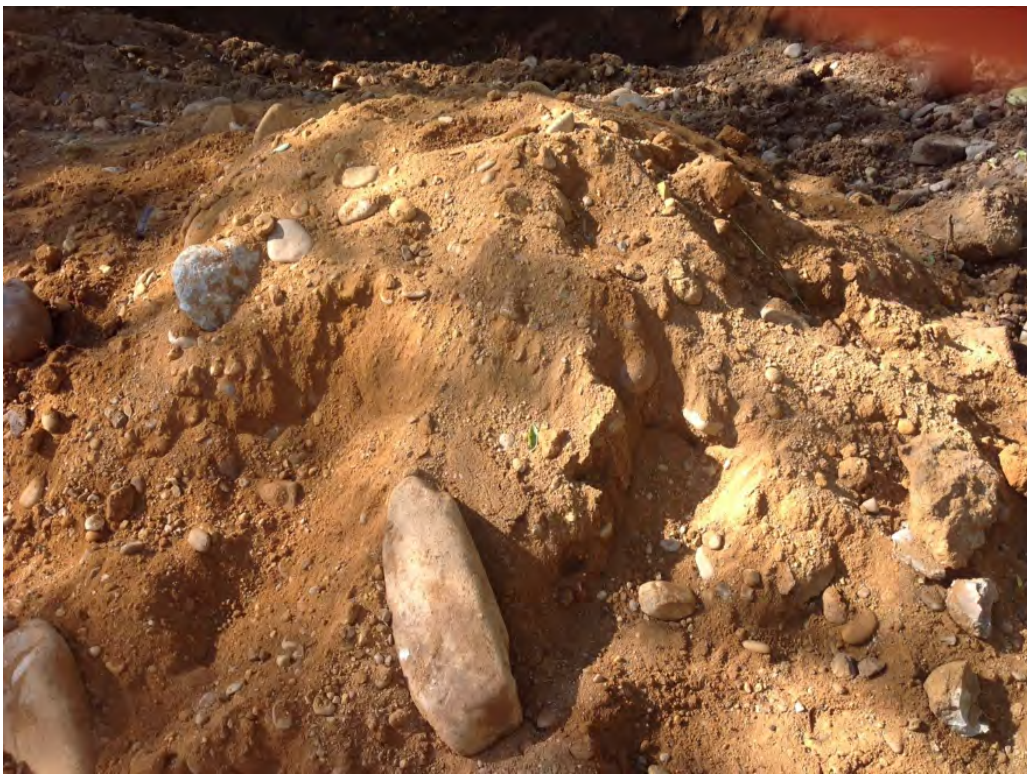
Photo 6:

Below 2 feet in depth material consists of a medium brown sandy gravel with well rounded cobbles and gravel. No trash or debris of any kind noted below 2 feet in depth.

Typical material below 2 feet in depth.

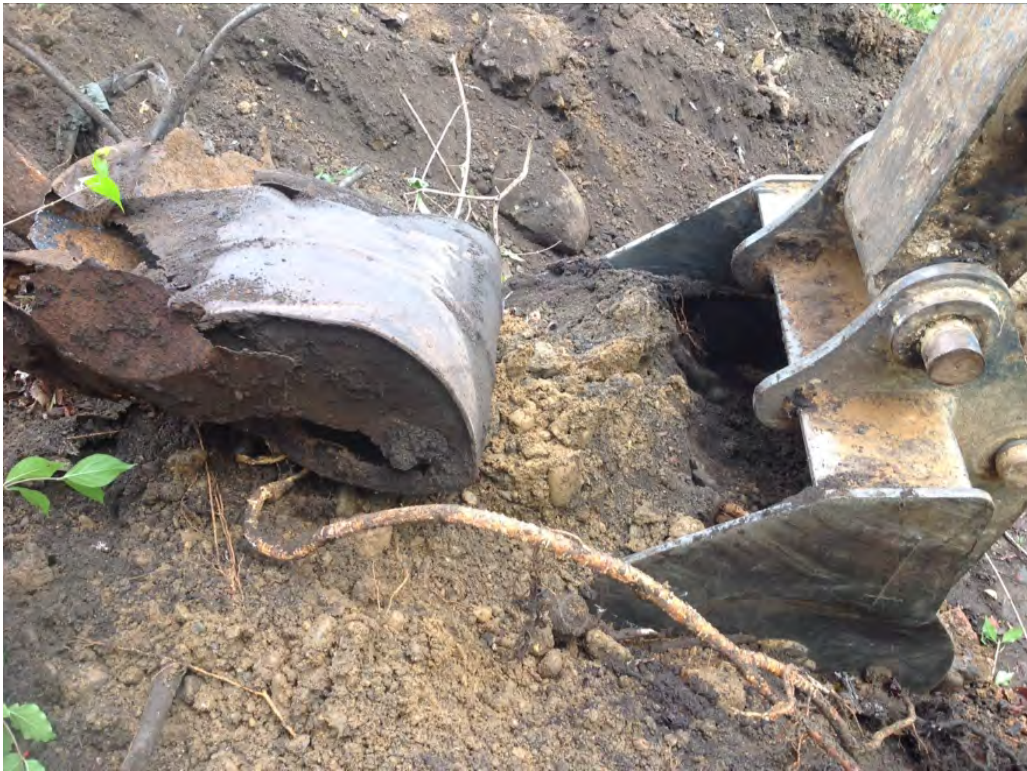
Photo 2:

Top 2 feet of material contains a variety of debris including a 55 gallon drum, brick, and styrofoam. No odor or staining was noted adjacent to the 55 gallon drum when excavated

Portions of a 55 gallon drum.

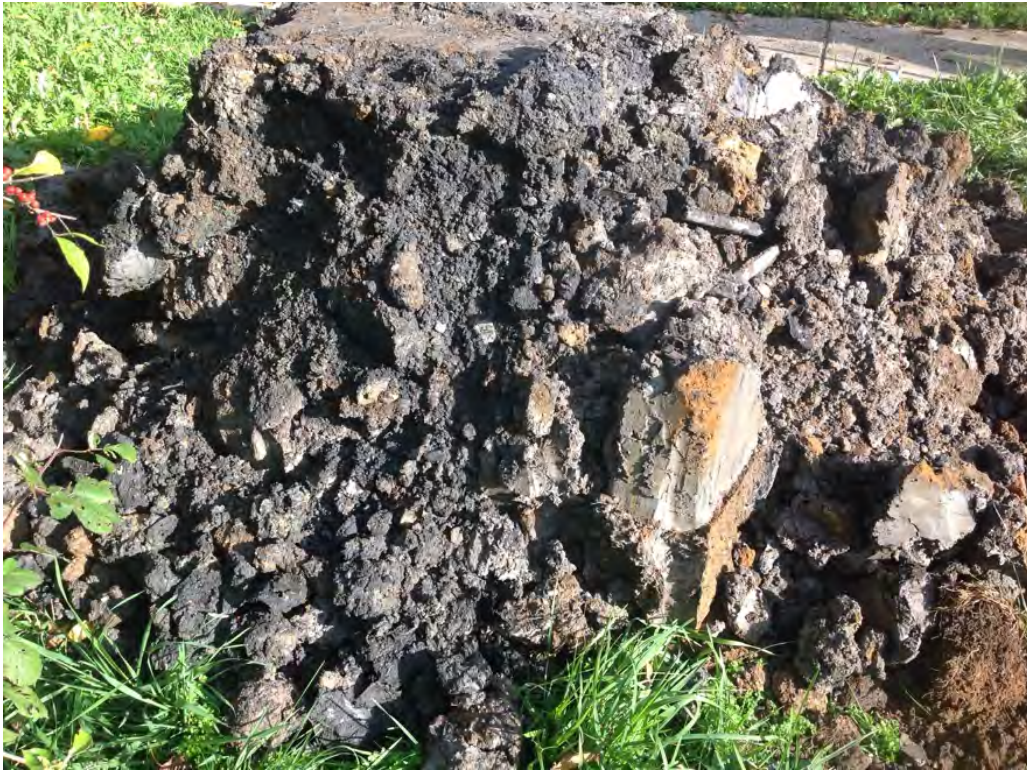
Photo 5:

Typical debris below 4 feet.

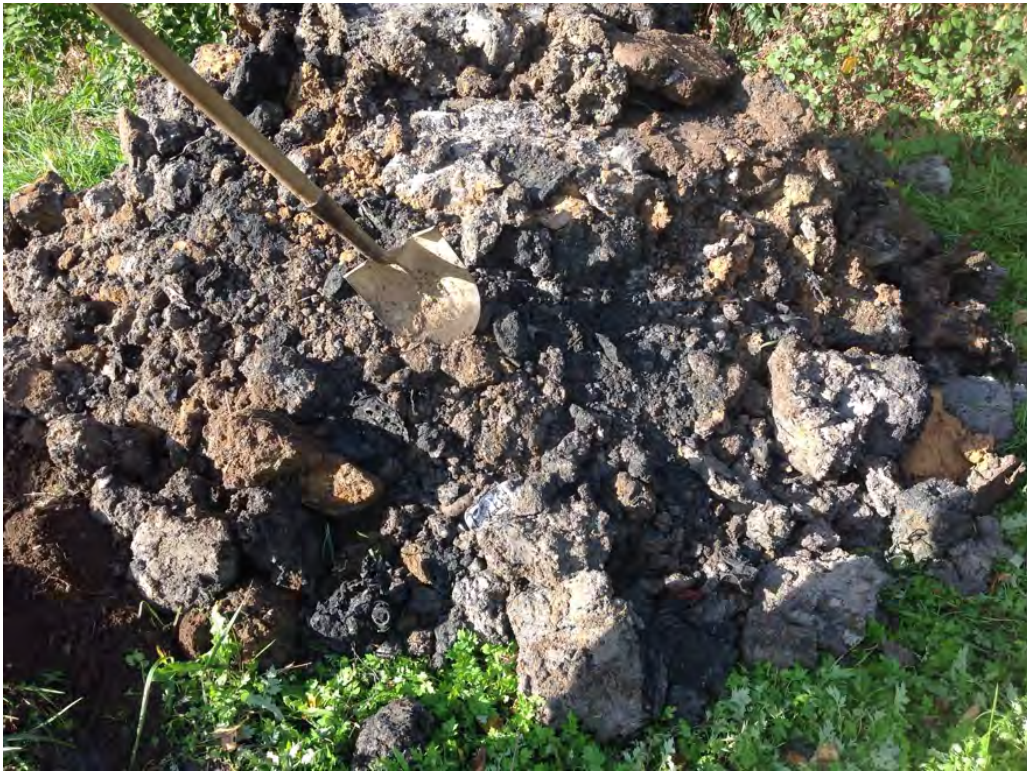
Photo 6:

Below 10 feet, the material consists of a black layer with large amounts of trash including paint cans. Moist Layer with dark asphalt to bottom of pit at 12 feet.

Typical debris consisting of metal cans, wire, and paint cans.

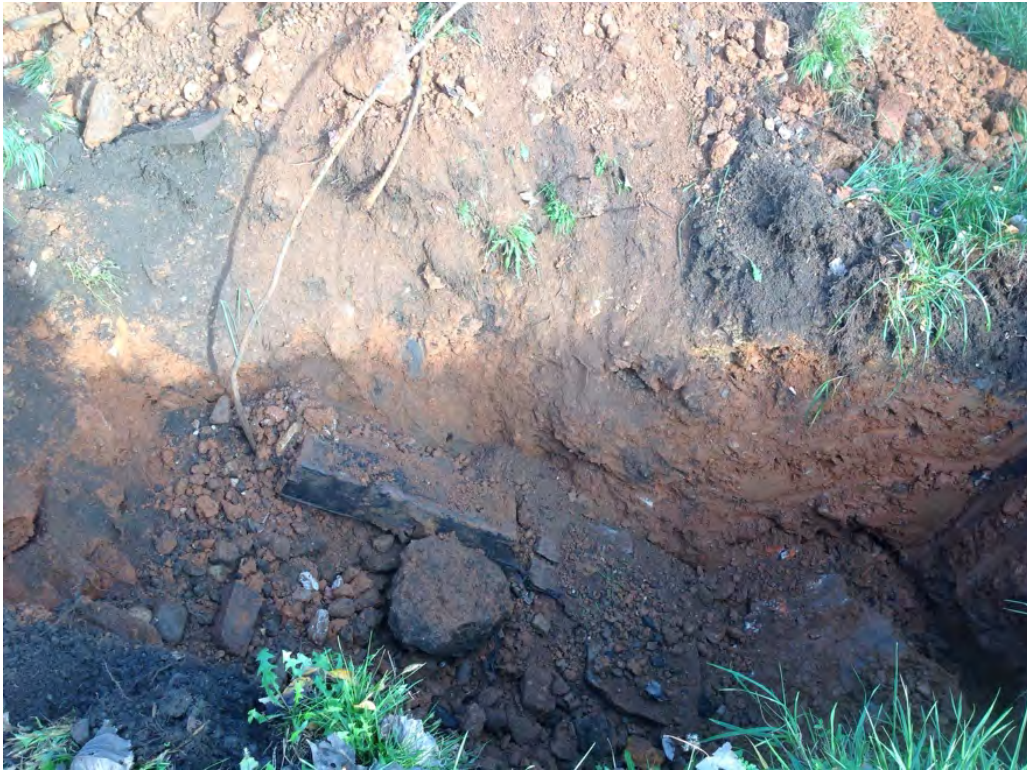
Photo 1:

Below 7 feet grey silty clay with large amounts (20 percent) of debris including rope, railroad ties, metal wheels, and concrete to 10 feet. Grey clay has black staining in places which register on the PID in the 20 ppm range. Slight petrochemical odor.

Rebar and railroad tie at 4 feet in depth.

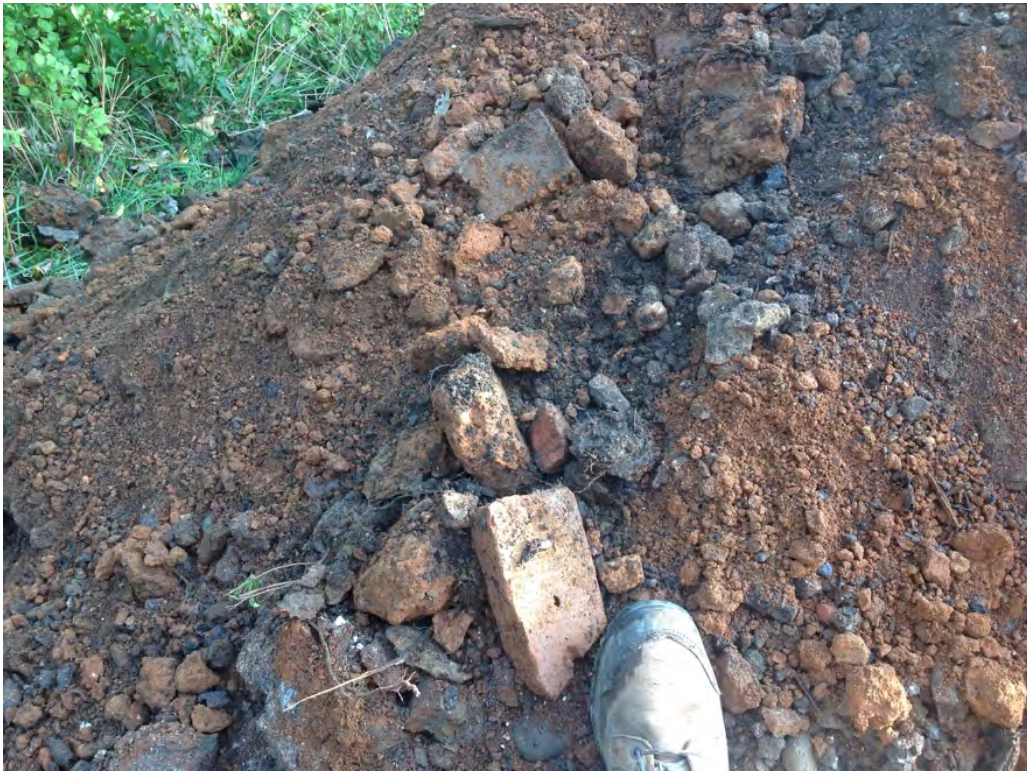
Photo 6:

Common debris noted in test pit.

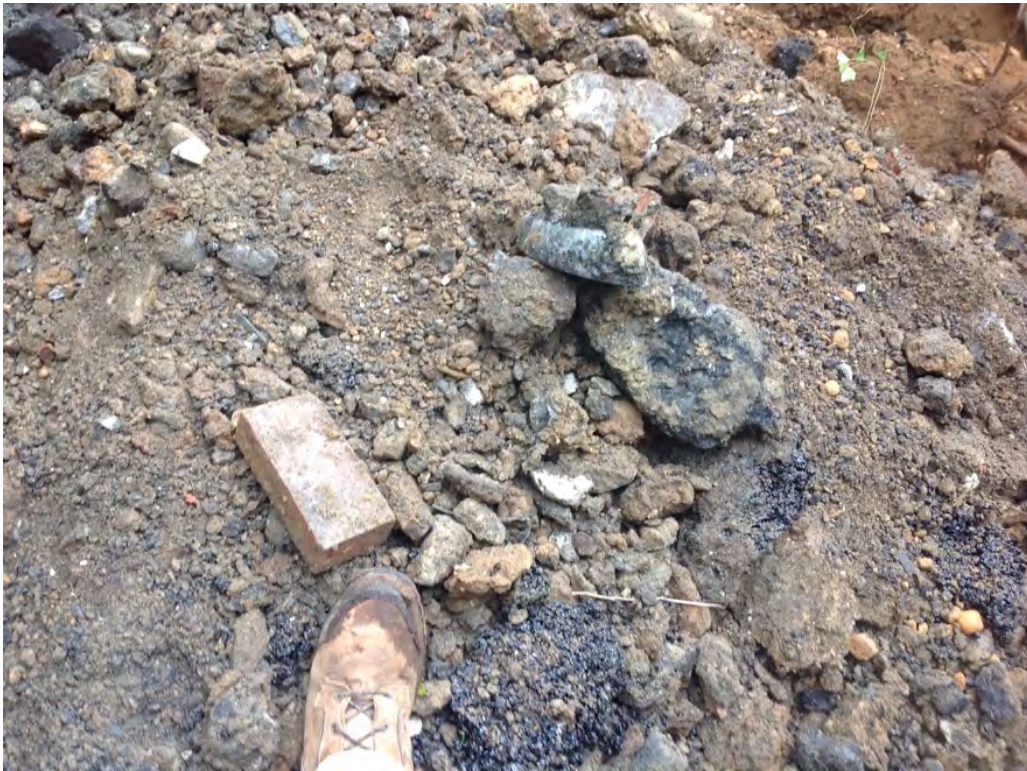
Photo 2:

At 8 feet the material transitions to a medium grey silty clay with river cobbles. Asphalt, brick, concrete, glass, ceramic tiles, and tarry asphalt like material. Petrochemical odor noted here and PID readings in the 10 to 20 ppm range.

Typical material from test pit.

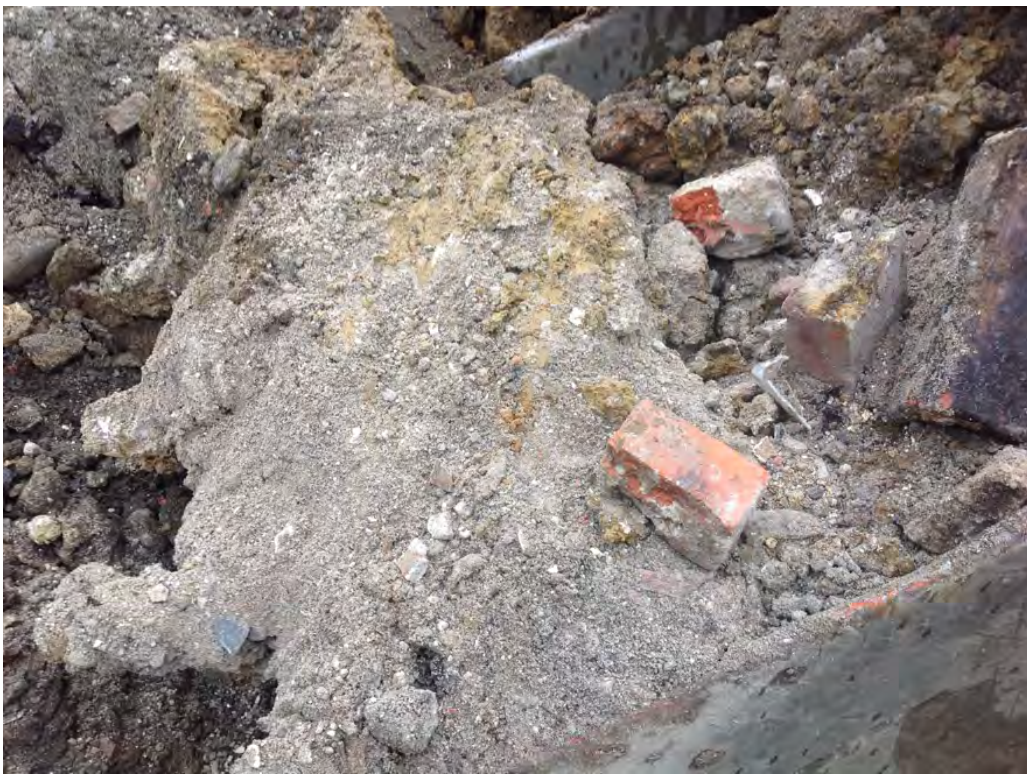
Photo 6:

At 12 feet material consists of a dark brown sandy silt with gravel and a large percentage (20 percent) of construction debris including brick, terra cotta, coal slag, and additional trash including a rusty metal bucket. Petrochemical odor noted in breathing zone.

Material from the bottom of the pit.
