NONPOINT SOURCE SUCCESS STORY

District of Columbia Neighborhood Residents Lead Water Quality Improvement Project to Restore Spring Valley Run

EPA 841-F-23-001A
January 2023

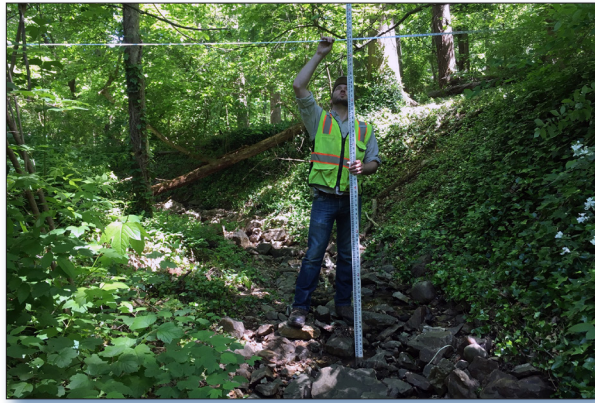
The 32-acre watershed drainage area is composed of single-family homes and is part of the American University campus. Approximately one-third of the watershed is covered by impervious surfaces such as roads, homes and university buildings. The surrounding neighborhood was developed before the enactment of stormwater regulations and, consequently, uncontrolled storm flows eroded the stream banks and riparian habitat. Before restoration, the stream channel was unstable, with highly visible signs of degradation such as high rates of adjustment including lateral migration against valley walls, toe slope failures, deep downcutting and incision. Mean bank heights were approximately 7 feet (12 feet in some project areas), which prevented the storm flows from connecting to the floodplains (Figure 2).

Figure 2. Measuring the eroded bank height.

After years of community advocacy, DC Councilwoman Mary Cheh presented the project to DOEE. In 2017, DOEE contracted with Biohabitats, Inc. to undertake full design and construction for the restoration of 1,000 feet of Spring Valley Run. The design approach focused on regenerative stream channel techniques to raise the stream bed, promote infiltration, and connect it to the floodplain. Raising the stream bed

increased storage capacity of groundwater and restored subterranean reservoirs within the riparian area. Regenerative stream channel design included installing a series of riffles and pools, sand and wood chip fill, rock weirs, and large woody debris to reduce stream velocity, control stormflow and allow for infiltration (Figure 4). DOEE and Biohabitats coordinated with DC Water to protect and bury sanitary sewer lines to prevent further stream impairment. Implementing the project also created a sustained baseflow for aquatic biota survival and established native riparian vegetative communities. Project partners cleared an old inlet at the bottom of the stream to allow the full flow of the stream to exit the site. They also covered exposed roots along the trail and installed rolling dips, which created a trough in the trail that sloped toward the stream and directed runoff into a vegetated swale before draining into a nearby pool.

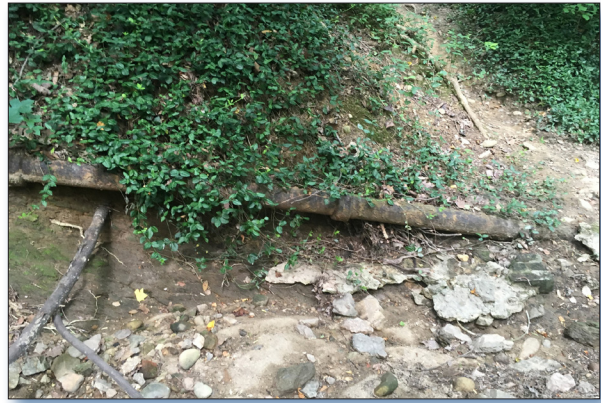
Downcutting caused by storm flows caused severe erosion that exposed three sanitary sewer lines running through the park (Figure 3). The storm drain inlet was constantly clogged due to excessive sedimentation, which resulted in frequent park flooding.

Figure 3. Sewer pipe exposed by erosion.

The Spring Valley Run restoration project illustrates how environmental advocacy can lead to an effective collaboration with government agencies that achieves watershed restoration goals. Neighborhood residents identified a stream that was highly incised with exposed sanitary sewer lines, then partnered with several Washington, DC, agencies to restore it. Spring Valley Run is a tributary of Dalecarlia Tributary, which is listed as impaired for multiple pollutants, namely, *Escherichia coli* and total suspended solids (TSS), pursuant to Clean Water Act (CWA) section 303(d). To reduce loadings into the stream, the restoration project's environmental design goals included stabilizing stormwater outfalls, reducing the volume and velocity of stormwater flowing into the stream, improving infiltration, protecting exposed sanitary sewer lines, and repairing an adjacent walking trail.

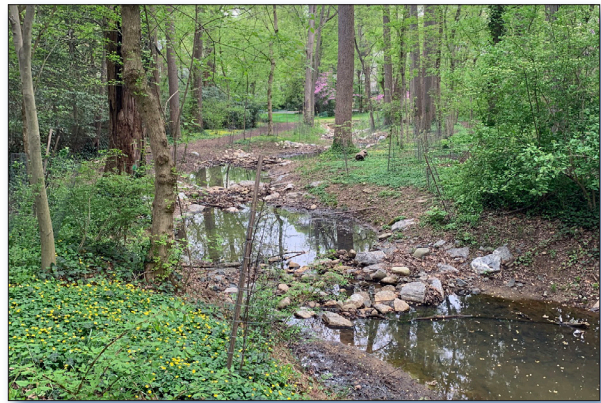
Figure 4. Restored area along Spring Valley Run.

Stabilizing the banks and raising the streambed of Spring Valley Run would yield load reductions of 72,648 pounds per year (lbs/yr) of total suspended solids, 457 lbs/yr of nitrogen and 210 lbs/yr of phosphorous, according to the Chesapeake Bay program's stream restoration protocols. In addition, DOEE contracted with the Metropolitan Washington Council of Governments to conduct pre- and post-stream restoration monitoring. Before the project, mean bank stability at the site was approximately 66.4% (fair), while post-restoration mean bank stability was measured at 94.5% (excellent). Reducing the mean bank height by almost 50% has substantially improved storm flows' connectivity to the floodplain. In addition,

riparian cover was restored by removing invasive plants and planting over 1,000 native plants and trees. Repairing the walking trail that winds through Spring Valley Park also improved public access to green space and afforded residents the enjoyment of restored stream and wildlife habitat.
