OUTFALL SUMMARY REPORT

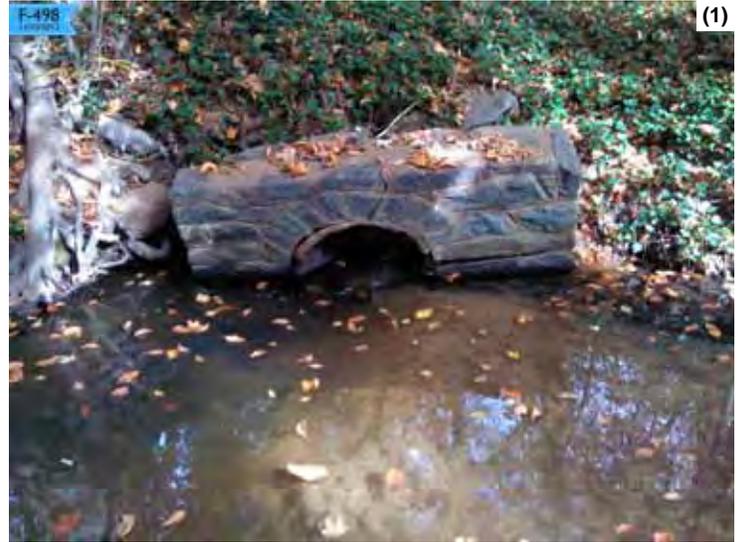
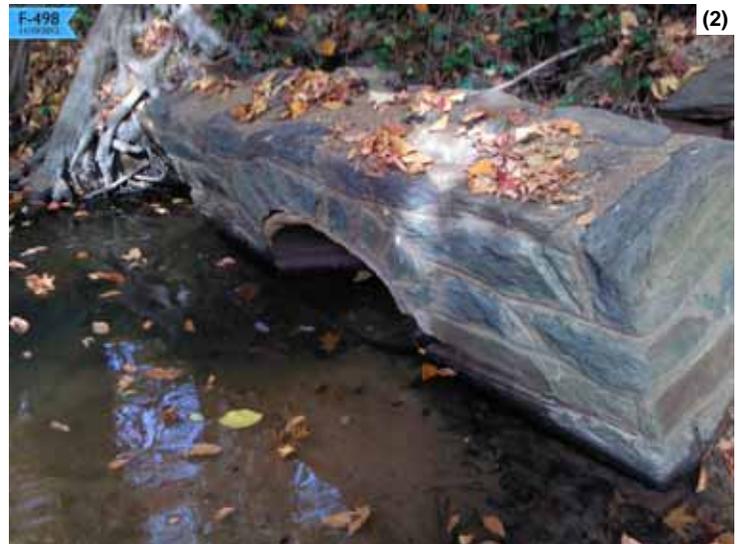
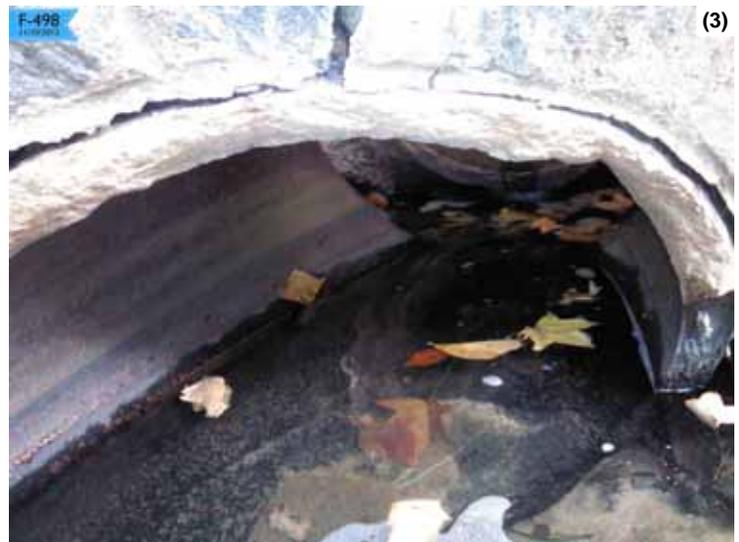
Stream Bank / Pool	<input type="text" value="0"/>	<input type="text" value="Stable"/>	Repairs Recommended? NO
Stream Bank / Pool (x2)	<input type="text" value="0"/>		
Structure	<input type="text" value="2"/>	<input type="text" value="Poor"/>	
Criticality	<input type="text" value="0"/>	<input type="text" value="Normal"/>	
Total Score	<input type="text" value="2"/>	<small>Total = Stream Bank / Pool x2 + Structure + Criticality</small>

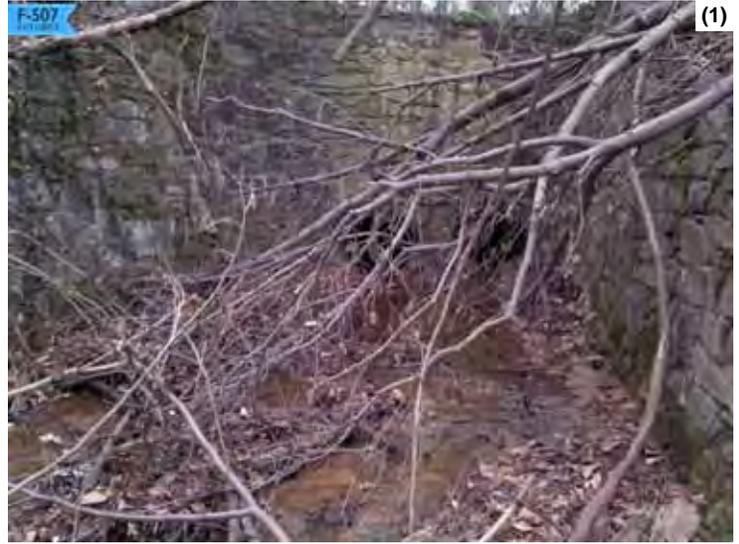
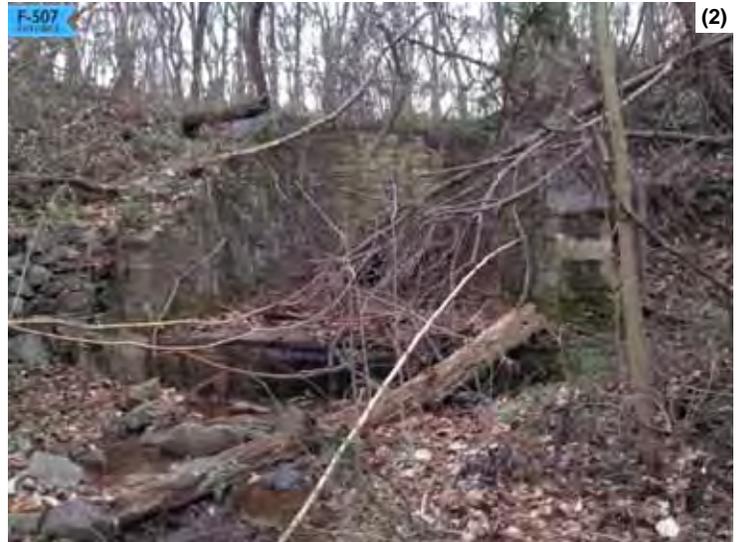
Stream Bank / Pool	<input type="text" value="1"/>	<input type="text" value="Some Erosion"/>	Repairs Recommended? NO
Stream Bank / Pool (x2)	<input type="text" value="2"/>		
Structure	<input type="text" value="0"/>	<input type="text" value="Excellent / Like New"/>	
Criticality	<input type="text" value="0"/>	<input type="text" value="Normal"/>	
Total Score	<input type="text" value="2"/>	<i>Total = Stream Bank / Pool x2 + Structure + Criticality</i>

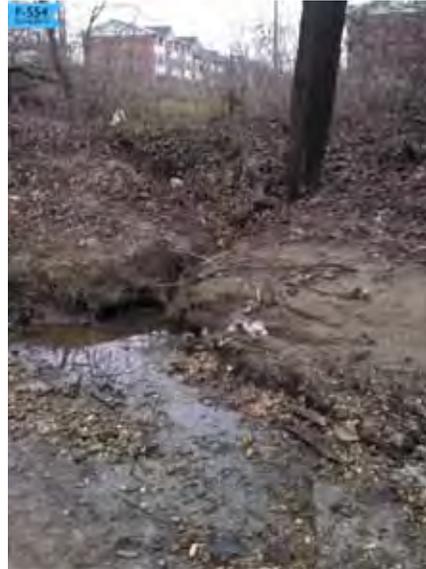
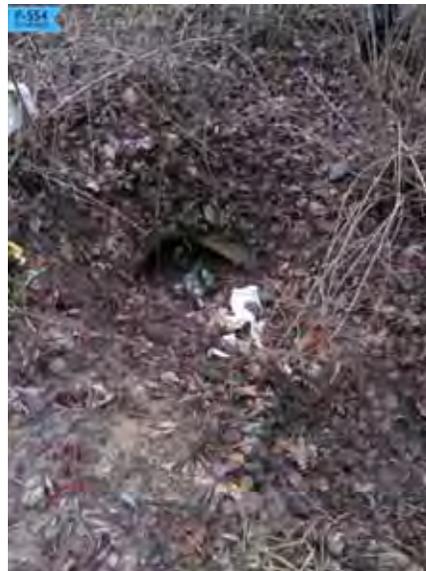
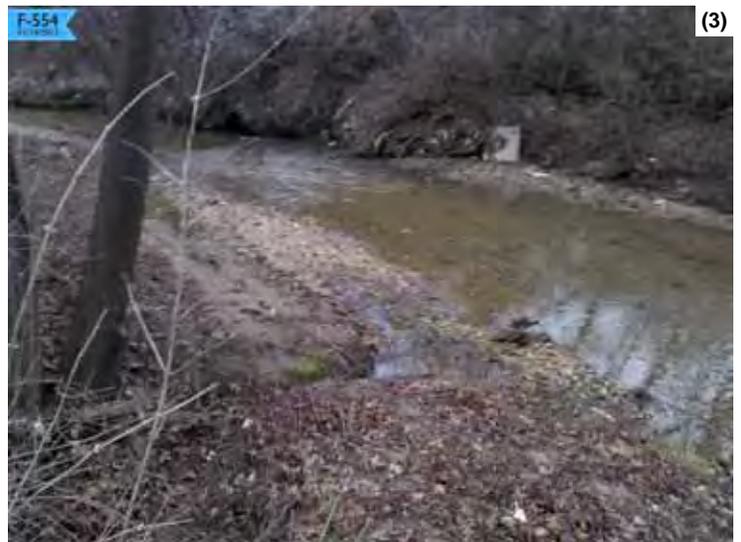
Stream Bank / Pool	<input type="text" value="1"/>	<input type="text" value="Some Erosion"/>	Repairs Recommended? NO
Stream Bank / Pool (x2)	<input type="text" value="2"/>		
Structure	<input type="text" value="0"/>	<input type="text" value="Excellent / Like New"/>	
Criticality	<input type="text" value="0"/>	<input type="text" value="Normal"/>	
Total Score	<input type="text" value="2"/>	<small>Total = Stream Bank / Pool x2 + Structure + Criticality</small>

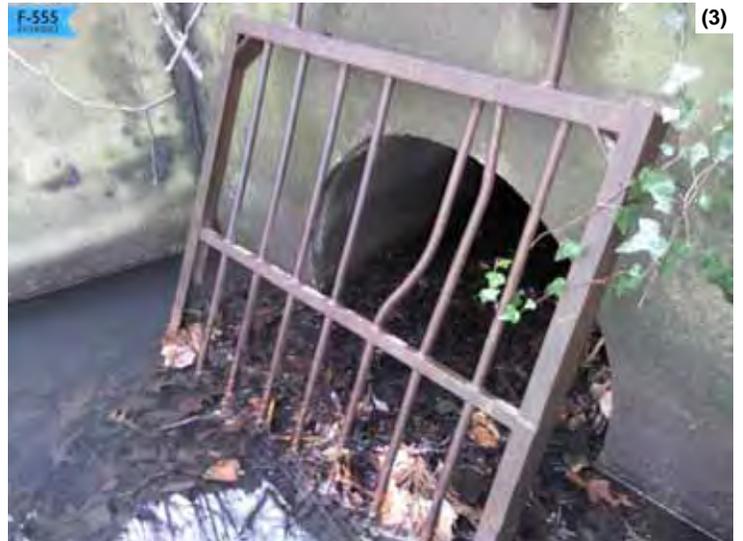
Stream Bank / Pool	<input type="text" value="1"/>	<input type="text" value="Some Erosion"/>	Repairs Recommended? NO
Stream Bank / Pool (x2)	<input type="text" value="2"/>		
Structure	<input type="text" value="0"/>	<input type="text" value="Excellent / Like New"/>	
Criticality	<input type="text" value="0"/>	<input type="text" value="Normal"/>	
Total Score	<input type="text" value="2"/>	<small>Total = Stream Bank / Pool x2 + Structure + Criticality</small>

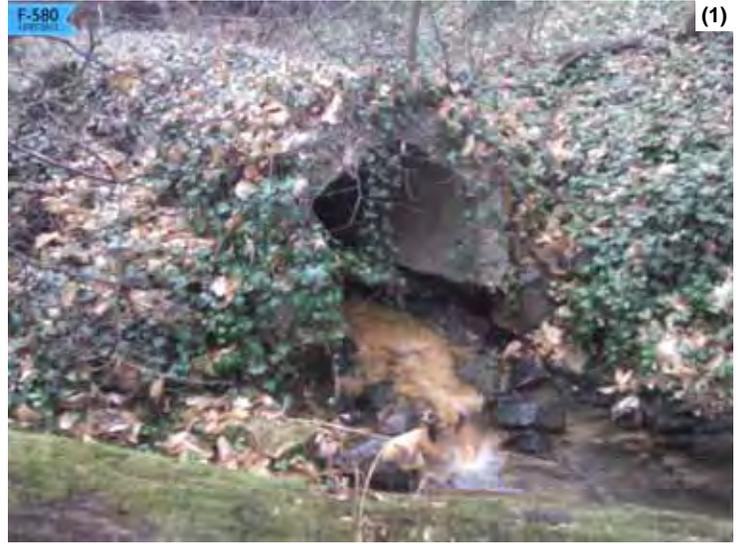
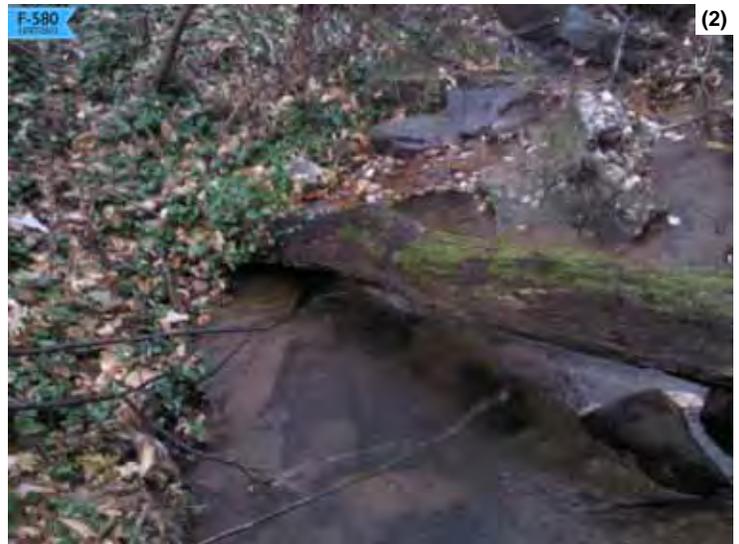
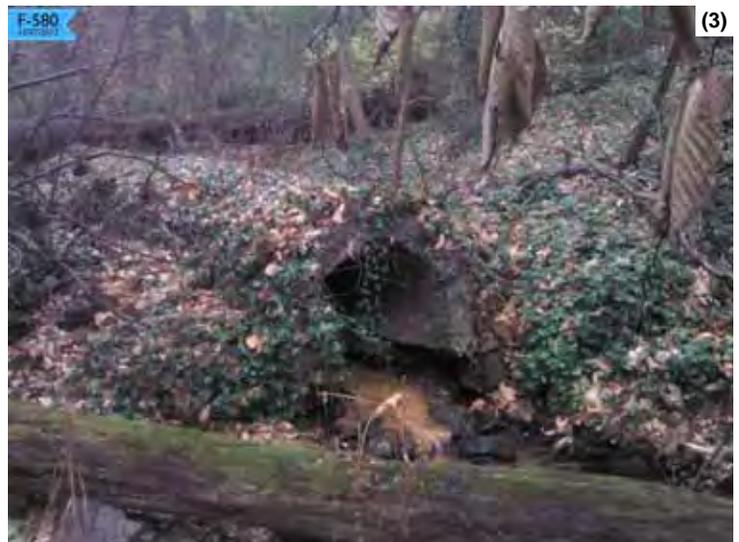
Stream Bank / Pool	<input type="text" value="0"/>	<input type="text" value="Stable"/>	Repairs Recommended? NO
Stream Bank / Pool (x2)	<input type="text" value="0"/>		
Structure	<input type="text" value="1"/>	<input type="text" value="Moderate"/>	
Criticality	<input type="text" value="0"/>	<input type="text" value="Normal"/>	
Total Score	<input type="text" value="1"/>	<i>Total = Stream Bank / Pool x2 + Structure + Criticality</i>

Missing pipe invert.

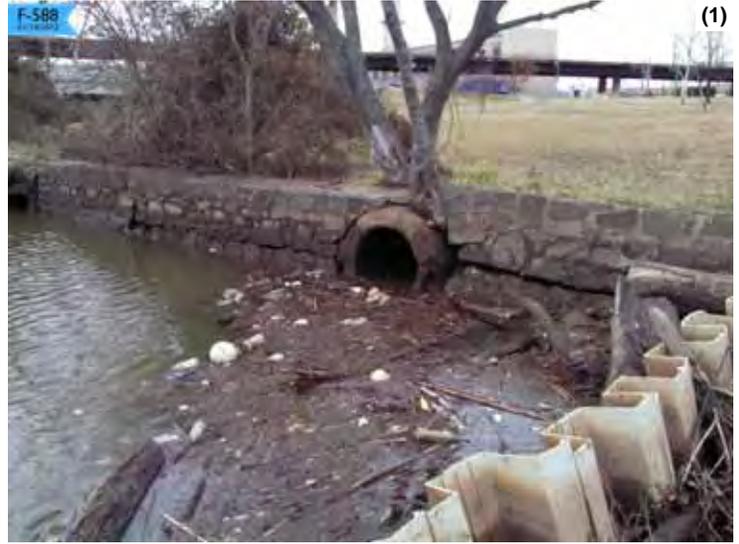
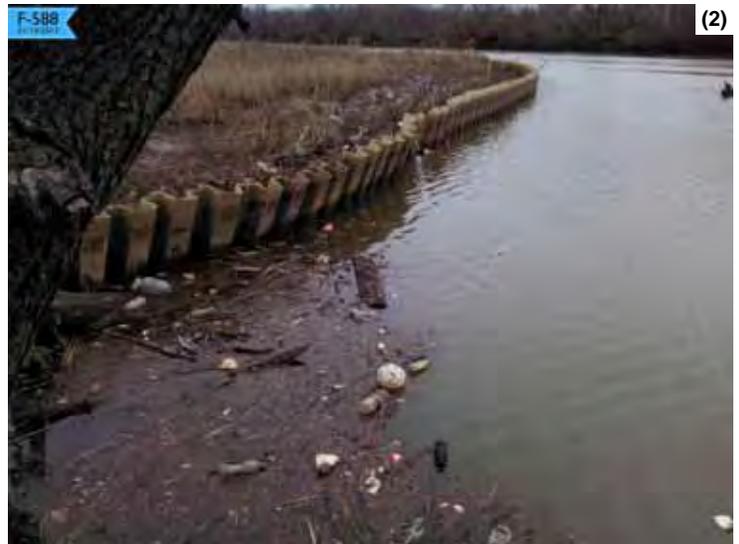
Stream Bank / Pool	<input type="text" value="0"/>	<input type="text" value="Stable"/>	Repairs Recommended? NO
Stream Bank / Pool (x2)	<input type="text" value="0"/>		
Structure	<input type="text" value="1"/>	<input type="text" value="Moderate"/>	
Criticality	<input type="text" value="0"/>	<input type="text" value="Normal"/>	
Total Score	<input type="text" value="1"/>	<i>Total = Stream Bank / Pool x2 + Structure + Criticality</i>

Remove tree and repair stone wall.

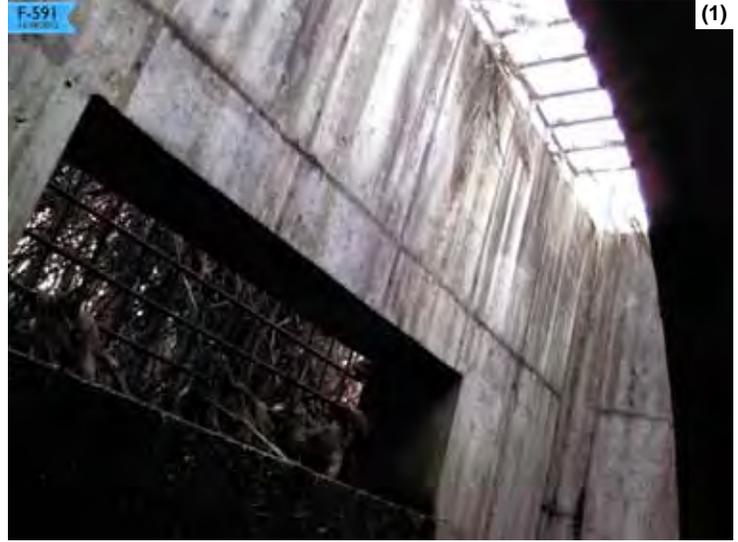
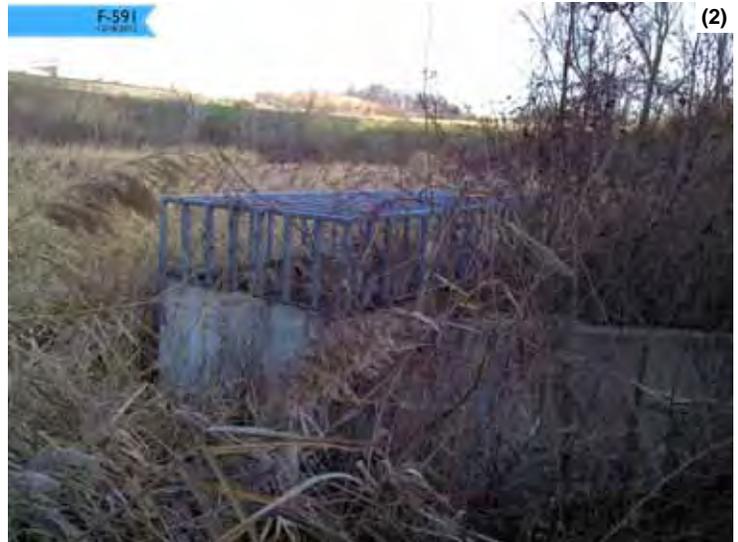
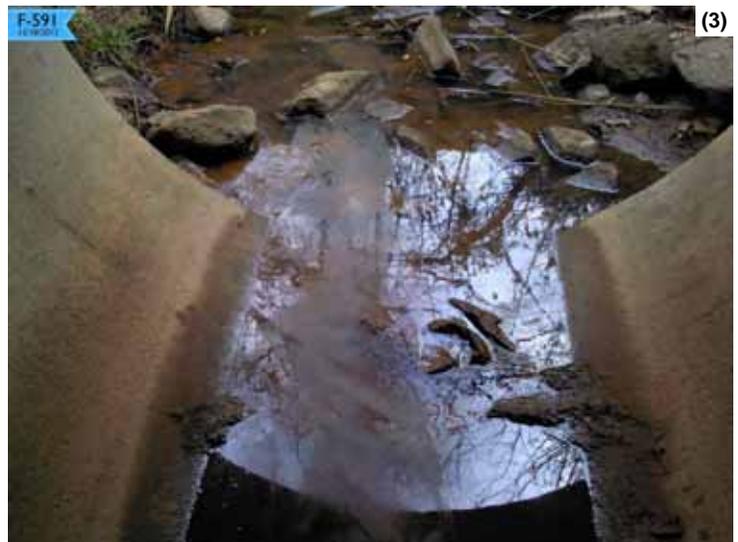
Stream Bank / Pool	<input type="text" value="0"/>	<input type="text" value="Stable"/>	Repairs Recommended? NO
Stream Bank / Pool (x2)	<input type="text" value="0"/>		
Structure	<input type="text" value="0"/>	<input type="text" value="Excellent / Like New"/>	
Criticality	<input type="text" value="0"/>	<input type="text" value="Normal"/>	
Total Score	<input type="text" value="0"/>	<small>Total = Stream Bank / Pool x2 + Structure + Criticality</small>

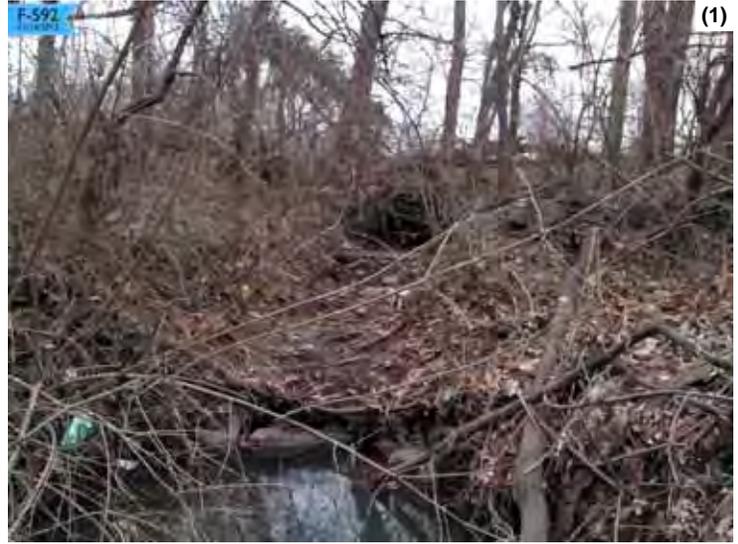
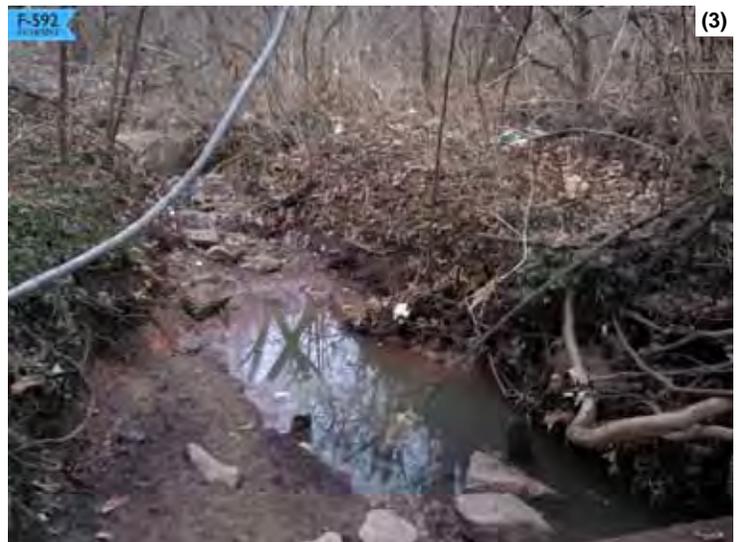
Stream Bank / Pool	<input type="text" value="1"/>	<input type="text" value="Some Erosion"/>	Repairs Recommended? NO
Stream Bank / Pool (x2)	<input type="text" value="2"/>		
Structure	<input type="text" value="0"/>	<input type="text" value="Excellent / Like New"/>	
Criticality	<input type="text" value="0"/>	<input type="text" value="Normal"/>	
Total Score	<input type="text" value="2"/>	<small>Total = Stream Bank / Pool x2 + Structure + Criticality</small>

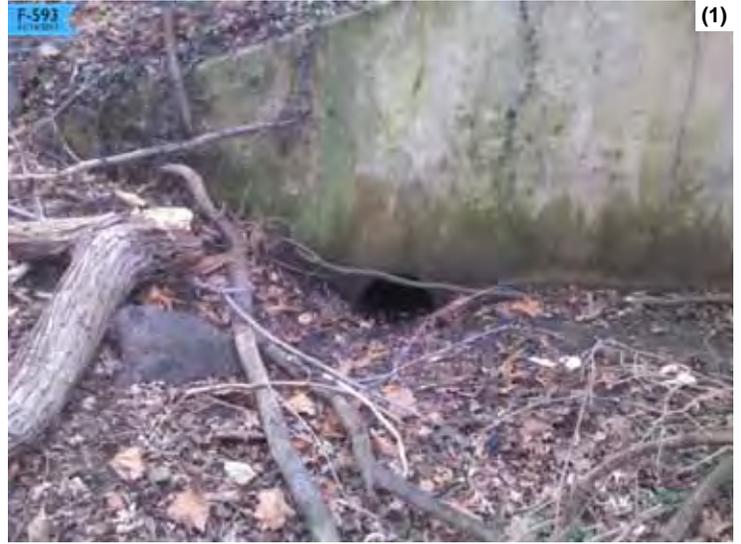
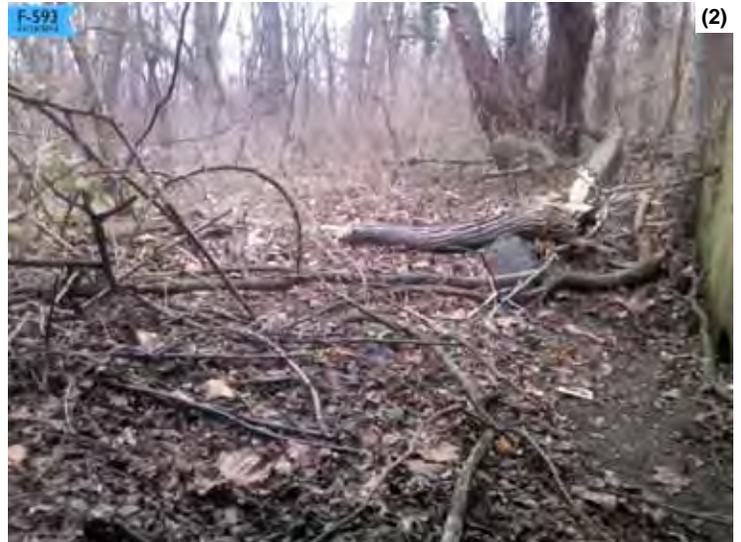
Stream Bank / Pool	<input type="text" value="0"/>	<input type="text" value="Stable"/>	Repairs Recommended? NO
Stream Bank / Pool (x2)	<input type="text" value="0"/>		
Structure	<input type="text" value="0"/>	<input type="text" value="Excellent / Like New"/>	
Criticality	<input type="text" value="0"/>	<input type="text" value="Normal"/>	
Total Score	<input type="text" value="0"/>	<small>Total = Stream Bank / Pool x2 + Structure + Criticality</small>

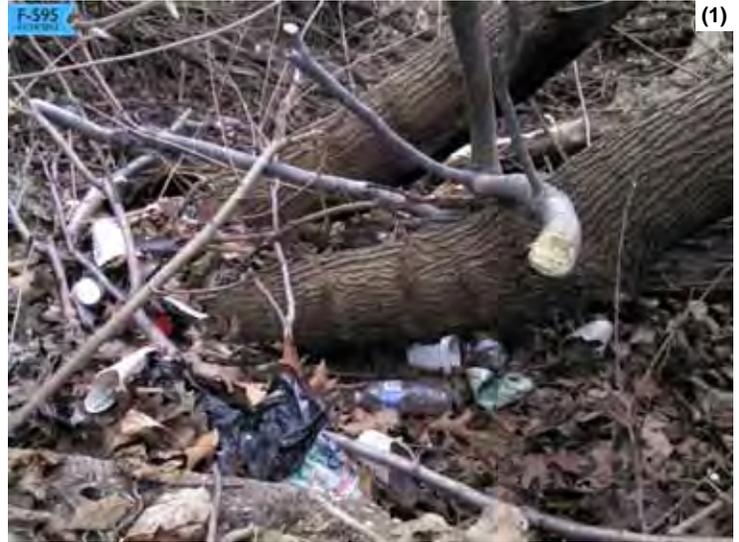
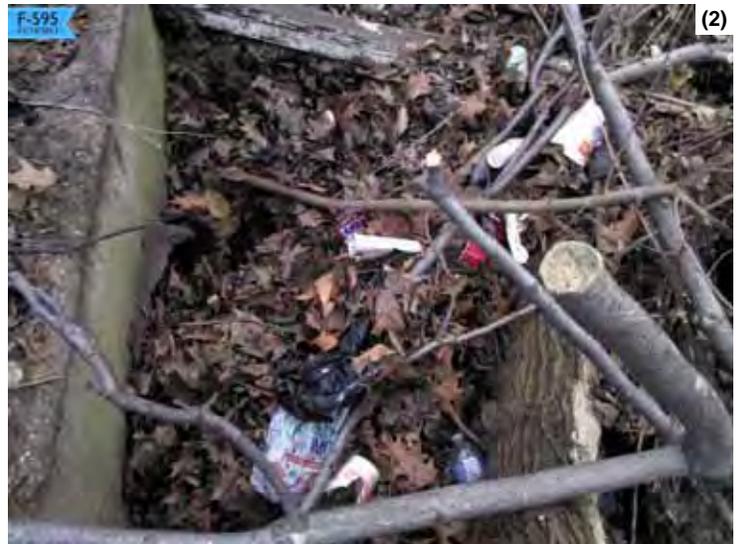
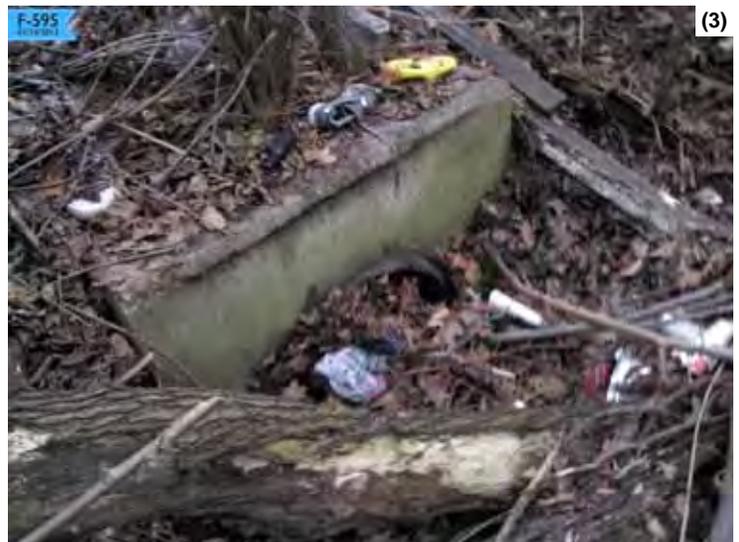
Stream Bank / Pool	<input type="text" value="1"/>	<input type="text" value="Some Erosion"/>	Repairs Recommended? NO
Stream Bank / Pool (x2)	<input type="text" value="2"/>		
Structure	<input type="text" value="0"/>	<input type="text" value="Excellent / Like New"/>	
Criticality	<input type="text" value="0"/>	<input type="text" value="Normal"/>	
Total Score	<input type="text" value="2"/>	<small>Total = Stream Bank / Pool x2 + Structure + Criticality</small>

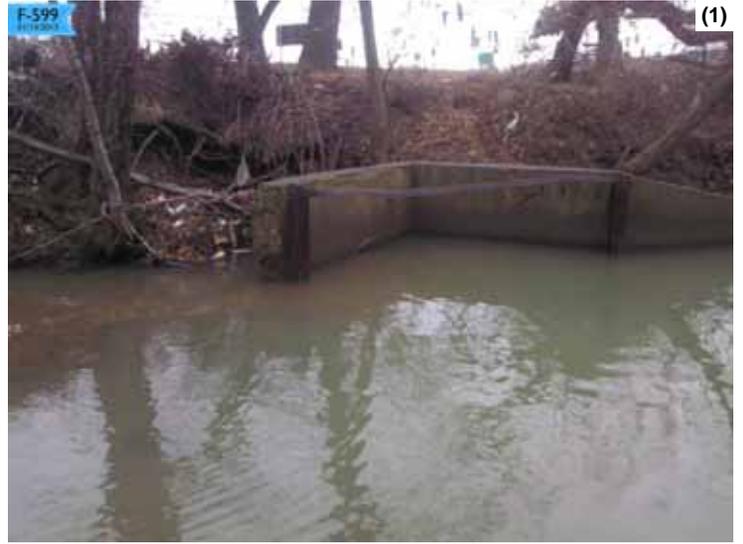
Stream Bank / Pool	<input type="text" value="0"/>	<input type="text" value="Stable"/>	Repairs Recommended? YES
Stream Bank / Pool (x2)	<input type="text" value="0"/>		
Structure	<input type="text" value="0"/>	<input type="text" value="Excellent / Like New"/>	
Criticality	<input type="text" value="0"/>	<input type="text" value="Normal"/>	
Total Score	<input type="text" value="0"/>	<i>Total = Stream Bank / Pool x2 + Structure + Criticality</i>

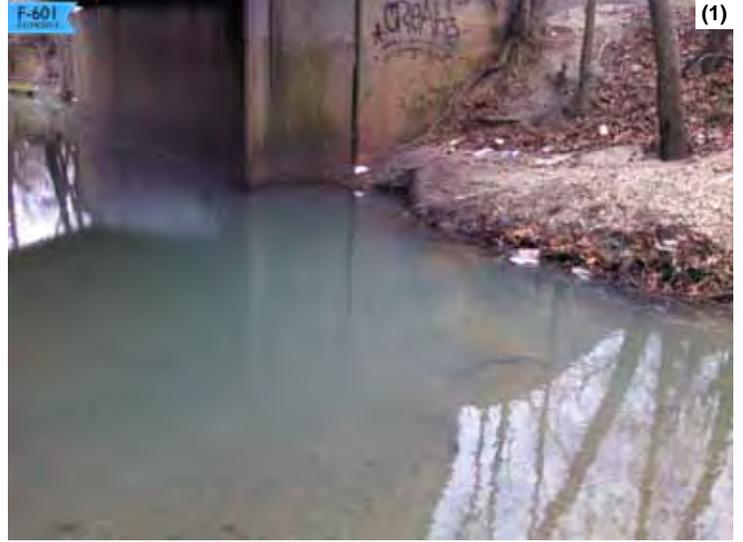
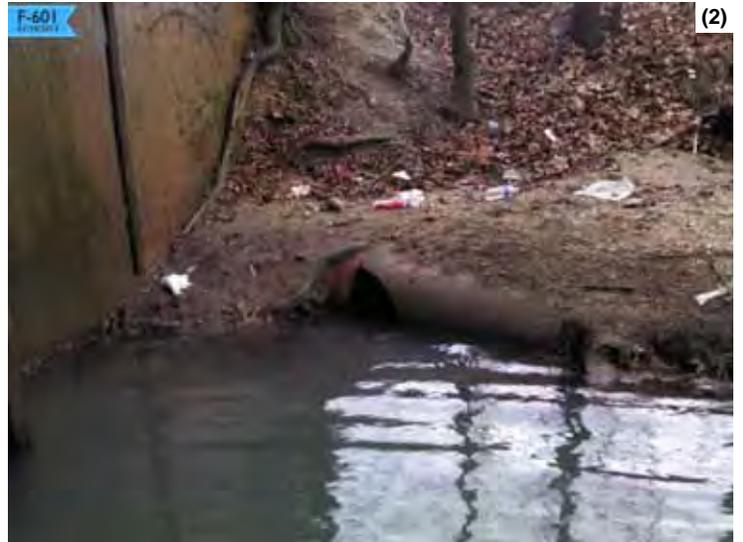
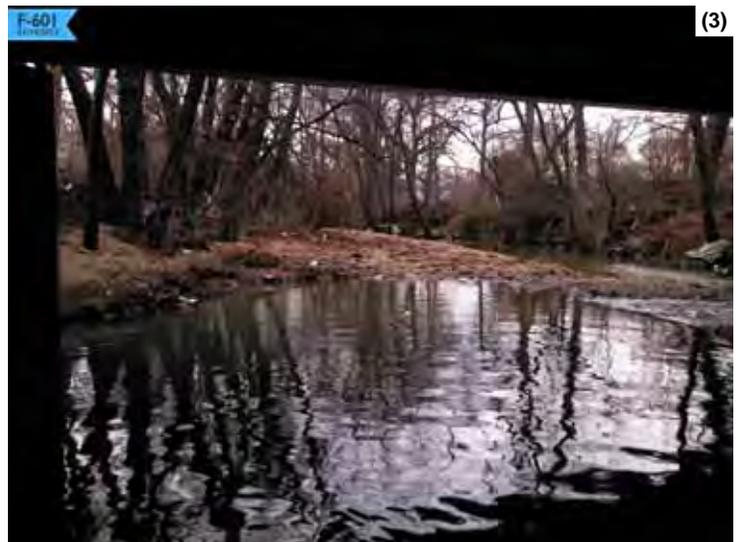
Stream Bank / Pool	<input type="text" value="0"/>	<input type="text" value="Stable"/>	Repairs Recommended? NO
Stream Bank / Pool (x2)	<input type="text" value="0"/>		
Structure	<input type="text" value="3"/>	<input type="text" value="Very Poor"/>	
Criticality	<input type="text" value="0"/>	<input type="text" value="Normal"/>	
Total Score	<input type="text" value="3"/>	<small>Total = Stream Bank / Pool x2 + Structure + Criticality</small>

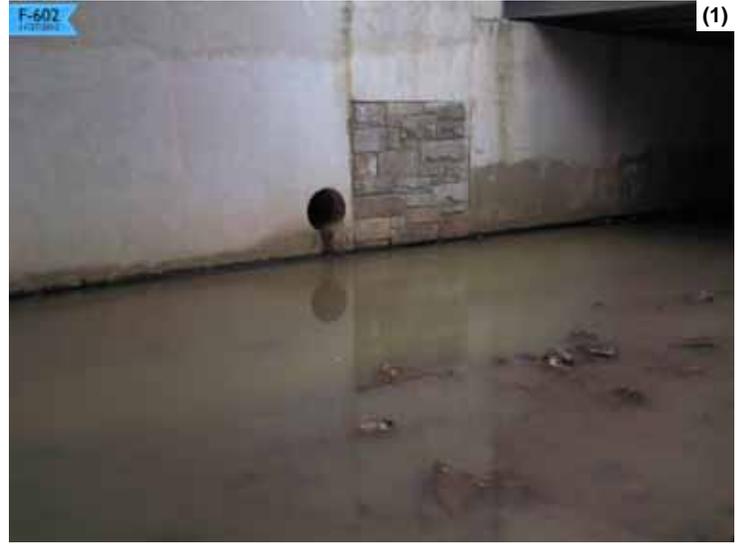
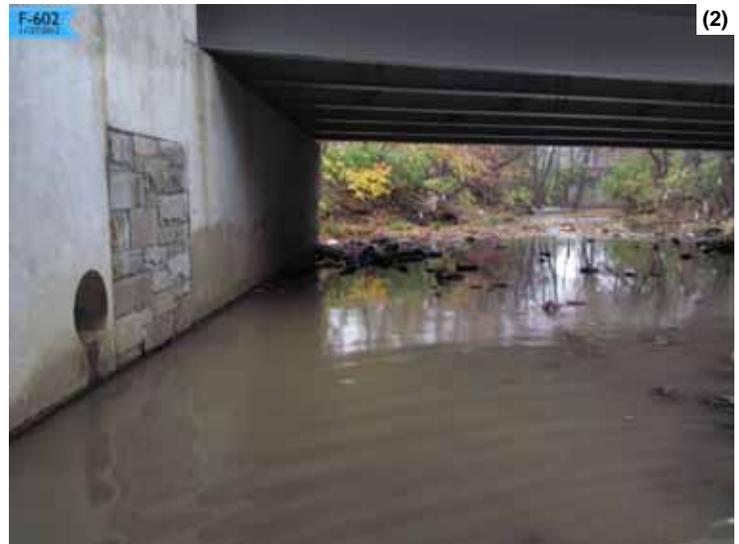
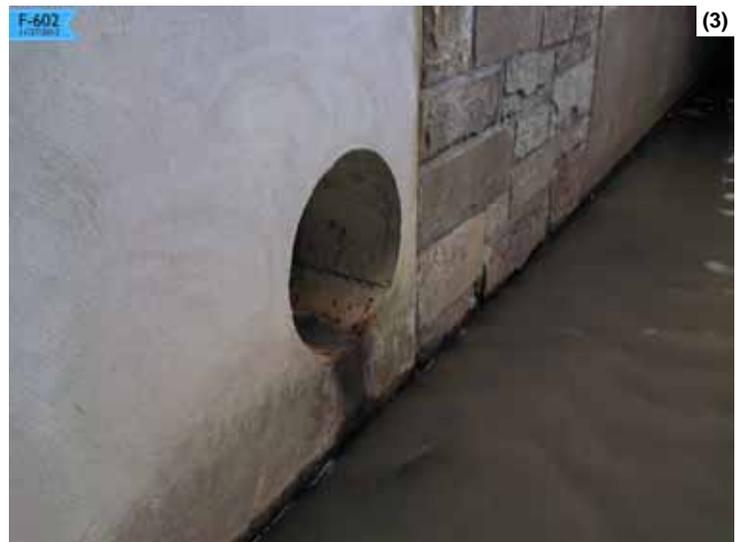
Stream Bank / Pool	<input type="text" value="0"/>	<input type="text" value="Stable"/>	Repairs Recommended? NO
Stream Bank / Pool (x2)	<input type="text" value="0"/>		
Structure	<input type="text" value="0"/>	<input type="text" value="Excellent / Like New"/>	
Criticality	<input type="text" value="0"/>	<input type="text" value="Normal"/>	
Total Score	<input type="text" value="0"/>	<small>Total = Stream Bank / Pool x2 + Structure + Criticality</small>

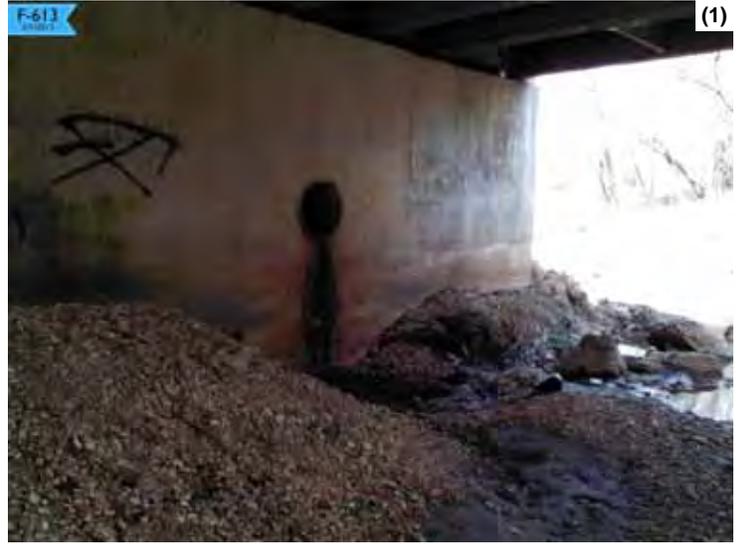
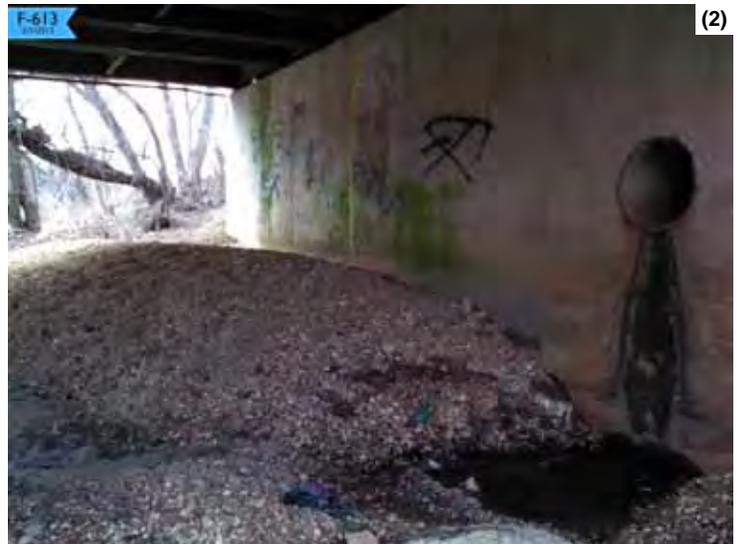
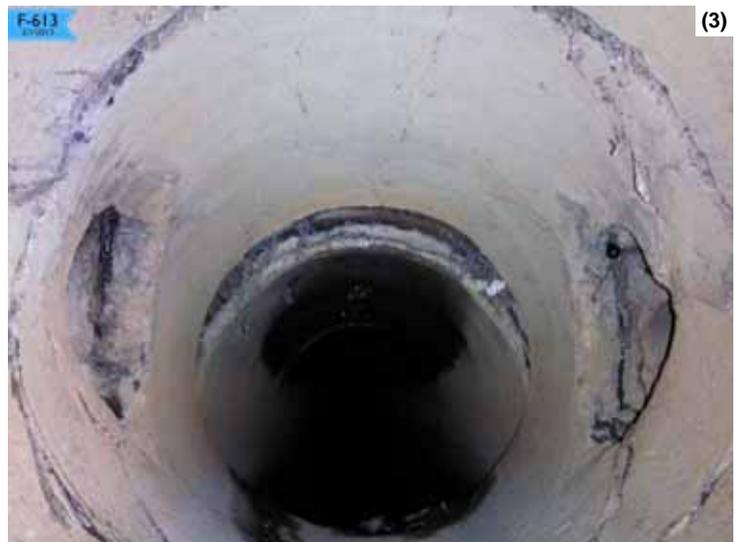
Stream Bank / Pool	<input type="text" value="0"/>	<input type="text" value="Stable"/>	Repairs Recommended? NO
Stream Bank / Pool (x2)	<input type="text" value="0"/>		
Structure	<input type="text" value="1"/>	<input type="text" value="Moderate"/>	
Criticality	<input type="text" value="1"/>	<input type="text" value="Important"/>	
Total Score	<input type="text" value="2"/>	<small>Total = Stream Bank / Pool x2 + Structure + Criticality</small>

Broken pipe.

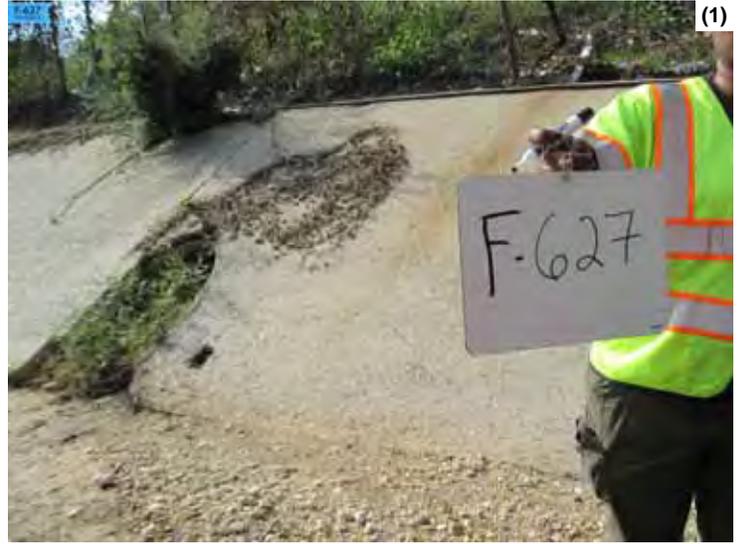
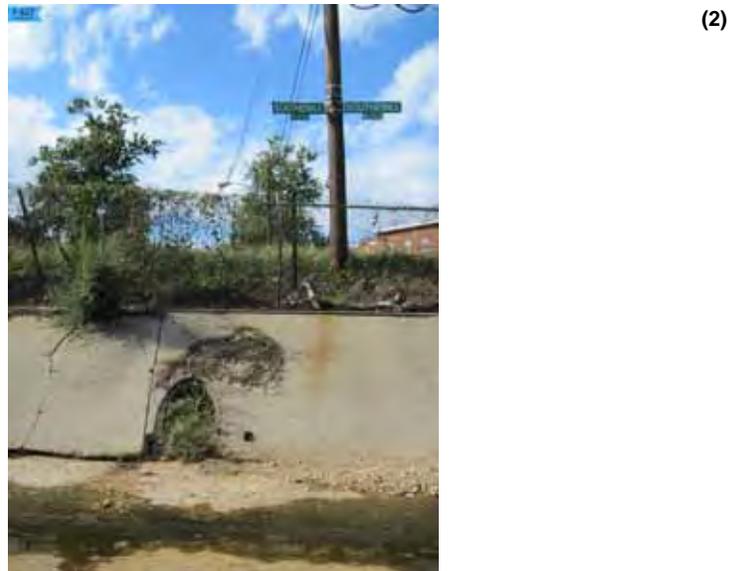
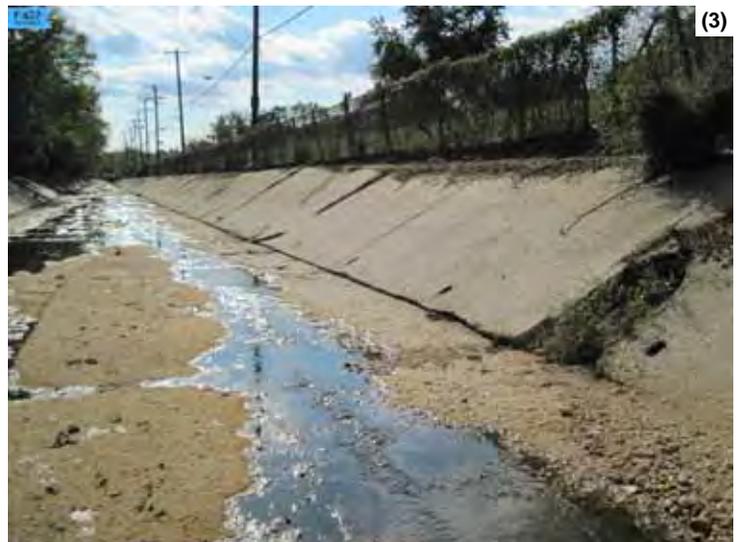
Minor cracking of channel wall around pipe end.

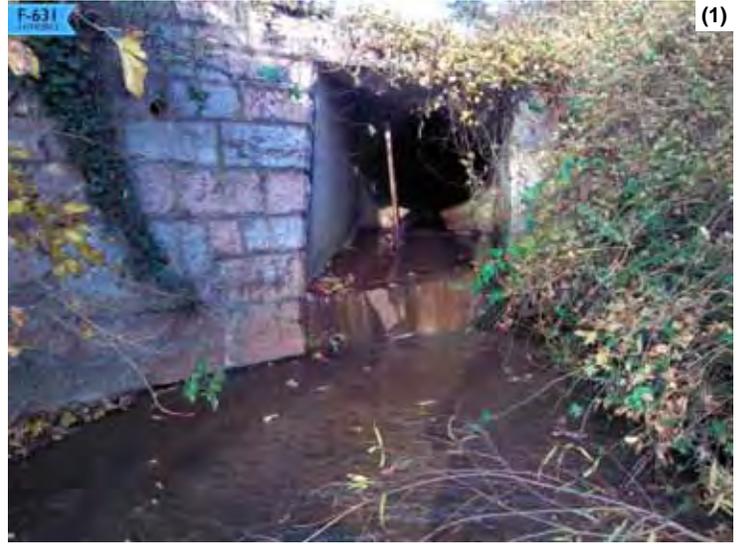
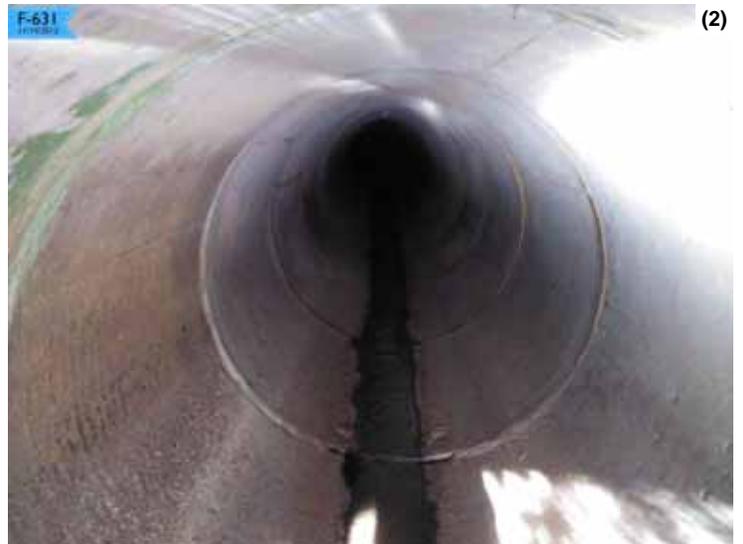
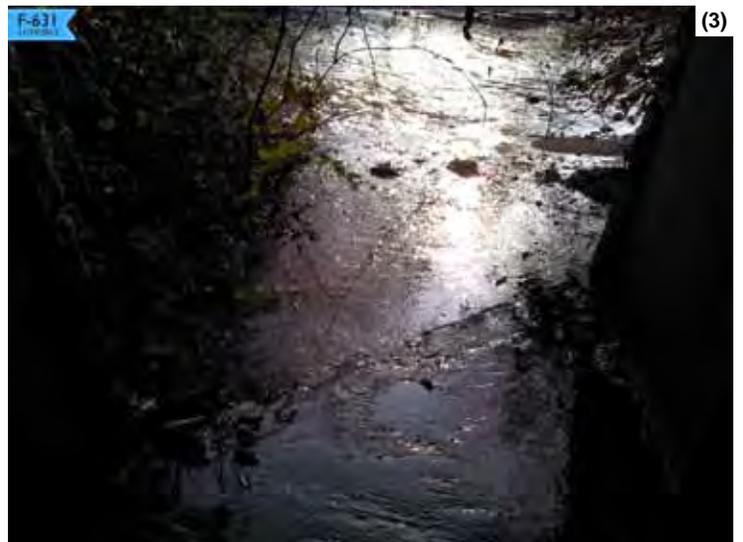
Stream Bank / Pool	<input type="text" value="0"/>	<input type="text" value="Stable"/>	Repairs Recommended? NO
Stream Bank / Pool (x2)	<input type="text" value="0"/>		
Structure	<input type="text" value="1"/>	<input type="text" value="Moderate"/>	
Criticality	<input type="text" value="0"/>	<input type="text" value="Normal"/>	
Total Score	<input type="text" value="1"/>	<i>Total = Stream Bank / Pool x2 + Structure + Criticality</i>

Broken security gate in flow path.

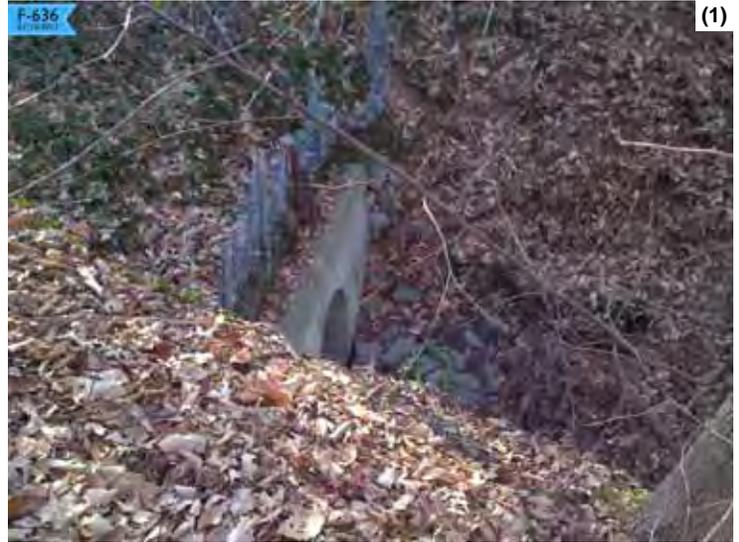
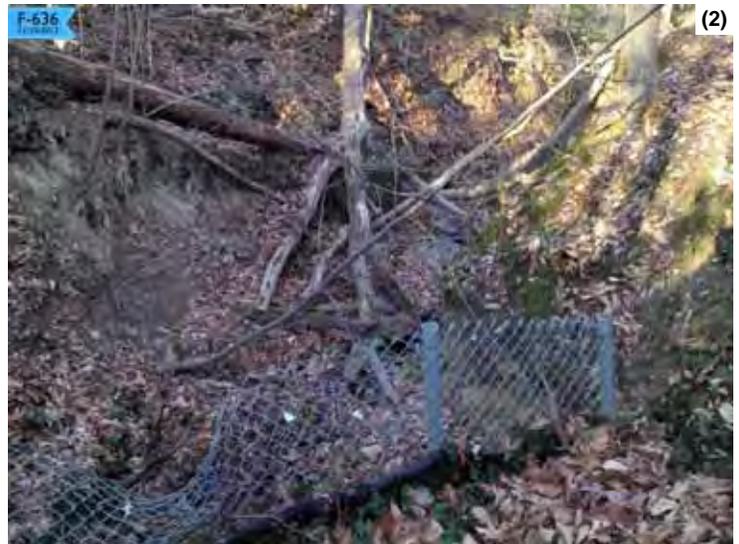
Stream Bank / Pool	<input type="text" value="3"/>	<input type="text" value="Severe Erosion"/>	Repairs Recommended? YES
Stream Bank / Pool (x2)	<input type="text" value="6"/>		
Structure	<input type="text" value="0"/>	<input type="text" value="Excellent / Like New"/>	
Criticality	<input type="text" value="0"/>	<input type="text" value="Normal"/>	
Total Score	<input type="text" value="6"/>	<small>Total = Stream Bank / Pool x2 + Structure + Criticality</small>

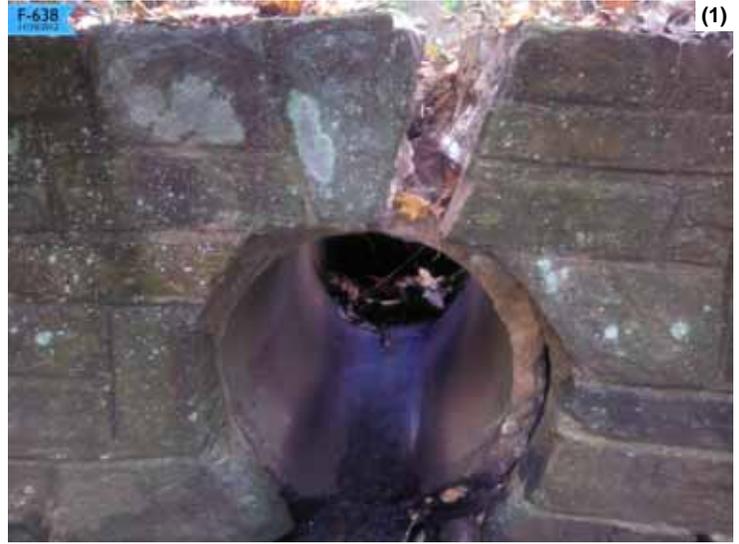
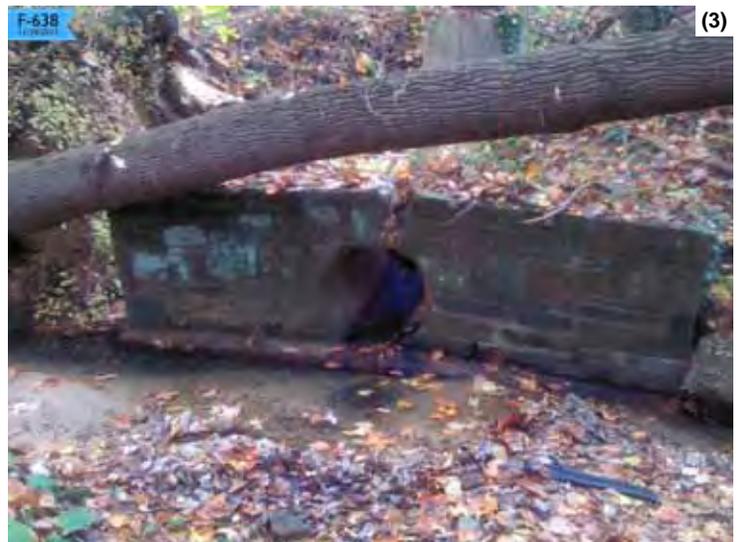
Stream Bank / Pool	<input type="text" value="2"/>	Active Erosion	Repairs Recommended? YES
Stream Bank / Pool (x2)	<input type="text" value="4"/>		
Structure	<input type="text" value="3"/>	Very Poor	
Criticality	<input type="text" value="0"/>	Normal	
Total Score	<input type="text" value="7"/>	<small>Total = Stream Bank / Pool x2 + Structure + Criticality</small>

Collapsed outfall with pipe separation at first joint. Note recent sanitary sewer point repair behind headwall. Evidence of downstream erosion but somewhat stable now.

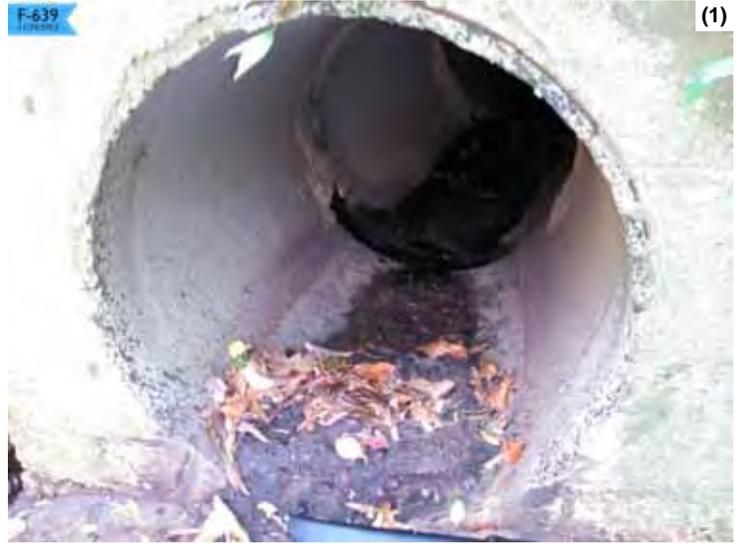
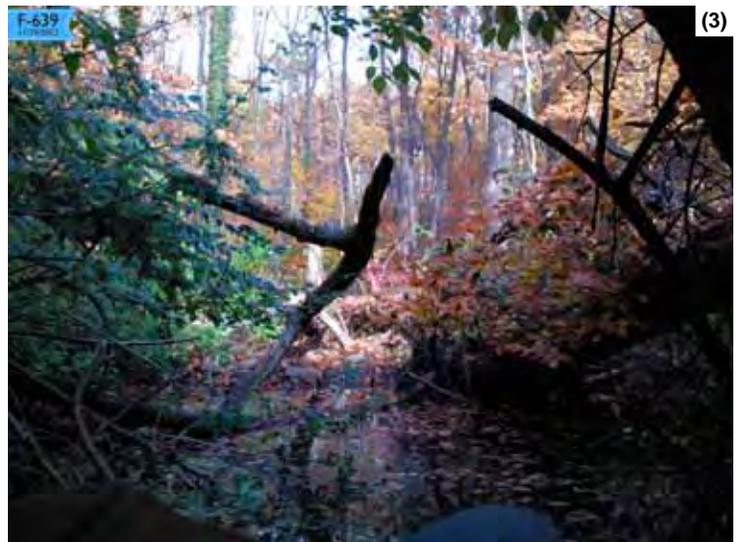
Stream Bank / Pool	<input type="text" value="2"/>	<input type="text" value="Active Erosion"/>	Repairs Recommended? YES
Stream Bank / Pool (x2)	<input type="text" value="4"/>		
Structure	<input type="text" value="1"/>	<input type="text" value="Moderate"/>	
Criticality	<input type="text" value="0"/>	<input type="text" value="Normal"/>	
Total Score	<input type="text" value="5"/>	<small>Total = Stream Bank / Pool x2 + Structure + Criticality</small>

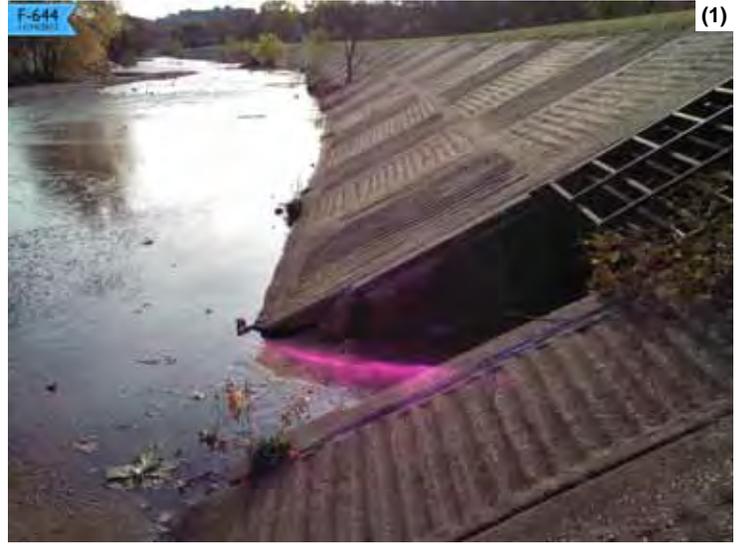
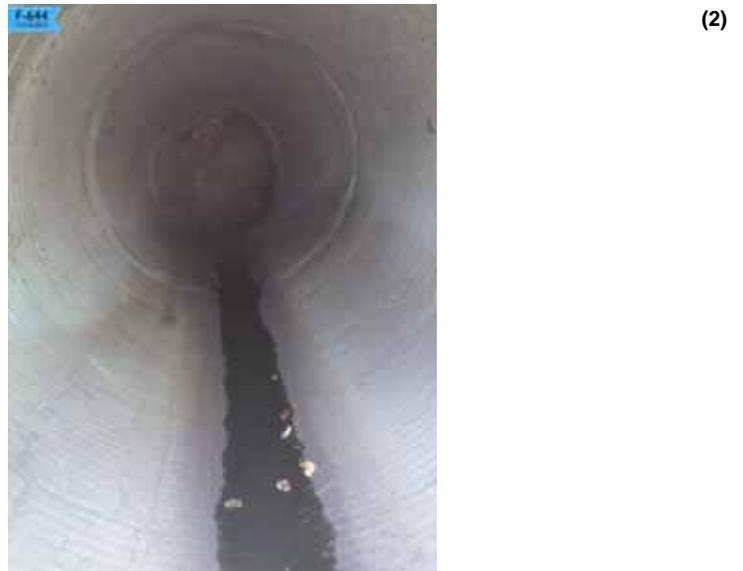
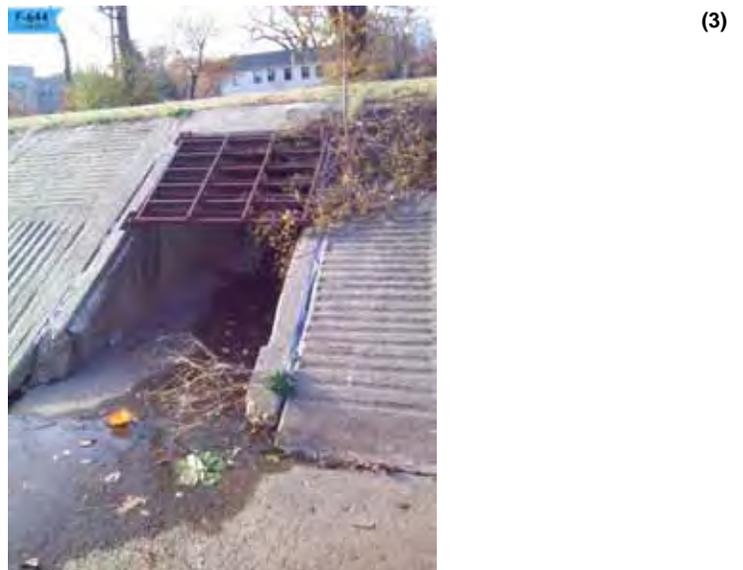
Stream Bank / Pool	<input type="text" value="0"/>	<input type="text" value="Stable"/>	Repairs Recommended? NO
Stream Bank / Pool (x2)	<input type="text" value="0"/>		
Structure	<input type="text" value="1"/>	<input type="text" value="Moderate"/>	
Criticality	<input type="text" value="0"/>	<input type="text" value="Normal"/>	
Total Score	<input type="text" value="1"/>	<small>Total = Stream Bank / Pool x2 + Structure + Criticality</small>

Missing a section of the security gate.
