OUTFALL SUMMARY REPORT

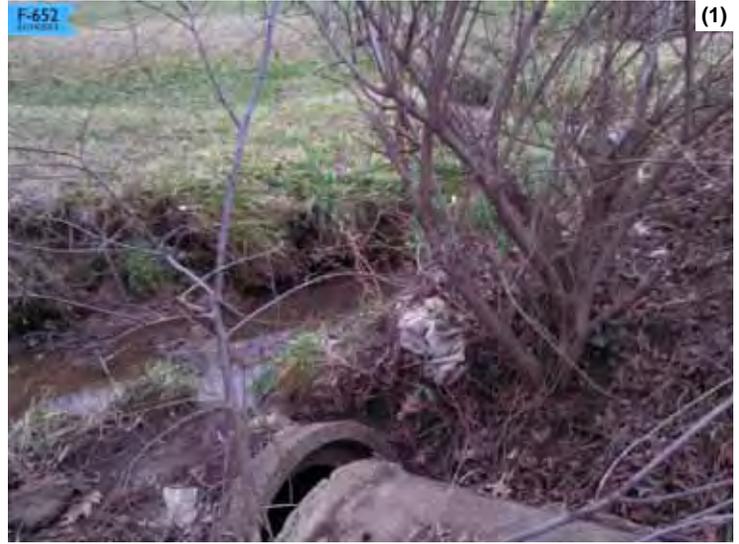
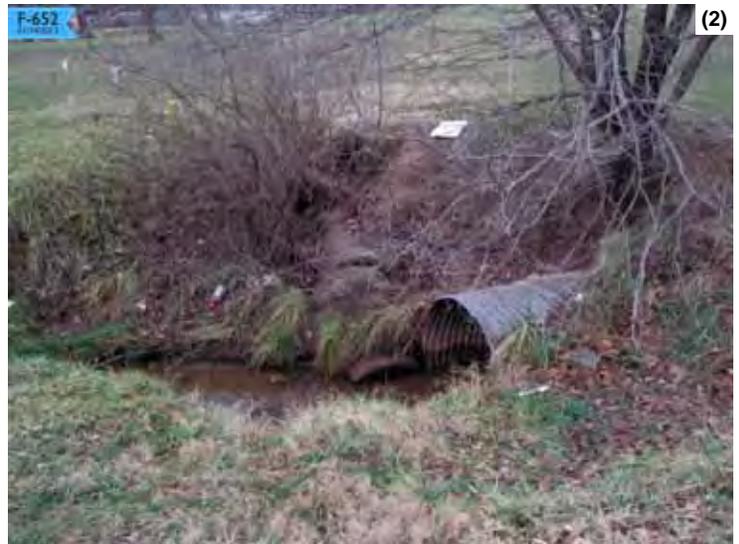
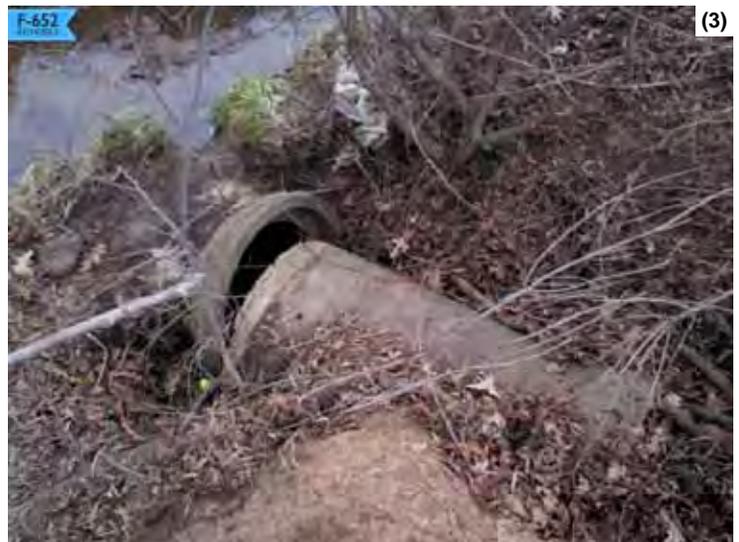
Stream Bank / Pool	<input type="text" value="2"/>	<input type="text" value="Active Erosion"/>	Repairs Recommended? YES
Stream Bank / Pool (x2)	<input type="text" value="4"/>		
Structure	<input type="text" value="2"/>	<input type="text" value="Poor"/>	
Criticality	<input type="text" value="0"/>	<input type="text" value="Normal"/>	
Total Score	<input type="text" value="6"/>	<small>Total = Stream Bank / Pool x2 + Structure + Criticality</small>

Point Repair

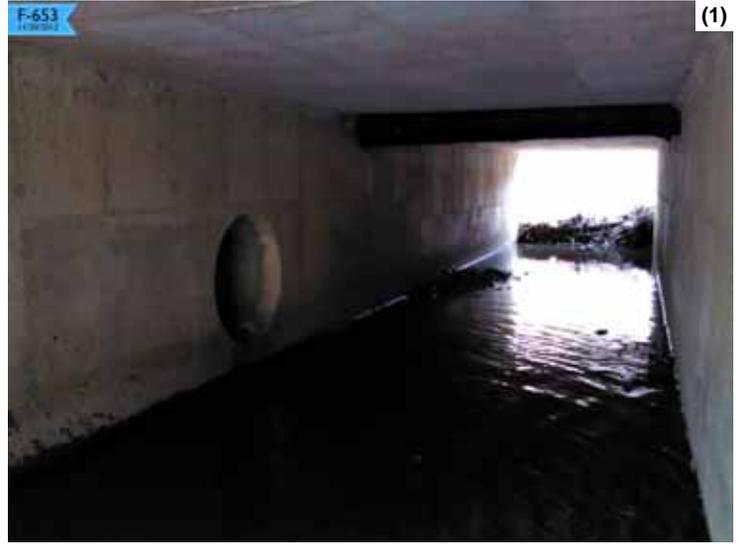
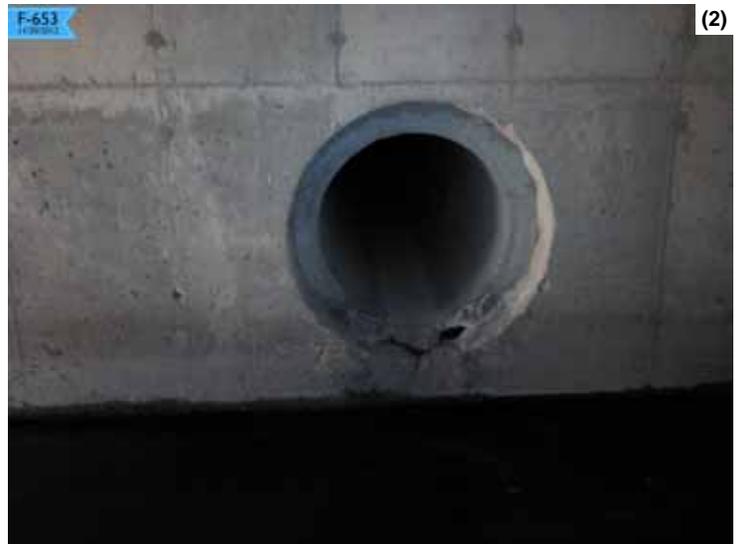
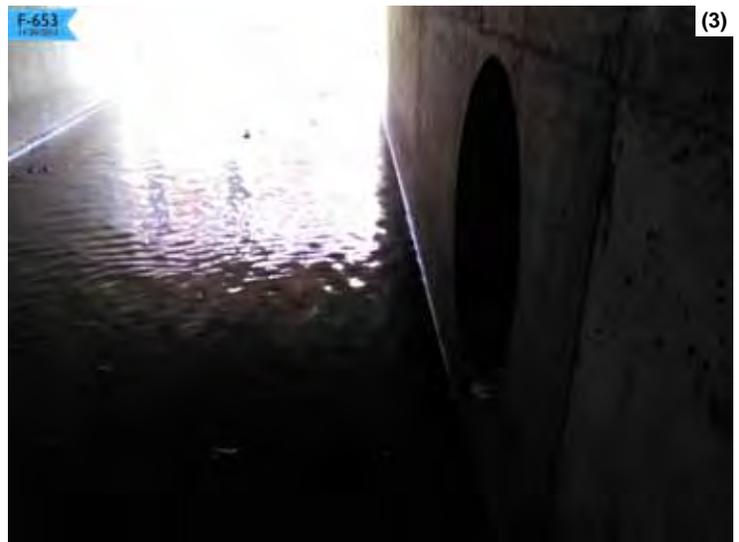
Stream Bank / Pool	<input type="text" value="0"/>	<input type="text" value="Stable"/>	Repairs Recommended? NO
Stream Bank / Pool (x2)	<input type="text" value="0"/>		
Structure	<input type="text" value="0"/>	<input type="text" value="Excellent / Like New"/>	
Criticality	<input type="text" value="0"/>	<input type="text" value="Normal"/>	
Total Score	<input type="text" value="0"/>	<small>Total = Stream Bank / Pool x2 + Structure + Criticality</small>

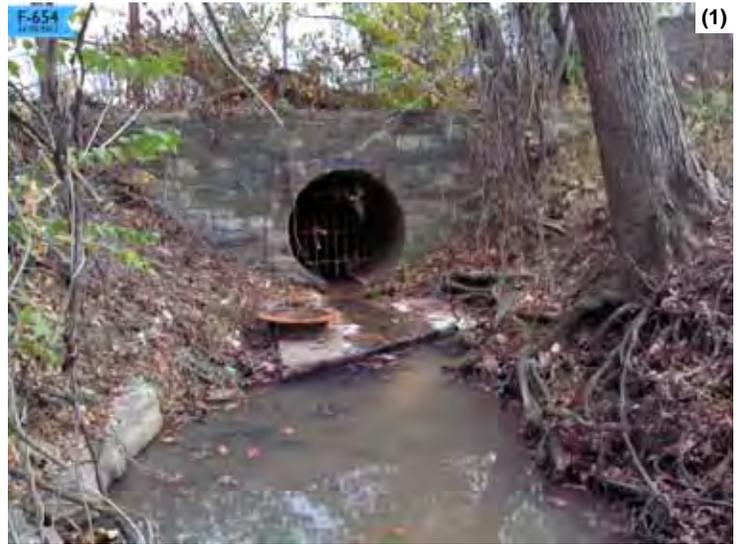
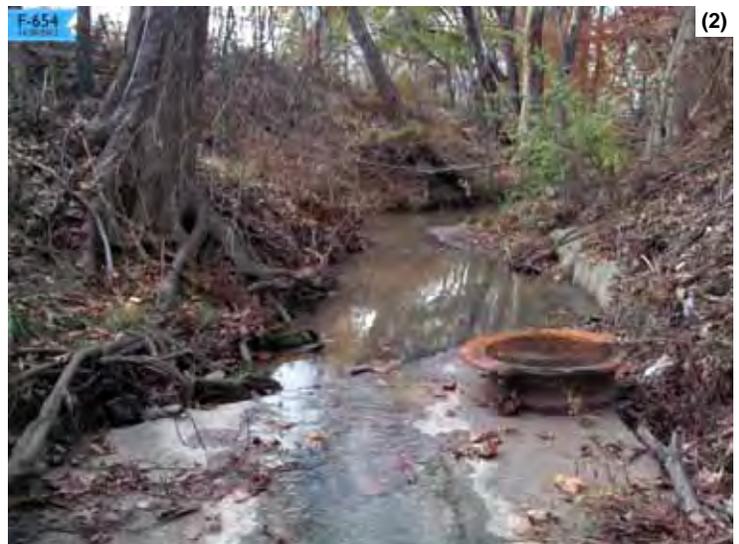
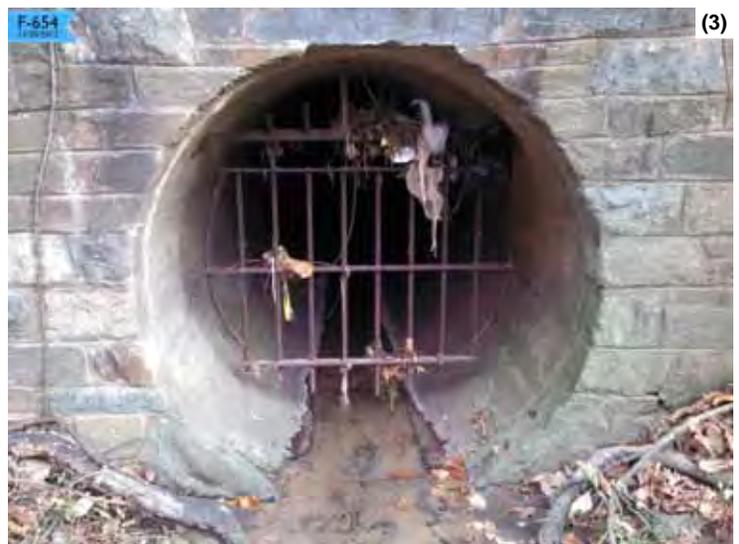
Stream Bank / Pool	<input type="text" value="1"/>	<input type="text" value="Some Erosion"/>	Repairs Recommended? NO
Stream Bank / Pool (x2)	<input type="text" value="2"/>		
Structure	<input type="text" value="0"/>	<input type="text" value="Excellent / Like New"/>	
Criticality	<input type="text" value="0"/>	<input type="text" value="Normal"/>	
Total Score	<input type="text" value="2"/>	<small>Total = Stream Bank / Pool x2 + Structure + Criticality</small>

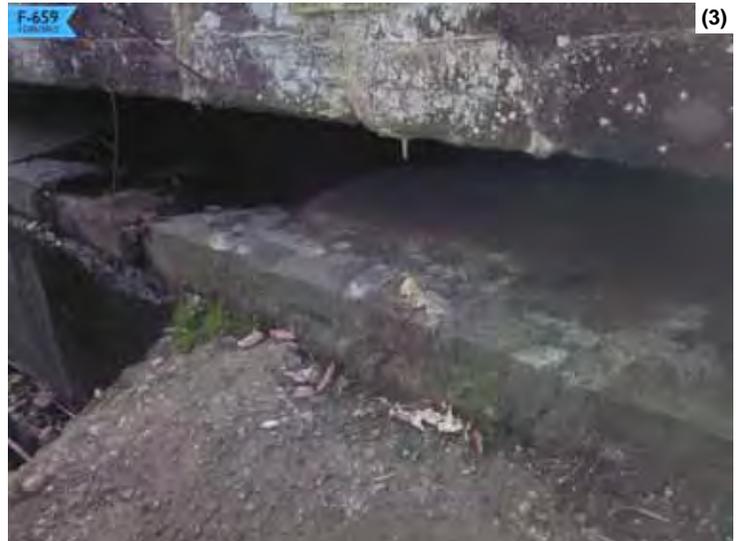
Stream Bank / Pool	<input type="text" value="2"/>	<input type="text" value="Active Erosion"/>	Repairs Recommended? YES
Stream Bank / Pool (x2)	<input type="text" value="4"/>		
Structure	<input type="text" value="1"/>	<input type="text" value="Moderate"/>	
Criticality	<input type="text" value="0"/>	<input type="text" value="Normal"/>	
Total Score	<input type="text" value="5"/>	<small>Total = Stream Bank / Pool x2 + Structure + Criticality</small>

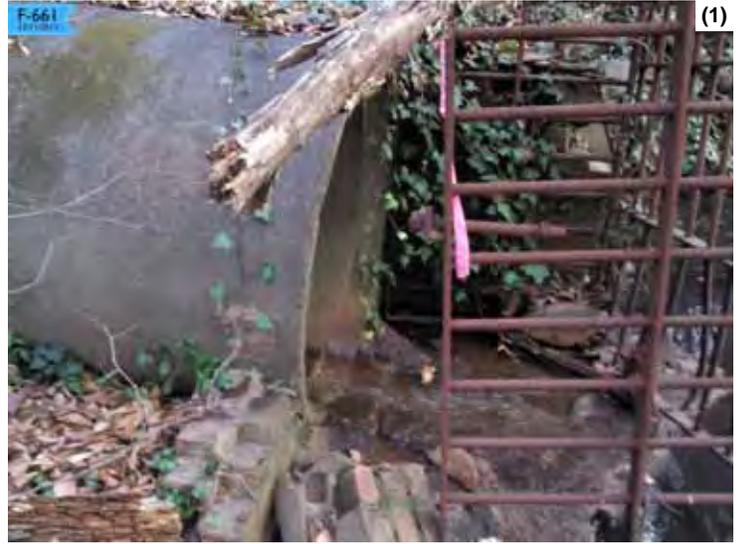
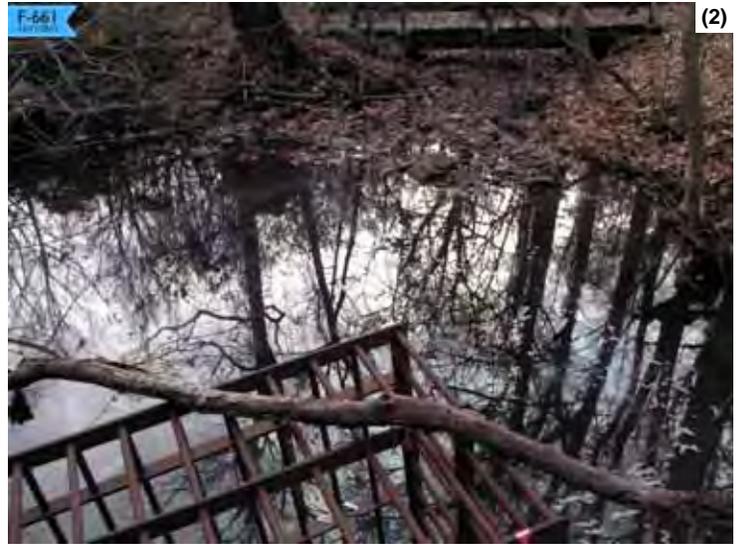
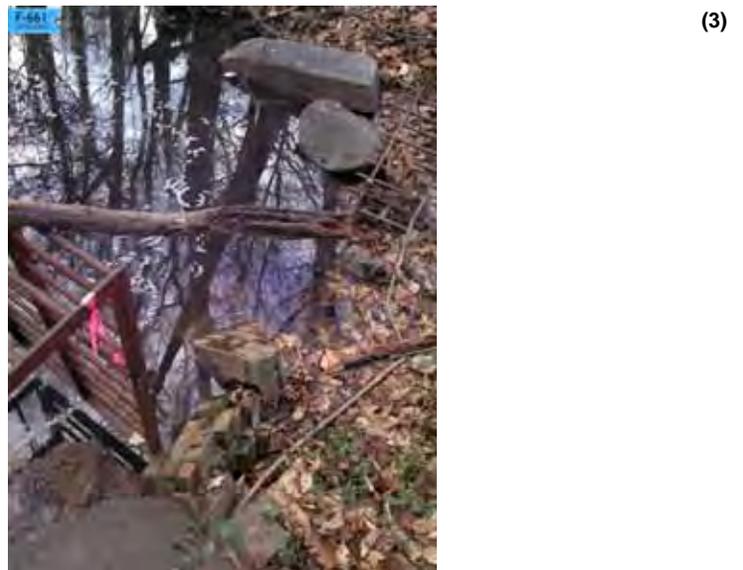
Security gate broken, headwall broken.

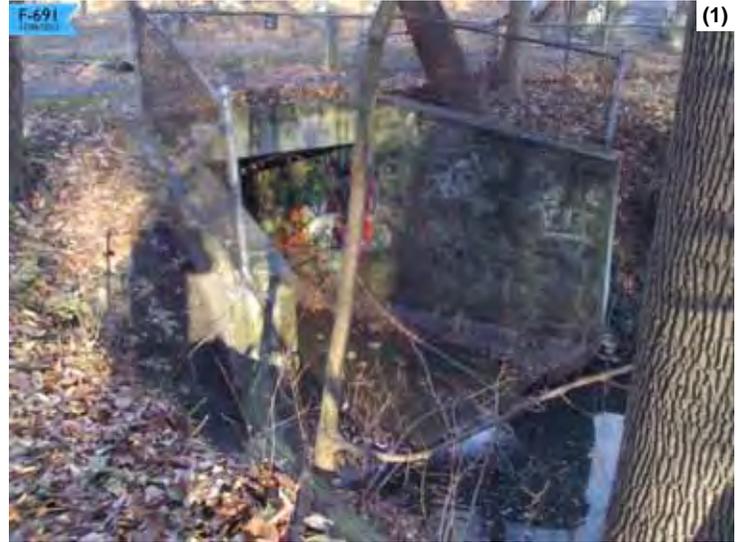
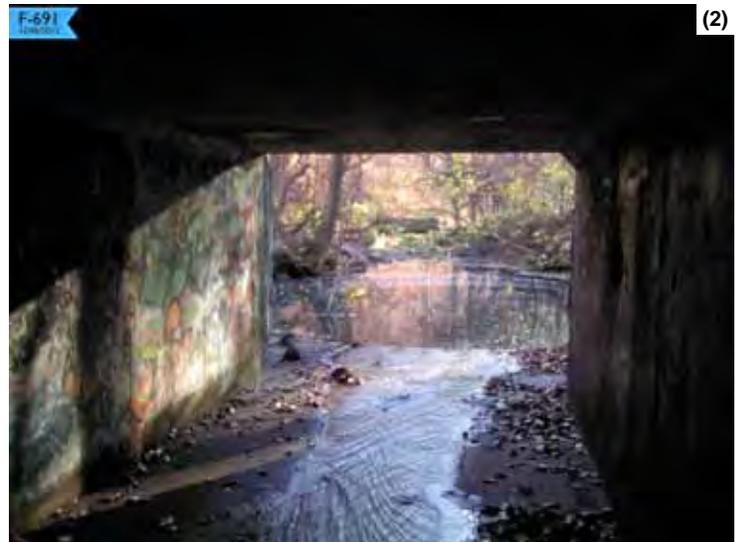
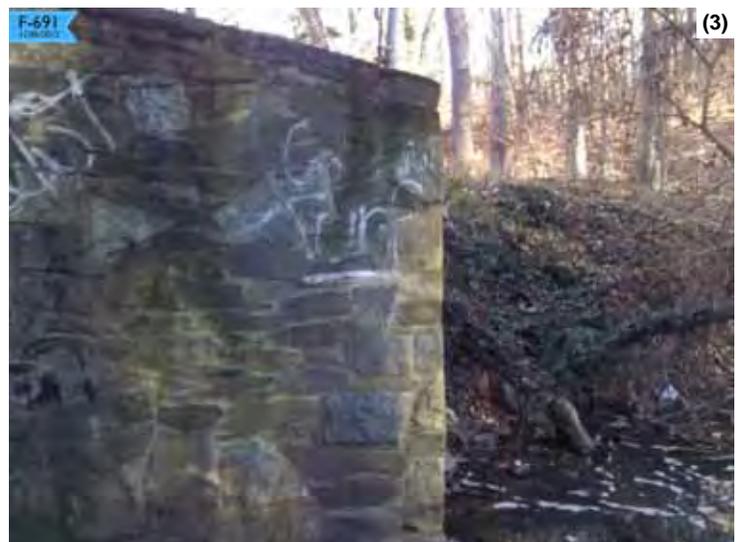
Stream Bank / Pool	<input type="text" value="1"/>	<input type="text" value="Some Erosion"/>	Repairs Recommended? NO
Stream Bank / Pool (x2)	<input type="text" value="2"/>		
Structure	<input type="text" value="0"/>	<input type="text" value="Excellent / Like New"/>	
Criticality	<input type="text" value="1"/>	<input type="text" value="Important"/>	
Total Score	<input type="text" value="3"/>	<i>Total = Stream Bank / Pool x2 + Structure + Criticality</i>

Missing security gate; some erosion under spillway. Walking trail above outfall.

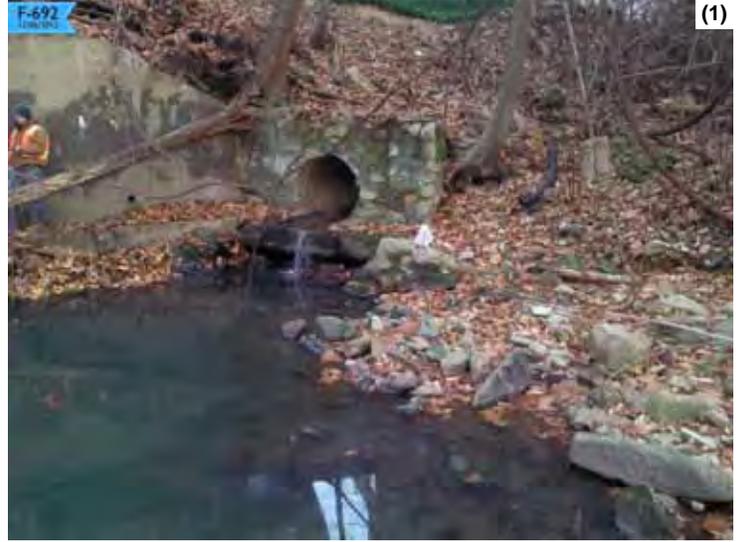
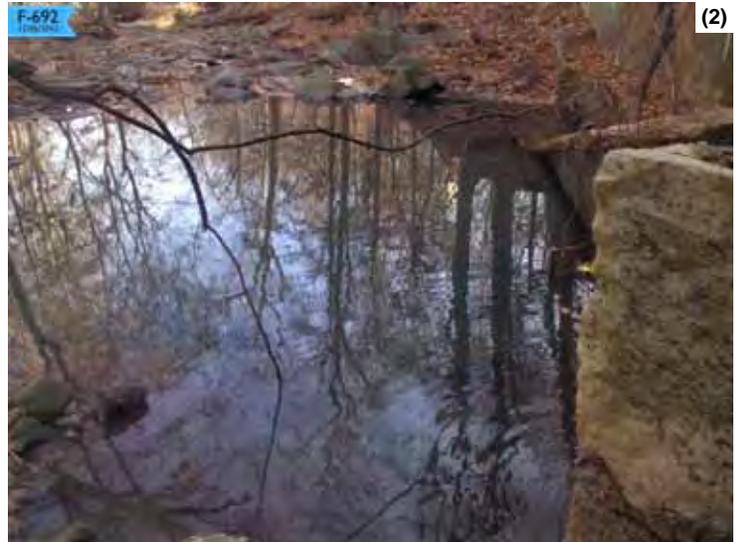
Stream Bank / Pool	<input type="text" value="1"/>	<input type="text" value="Some Erosion"/>	Repairs Recommended? NO
Stream Bank / Pool (x2)	<input type="text" value="2"/>		
Structure	<input type="text" value="0"/>	<input type="text" value="Excellent / Like New"/>	
Criticality	<input type="text" value="0"/>	<input type="text" value="Normal"/>	
Total Score	<input type="text" value="2"/>	<small>Total = Stream Bank / Pool x2 + Structure + Criticality</small>

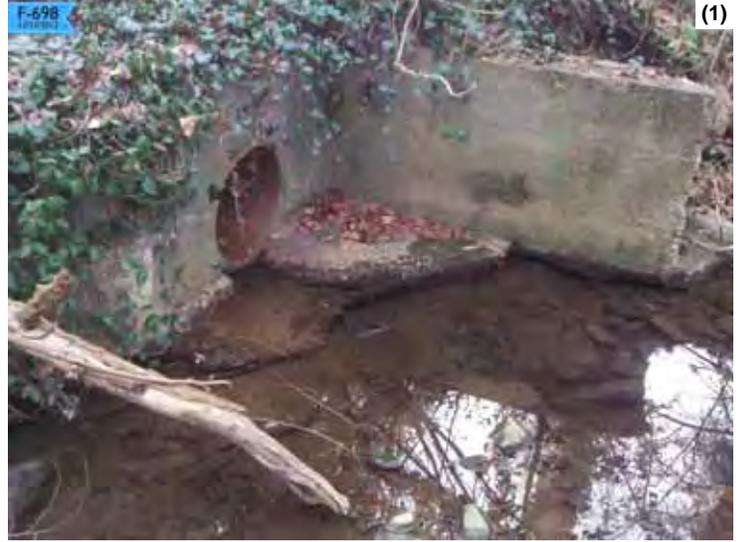
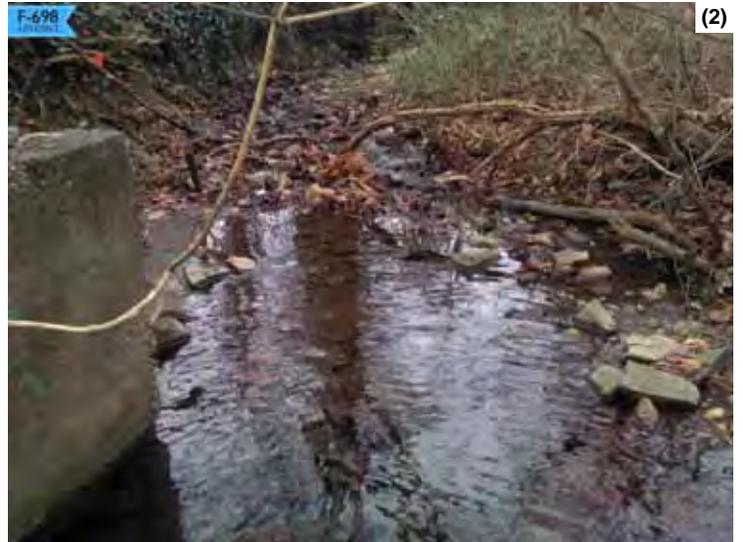
Stream Bank / Pool	<input type="text" value="2"/>	<input type="text" value="Active Erosion"/>	Repairs Recommended? YES
Stream Bank / Pool (x2)	<input type="text" value="4"/>		
Structure	<input type="text" value="0"/>	<input type="text" value="Excellent / Like New"/>	
Criticality	<input type="text" value="0"/>	<input type="text" value="Normal"/>	
Total Score	<input type="text" value="4"/>	<small>Total = Stream Bank / Pool x2 + Structure + Criticality</small>

Need additional photos to determine limits of repair.

Point Repair

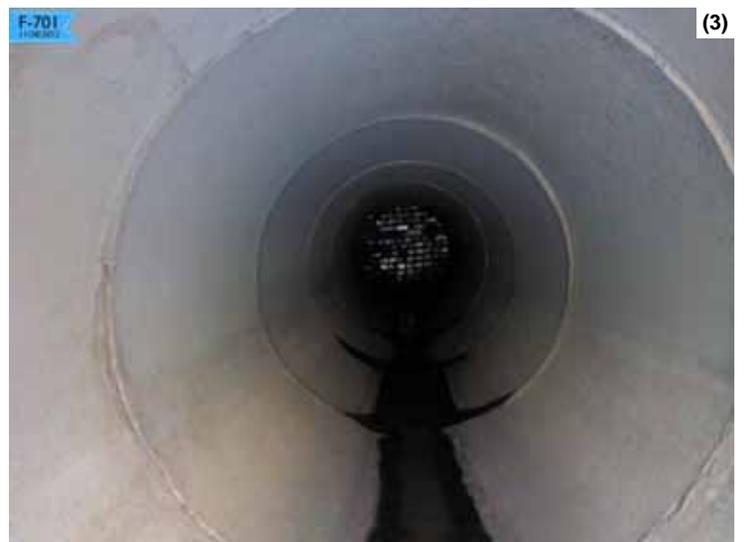
Stream Bank / Pool	<input type="text" value="2"/>	<input type="text" value="Active Erosion"/>	Repairs Recommended? YES
Stream Bank / Pool (x2)	<input type="text" value="4"/>		
Structure	<input type="text" value="1"/>	<input type="text" value="Moderate"/>	
Criticality	<input type="text" value="0"/>	<input type="text" value="Normal"/>	
Total Score	<input type="text" value="5"/>	<small>Total = Stream Bank / Pool x2 + Structure + Criticality</small>

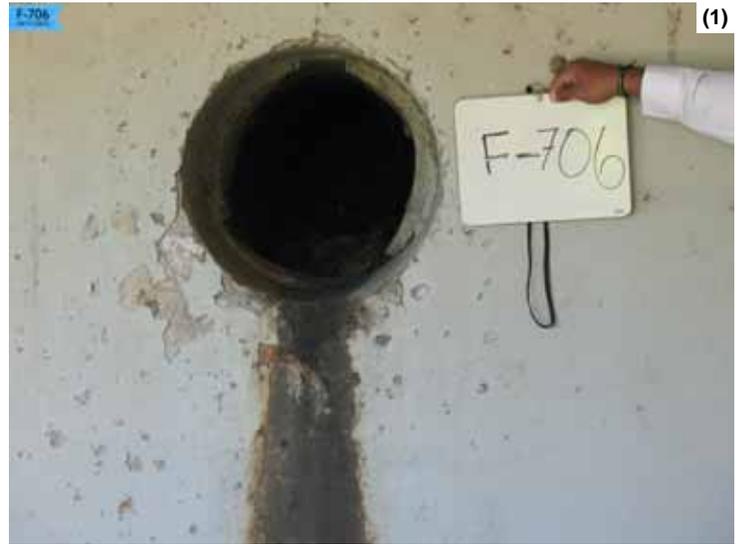
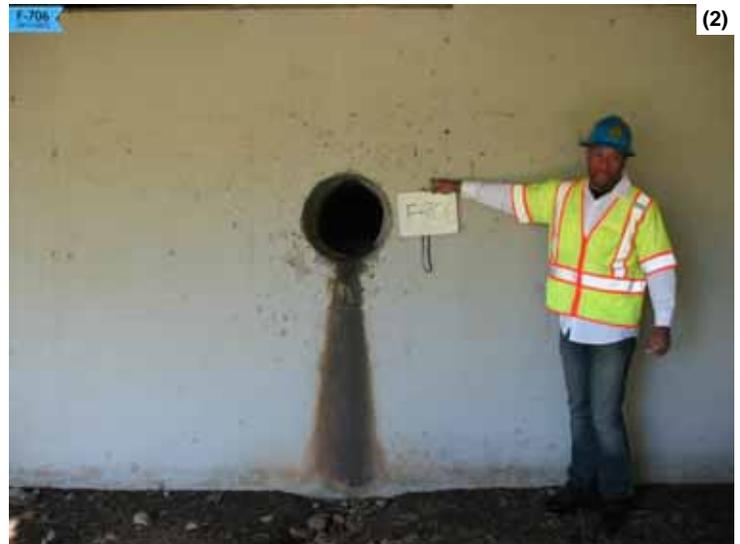
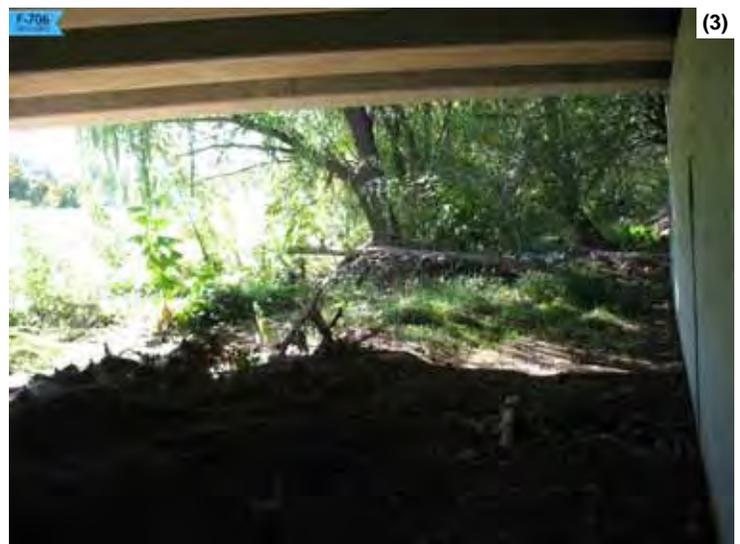
Stream Bank / Pool	<input type="text" value="0"/>	<input type="text" value="Stable"/>	Repairs Recommended? NO
Stream Bank / Pool (x2)	<input type="text" value="0"/>		
Structure	<input type="text" value="1"/>	<input type="text" value="Moderate"/>	
Criticality	<input type="text" value="0"/>	<input type="text" value="Normal"/>	
Total Score	<input type="text" value="1"/>	<small>Total = Stream Bank / Pool x2 + Structure + Criticality</small>

River stone in pipe invert may be indicative of broken pipe beyond what we could see.

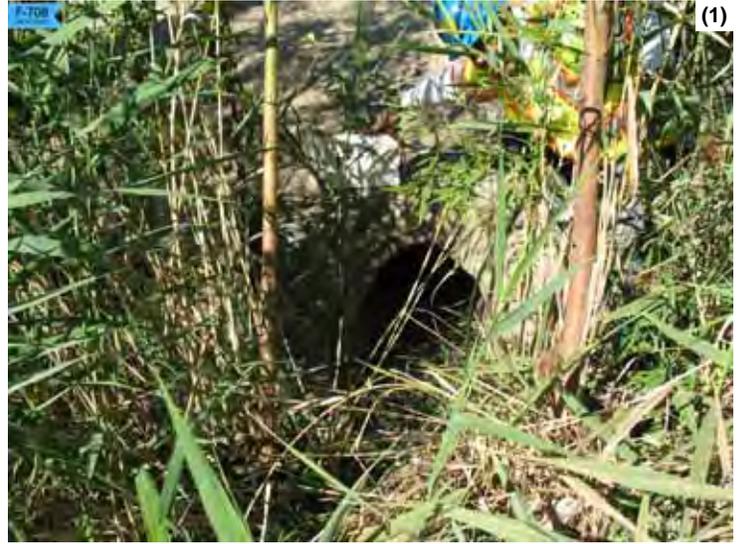
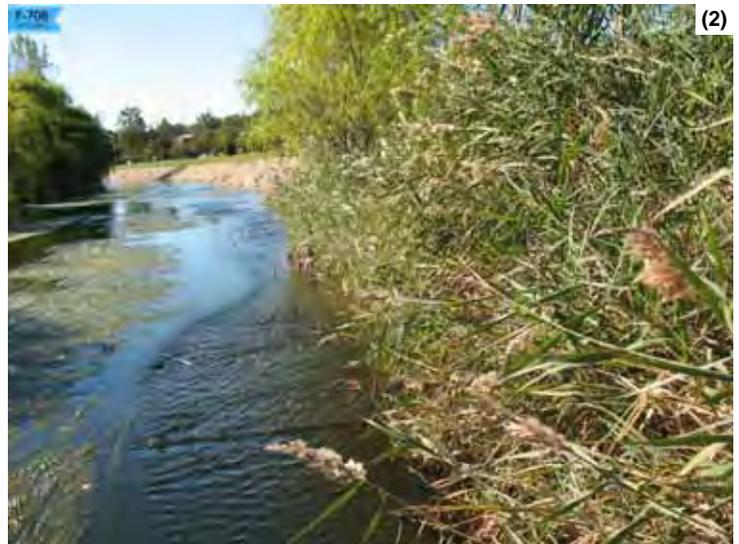
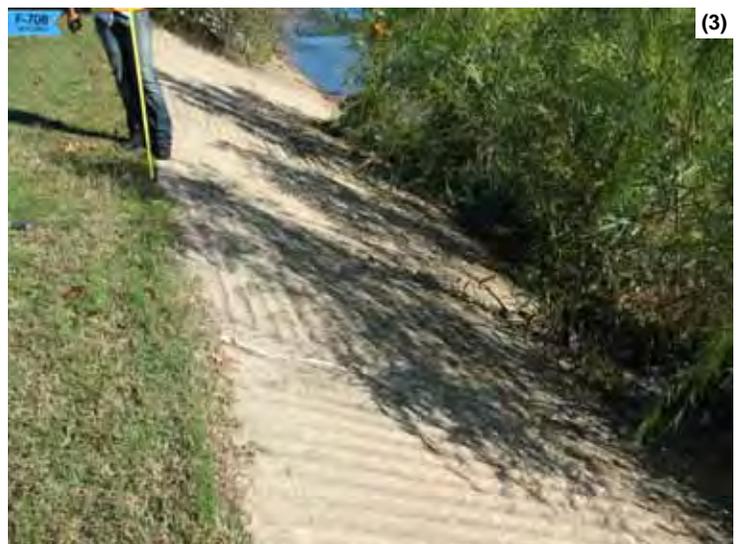
Headwall is cracked. Minor erosion hole behind headwall is approx. 10" deep.

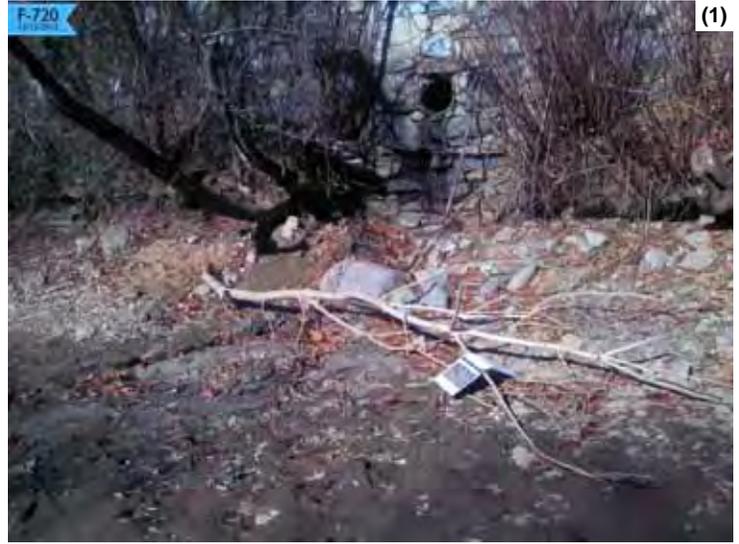
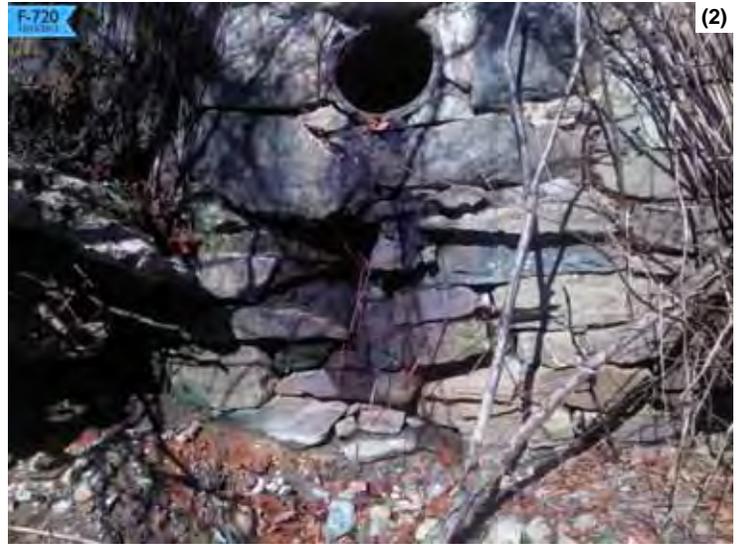
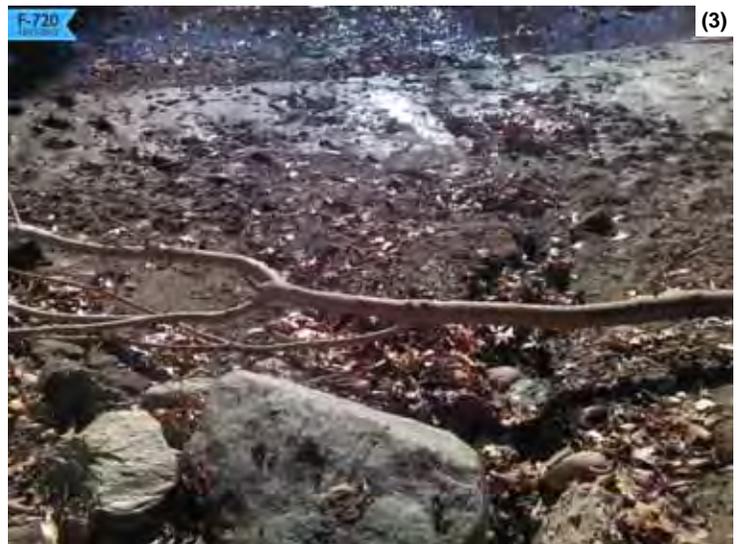
Stream Bank / Pool	<input type="text" value="0"/>	<input type="text" value="Stable"/>	Repairs Recommended? NO
Stream Bank / Pool (x2)	<input type="text" value="0"/>		
Structure	<input type="text" value="1"/>	<input type="text" value="Moderate"/>	
Criticality	<input type="text" value="2"/>	<input type="text" value="Critical"/>	
Total Score	<input type="text" value="3"/>	<small>Total = Stream Bank / Pool x2 + Structure + Criticality</small>

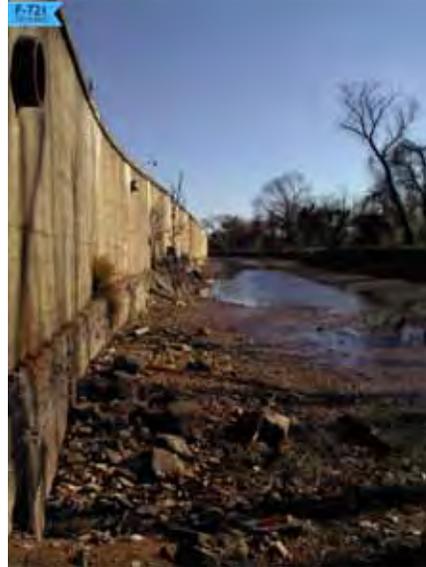
(1)

Stream Bank / Pool	<input type="text" value="1"/>	<input type="text" value="Some Erosion"/>	Repairs Recommended? NO
Stream Bank / Pool (x2)	<input type="text" value="2"/>		
Structure	<input type="text" value="1"/>	<input type="text" value="Moderate"/>	
Criticality	<input type="text" value="2"/>	<input type="text" value="Critical"/>	
Total Score	<input type="text" value="5"/>	<small>Total = Stream Bank / Pool x2 + Structure + Criticality</small>

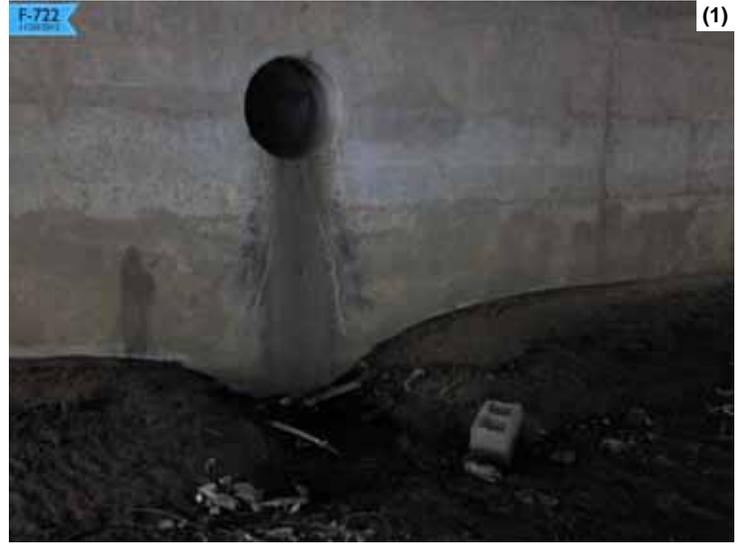
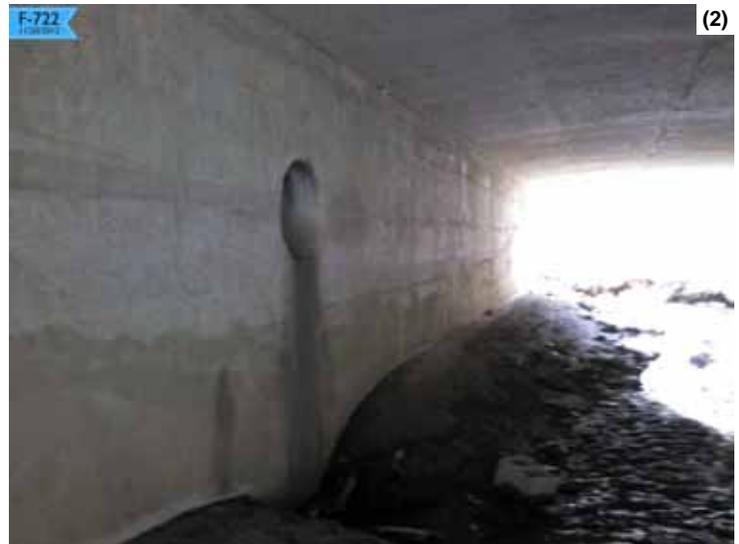
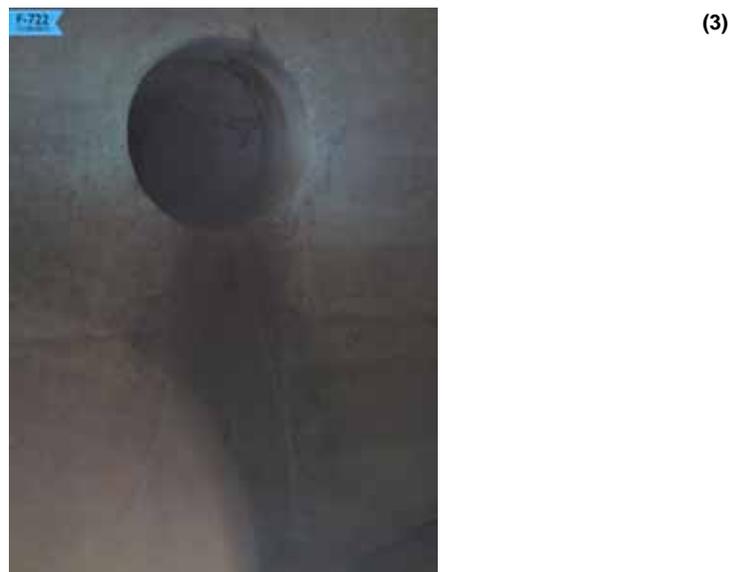
Stream Bank / Pool	<input type="text" value="0"/>	<input type="text" value="Stable"/>	Repairs Recommended? YES
Stream Bank / Pool (x2)	<input type="text" value="0"/>		
Structure	<input type="text" value="2"/>	<input type="text" value="Poor"/>	
Criticality	<input type="text" value="1"/>	<input type="text" value="Important"/>	
Total Score	<input type="text" value="3"/>	<small>Total = Stream Bank / Pool x2 + Structure + Criticality</small>

Description of Repair Approach

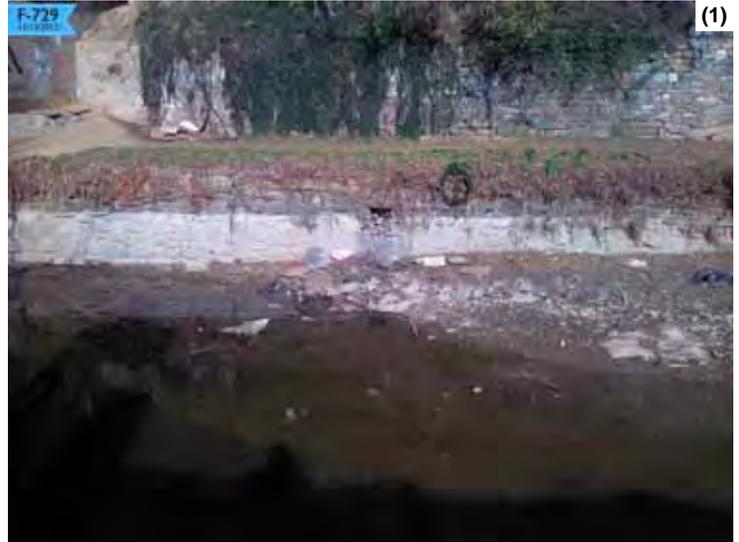
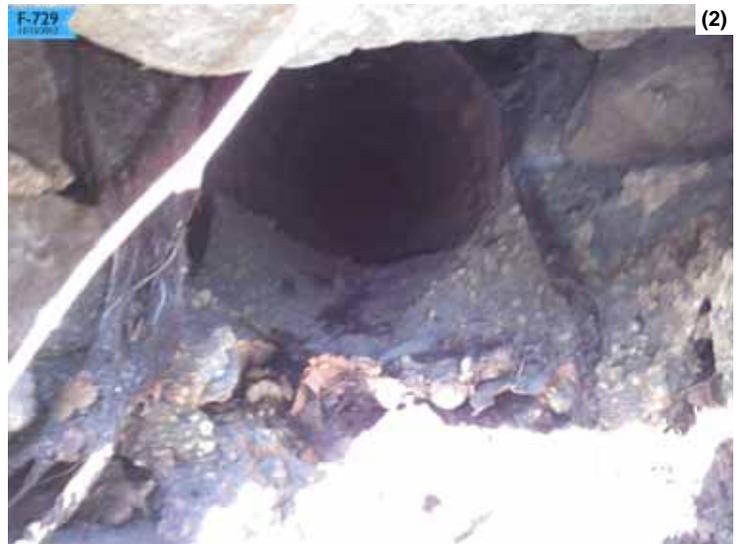
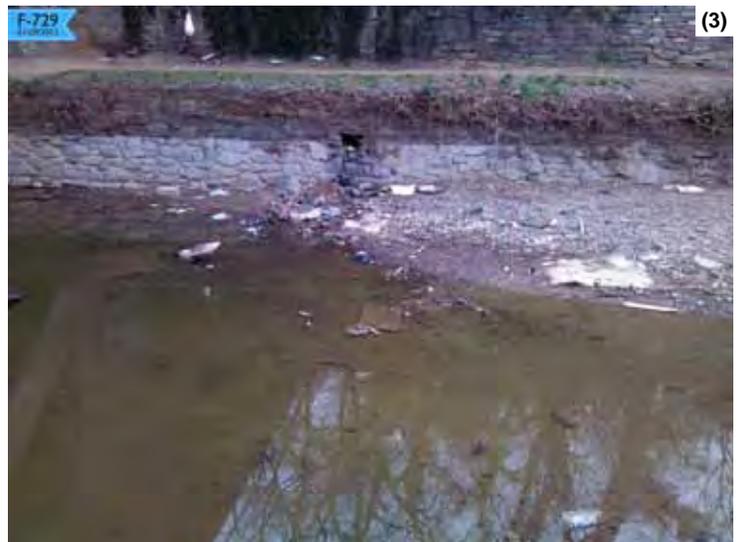
Stream Bank / Pool	<input type="text" value="0"/>	<input type="text" value="Stable"/>	Repairs Recommended? NO
Stream Bank / Pool (x2)	<input type="text" value="0"/>		
Structure	<input type="text" value="2"/>	<input type="text" value="Poor"/>	
Criticality	<input type="text" value="1"/>	<input type="text" value="Important"/>	
Total Score	<input type="text" value="3"/>	<small>Total = Stream Bank / Pool x2 + Structure + Criticality</small>

Description of Repair Approach

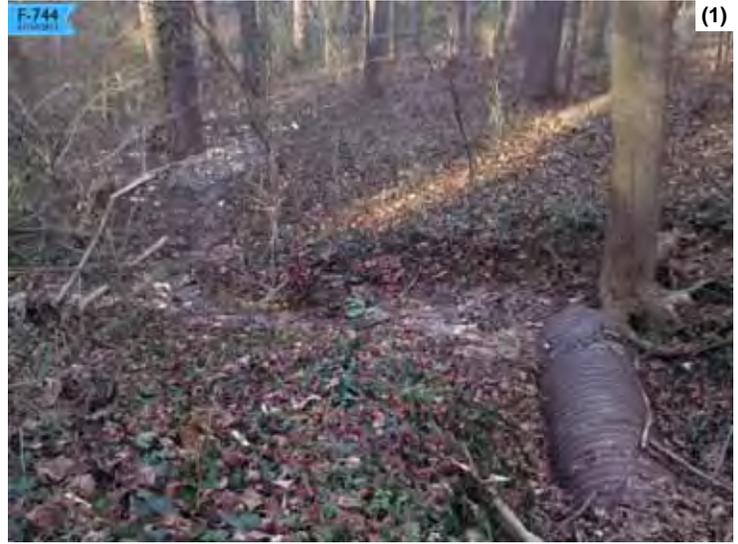
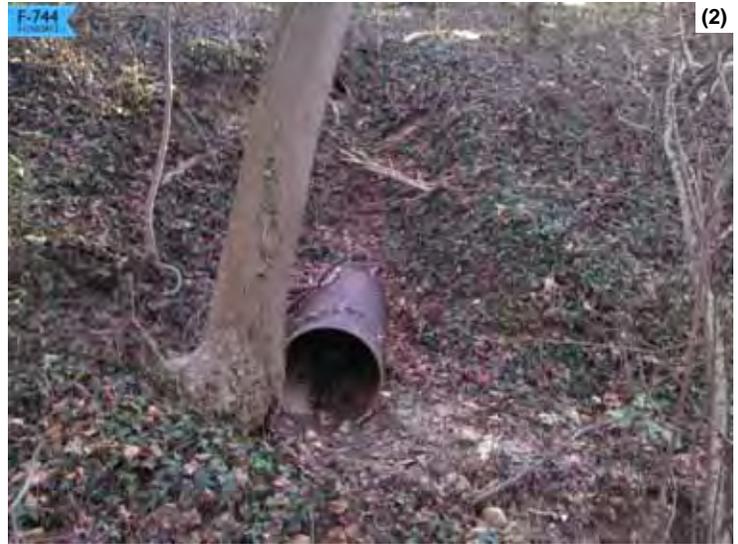
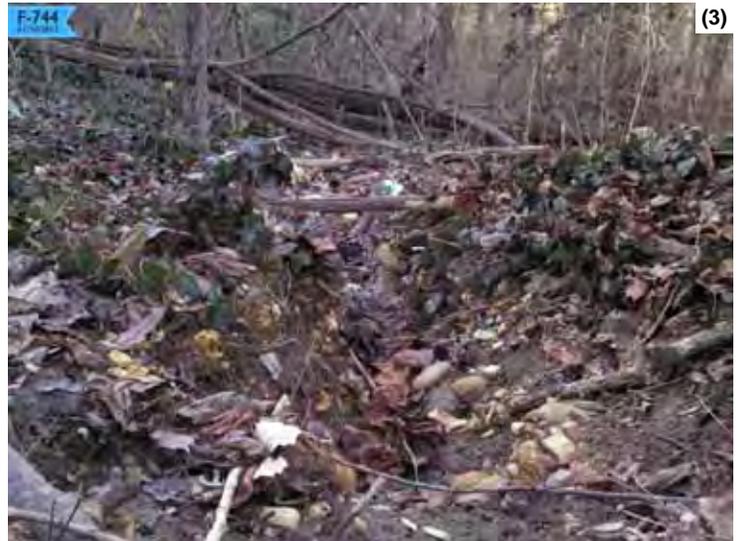
Stream Bank / Pool	<input type="text" value="2"/>	<input type="text" value="Active Erosion"/>	Repairs Recommended? <input checked="" type="text" value="YES"/>
Stream Bank / Pool (x2)	<input type="text" value="4"/>		
Structure	<input type="text" value="2"/>	<input type="text" value="Poor"/>	
Criticality	<input type="text" value="0"/>	<input type="text" value="Normal"/>	
Total Score	<input type="text" value="6"/>	<small>Total = Stream Bank / Pool x2 + Structure + Criticality</small>

Pipe is eroding a channel downstream and depositing lots of garbage in the woods. Bottom is rusted out of CMP.

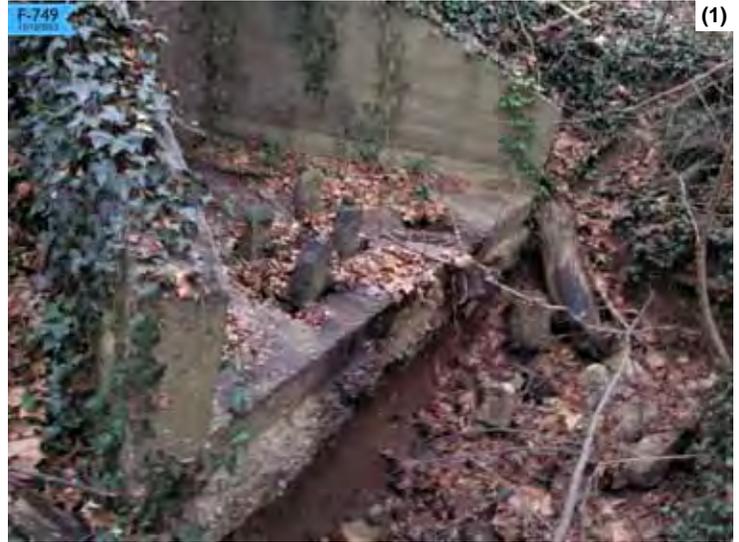
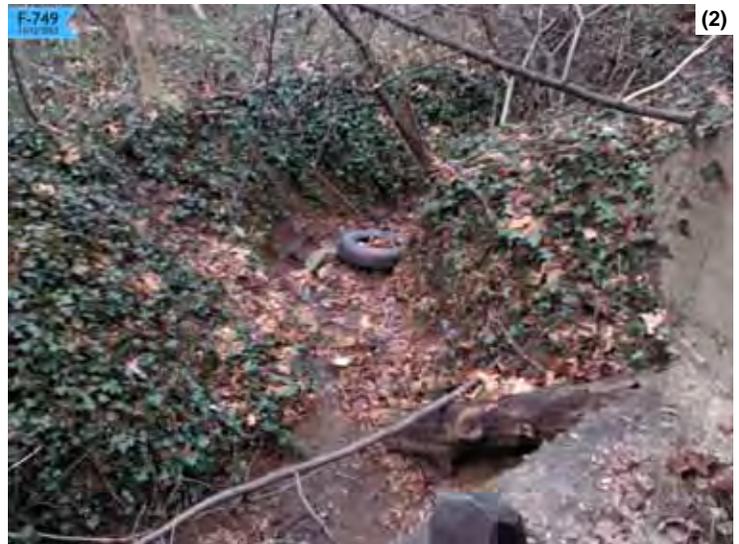
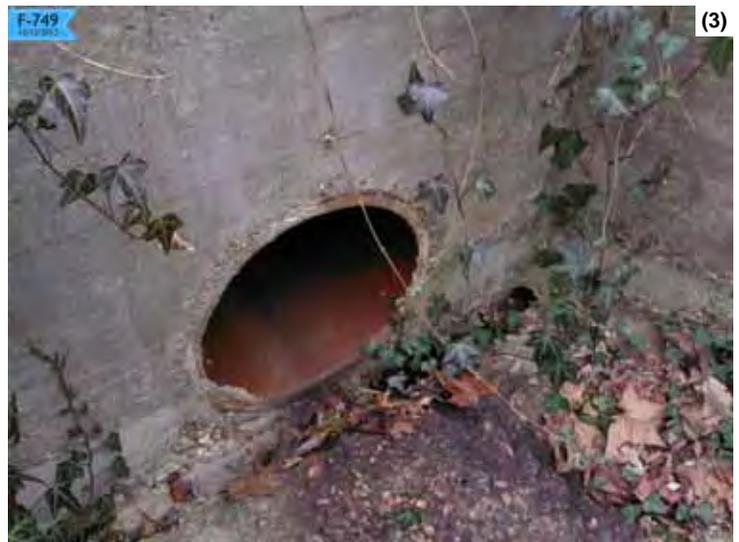
Stream Bank / Pool	<input type="text" value="2"/>	Active Erosion	Repairs Recommended? YES
Stream Bank / Pool (x2)	<input type="text" value="4"/>		
Structure	<input type="text" value="0"/>	Excellent / Like New	
Criticality	<input type="text" value="0"/>	Normal	
Total Score	<input type="text" value="4"/>	<small>Total = Stream Bank / Pool x2 + Structure + Criticality</small>

Erosion under spillway and downstream. Pipe broken at first joint and separated from structure.

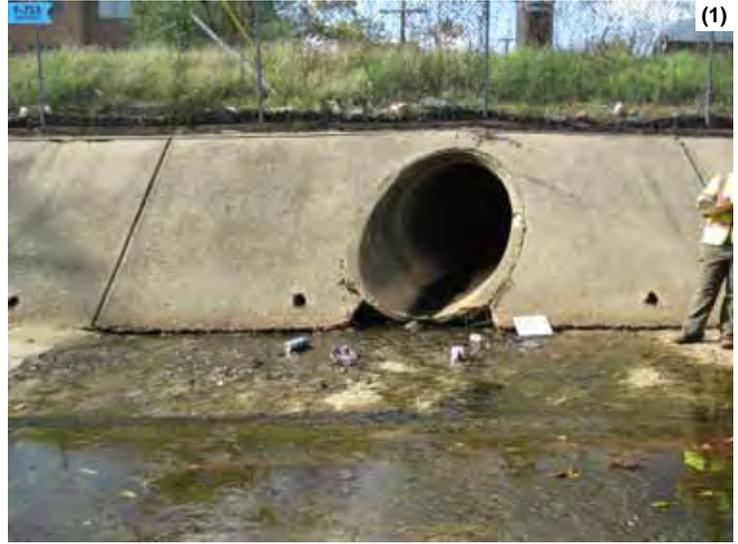
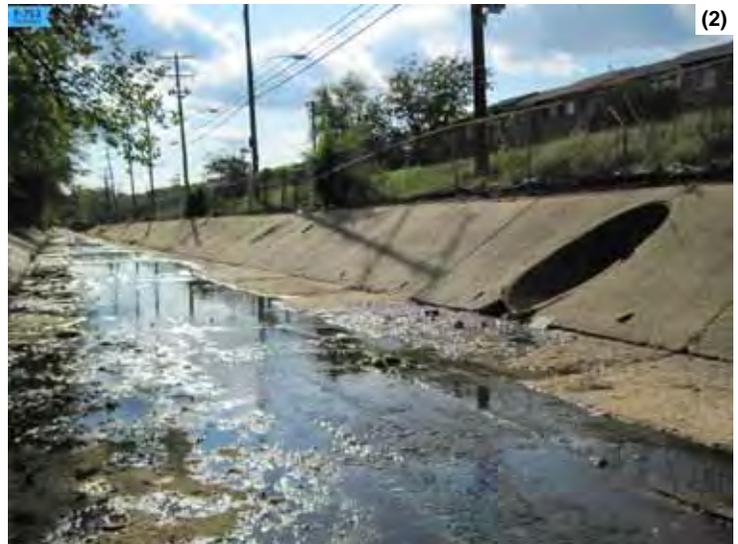
Stream Bank / Pool	<input type="text" value="0"/>	<input type="text" value="Stable"/>	Repairs Recommended? NO
Stream Bank / Pool (x2)	<input type="text" value="0"/>		
Structure	<input type="text" value="1"/>	<input type="text" value="Moderate"/>	
Criticality	<input type="text" value="0"/>	<input type="text" value="Normal"/>	
Total Score	<input type="text" value="1"/>	<small>Total = Stream Bank / Pool x2 + Structure + Criticality</small>
