Anacostia River Watershed Restoration Plan

Pope Branch Subwatershed Provisional Restoration Project Inventory

August 2009

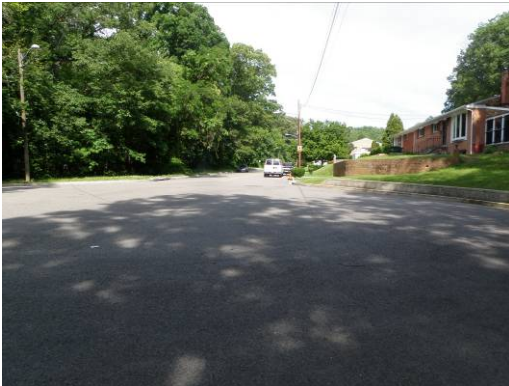
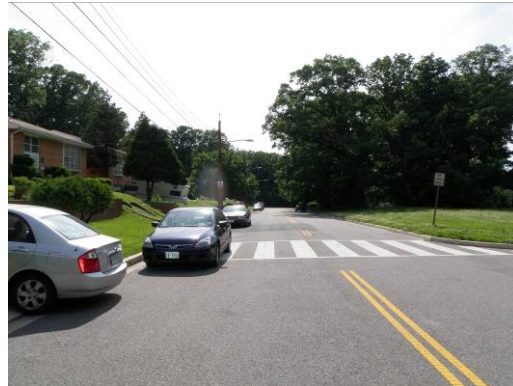
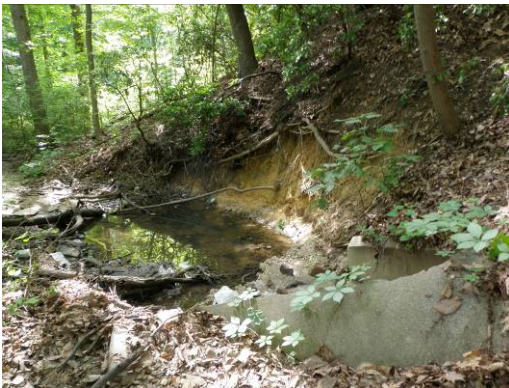
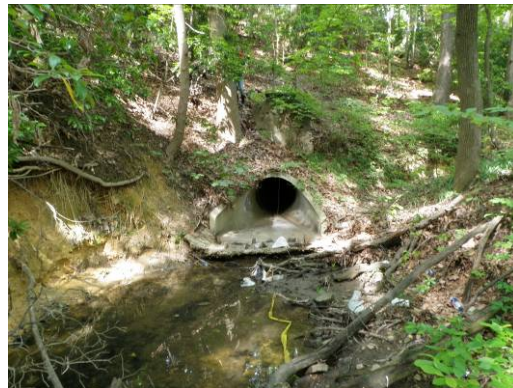
Figure 8d – Candidate Stormwater Retrofit Project

Site Location:	Neighborhood draining to outfall SS#1075, located along Carpenter Street SE between Highwood Drive SE and Nash Place SE, Washington, DC	
Project No.:	PO-U-01-S-4	
ADC Map Book Location:	18 B 6	Map ID: 9
Approximate Associated Drainage Area (acres):	19.9	
Approximate Imperviousness:	25%	5.0 acres
Description of Existing Conditions:	This site consists of a residential neighborhood and streets. Stormwater runoff drains to curb inlet drains and then to a three-foot-diameter concrete culvert into Pope Branch. The outfall provides the furthest upstream intermittent flow for Pope Branch. The outflow contained much sediment and soap scum. There is a large plunge pool and severe scouring at the outfall.	
Project Description:	Regenerative Stormwater Conveyance, LID Bioretention, LID Tree Box Filters, Rainscape - Install a regenerative stormwater conveyance system at the outfall to prevent channel scouring. Remove a portion of the pavement at the dead end of Texas Street SE and construct a bioretention system. Install tree box filters at the curb inlet drains. Install rain gardens and rain barrels at the downspouts in the neighborhood.

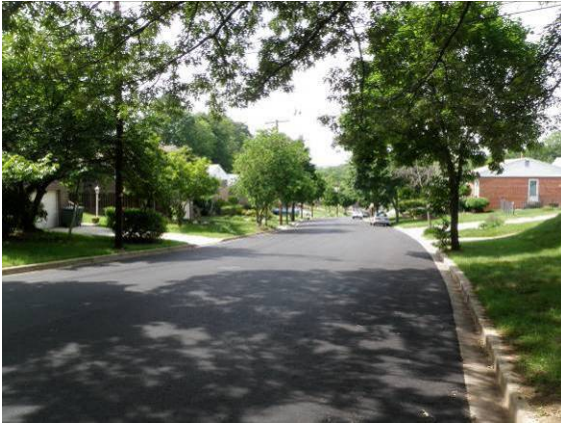
Figure 19d – Candidate Stormwater Retrofit Project

Site Location:	Residential neighborhood composed of 34th Street SE north of Carpenter Street SE to three residences into Pope Street SE, and Nash Place SE, Washington, DC	
Project No.:	PO-M-01-S-4	
ADC Map Book Location:	18 A 6	Map ID: 6
Approximate Associated Drainage Area (acres):	55.7	
Approximate Imperviousness:	25%	13.9 acres
Description of Existing Conditions:	The neighborhood is composed of one- and two-story residences. Stormwater runoff drains to curb inlet drains to outfall SS#1073.	
Project Description:	Regenerative Stormwater Conveyance, LID Bioretention, Rainscape - Install a regenerative stormwater conveyance at the outfall. Construct bioretention systems in the small community park above the outfall and install rain gardens and rain barrels at downspout locations in the neighborhood.

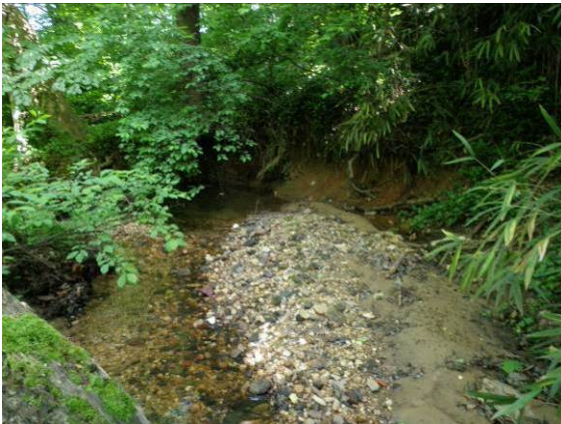
Figure 21a – Candidate Stream Restoration Project

Site Location:	Pope Branch between the headwaters and Fairlawn Avenue SE, Washington, DC	
Project No.:	PO-M-02-SR-1	
ADC Map Book Location:	18 A 6	Map ID: 7
Approximate Length (feet):	6,900	
Description of Existing Conditions:	Pope Branch has been confined to a narrow floodplain throughout its open reach. The majority of the stream is incised, and lacks sinuosity and connection to its floodplain.	
Project Description:	Stream Channel Morphology Restoration, In-stream Habitat Enhancement – Regrade banks and install appropriate bank stabilization measures (i.e. brush layering, live stakes) and toe protection. Install log vanes and riffle-pool sequences to protect banks and improve habitat.
