-FOUNDRY BRANCH- Development of a Dissolved Oxygen (DO) Model Framework MWWCOG Final Report

Prepared For:
District of Columbia
Department of the Environment

Prepared By:
Metropolitan Washington
Council of Governments

September 2011

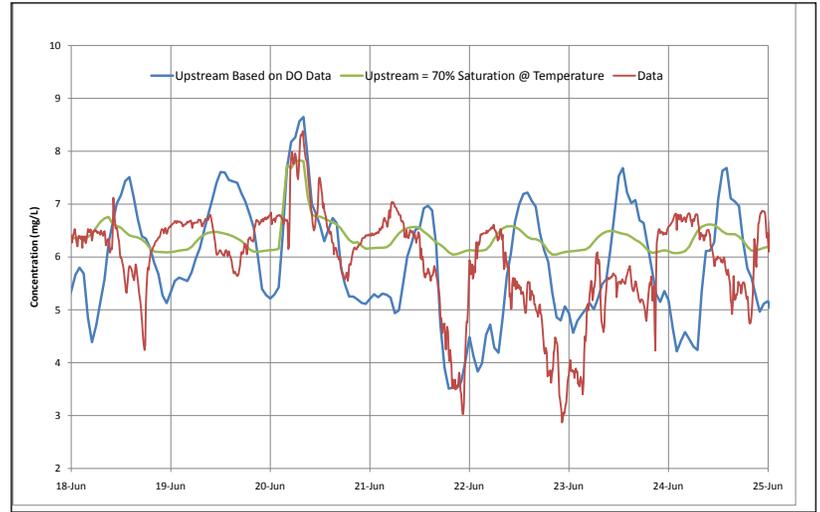
Figure 1. Upper Foundry Branch - DO Comparison at Sewer Crossing #4 (Wet Weather, June 2011 event) (LimnoTech, 2011)

The LimnoTech modeling report has been included as Appendix A. In general, the WASP5-based model did a much better job of simulating stormflow DO conditions than those for baseflow. Results show a wet weather event that is, like the 2010 events, not especially sensitive to the upstream DO formulation. It is noteworthy that the diurnal pattern (Figure 1) does not appear to represent expected photosynthesis effects with respect to timing; that is, the highest DO levels in the data occur in the early morning with the lowest DO levels in the late afternoon, roughly the opposite of the expected pattern. Figure 2 shows the effect of the inclusion of a hypothetical dry weather sanitary source. It should be noted that while this sanitary source did reduce DO levels, modeling results were somewhat inconclusive as they did not drive it as low as observed in the data. The preceding findings further suggest that there may be an intermittent sewage discharge problem present.

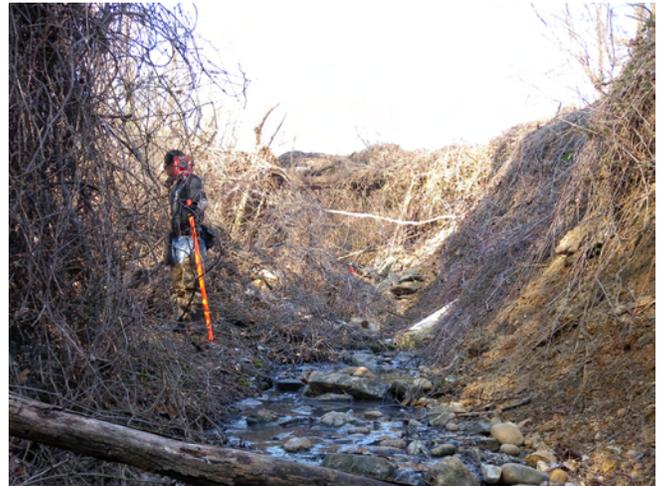
Figure 14. Upper Foundry Branch - Stream channel between cross-section stations 2 and 3

Stream channel cross-section (N=10) characterization results revealed that the mean cross-sectional area for the upper Foundry Branch main stem is approximately 91.7 ft². In addition, mean stream channel widths, bank heights and wetted perimeters were 20.4 feet, 3.4 feet and 6.9 feet, respectively. Figures 14 through 16 depict representative main stem cross-sections. As seen in Figure 14, the upper half of this urban stream channel (i.e., approximately the first 1,800 feet) is highly entrenched with mean bank heights in the five foot range. This upper portion of Foundry Branch also features a partial bedrock controlled streambed with four exposed sewer line areas, reflecting both decades of uncontrolled stormwater runoff and Fall Zone-related geology. The wetted perimeter in this section generally comprised 50 percent (or less) of the bottom channel width. It should be noted that, small Piedmont streams of this size draining totally forested watersheds typically have mean bank heights in the 1-2 foot range and wetted perimeters that cover 80 percent or more of the bottom channel width.

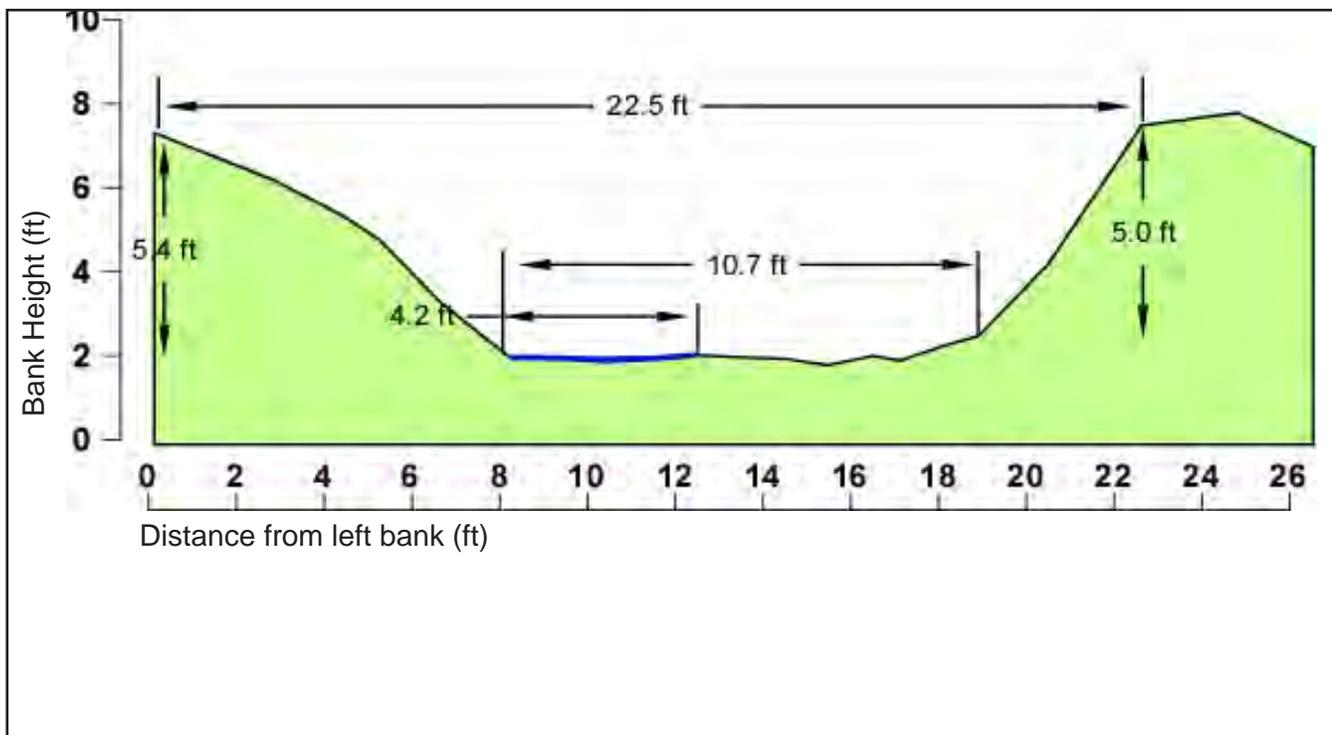
Figure 15. Upper Foundry Branch - Cross-Section Station 3 (FB-A-3; X-Section Area = 86.2 ft²)

As one proceeds downstream towards Massachusetts Avenue (Figures 15 - 18), stream gradient and bank heights both drop, the channel becomes much wider and the wetted perimeter generally comprises less than 30 percent of the bottom channel width. These conditions are especially pronounced from the fourth, large sewer line crossing (i.e., cross-section No. 7) to downstream approximately 150 feet to cross-section No. 9. In this channel section area (from cross-sections No. 7 - 10), the stream experiences significant backwater flooding during larger rainfall/runoff events from the partially

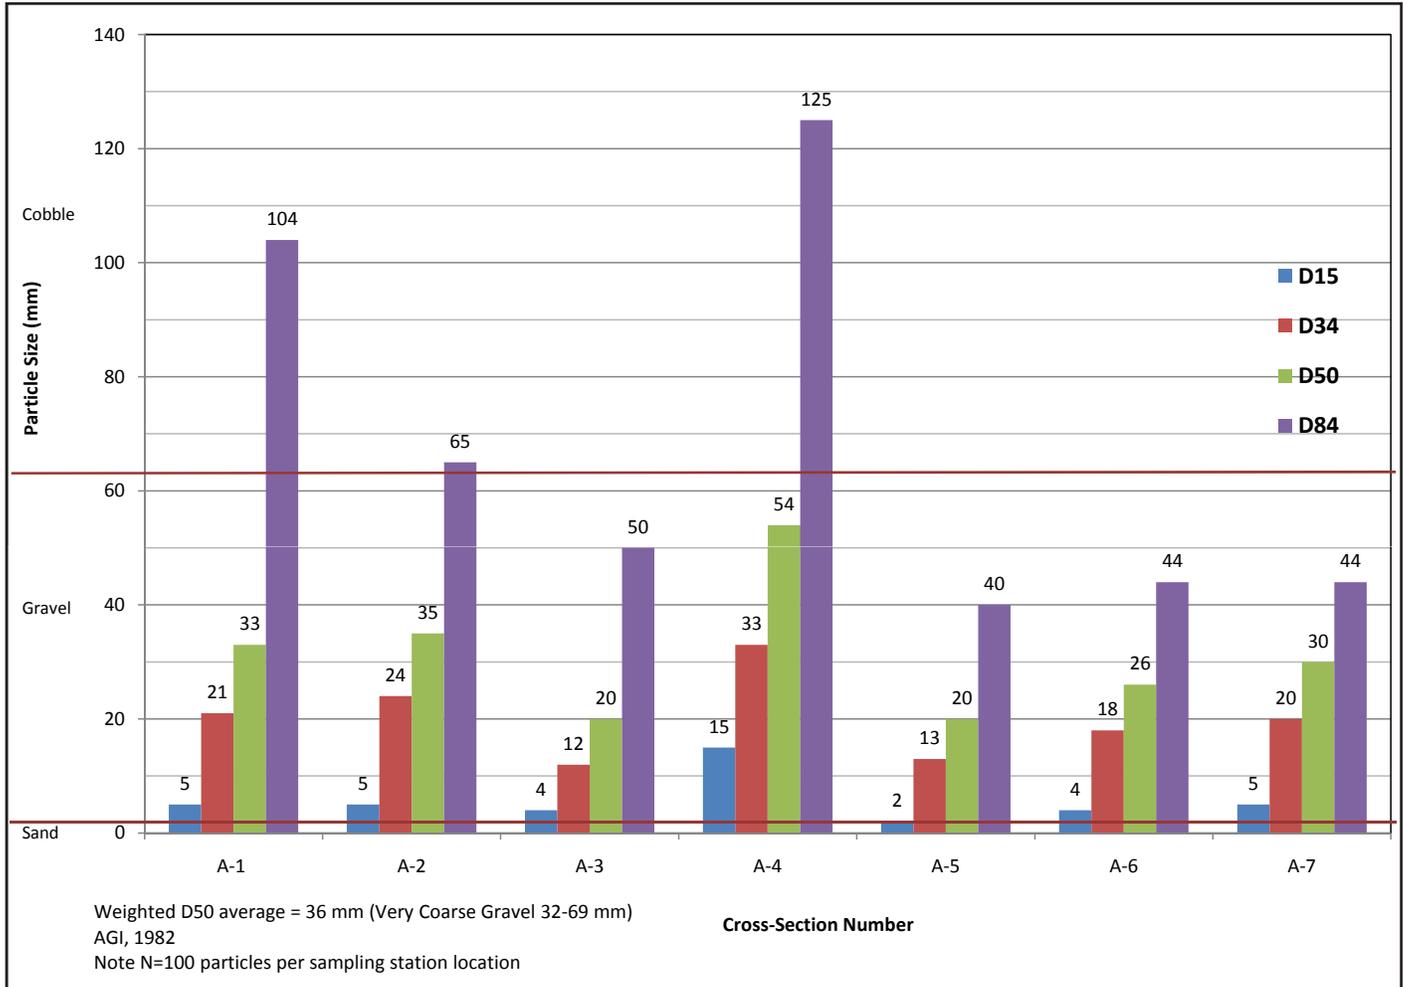
Figure 20. Upper Foundry Branch - Substrate Particle Size Distribution¹ - D15, D34, D50 and D84

Pebble count results revealed that the median (i.e., D-50) Foundry Branch particle size is very coarse gravel (i.e., 36 mm). In addition, the D-84 sized particle for all seven surveyed reaches was very coarse gravel

to small cobble (i.e., 32.00-127.99 mm). The preceding findings confirm that the Foundry Branch streambed material is generally gravel with some small cobble upstream of and including cross-section No. 4, and predominantly gravel below.

Pebble count results (Figure 20) indicated that the median (i.e., D-50) Foundry Branch particle size is very coarse gravel (i.e., 36 mm). In addition, the D-84 sized particle for all seven surveyed reaches was very coarse gravel to small cobble (i.e., 32.00-127.99 mm). The preceding findings confirm that the Foundry Branch streambed material is generally gravel with some small cobble upstream of cross-section station No. A-4, and predominantly gravel below. Typically, gravel-sized material with small diameter and round shape is inherently unstable and prone to rolling during stormflows.

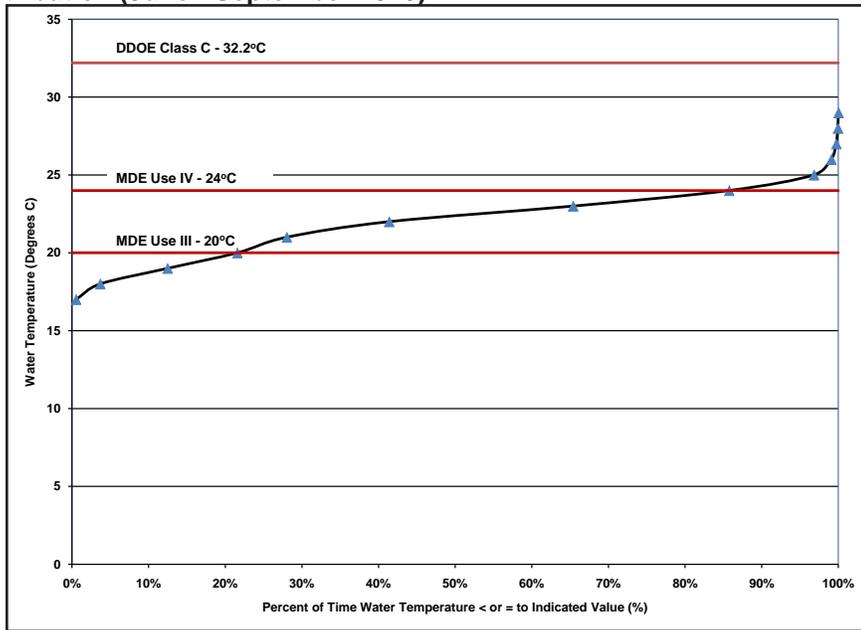
Figure 21. Upper Foundry Branch - Summer Water Temperature Distribution (June - September 2010)

As seen in Figures 21 and 22, Foundry Branch stream temperatures were well below the DDOE Class 'C' standard. Not surprisingly, the stream exhibited water temperature 'spikes' in response to stormflow inputs and high air temperatures. Additional results from the monitoring period are as follows: 1) the maximum daily water temperature recorded during the study (28.6°C) occurred on August 5, 2010; and 2) because of its relatively small baseflow discharge, the Foundry Branch thermal regime is strongly influenced by prevailing air temperatures. However, it should be noted that like many urban streams, Foundry Branch does receive some artificial inflow of cool water from

sources such as the condensate from the large, Mclean Garden Apartment's air conditioning system and sump pumping of building-related groundwater. Additional analysis revealed that water temperatures were at or below 20°C 21 percent of the time, and were at or below 24°C 86 percent of the time.

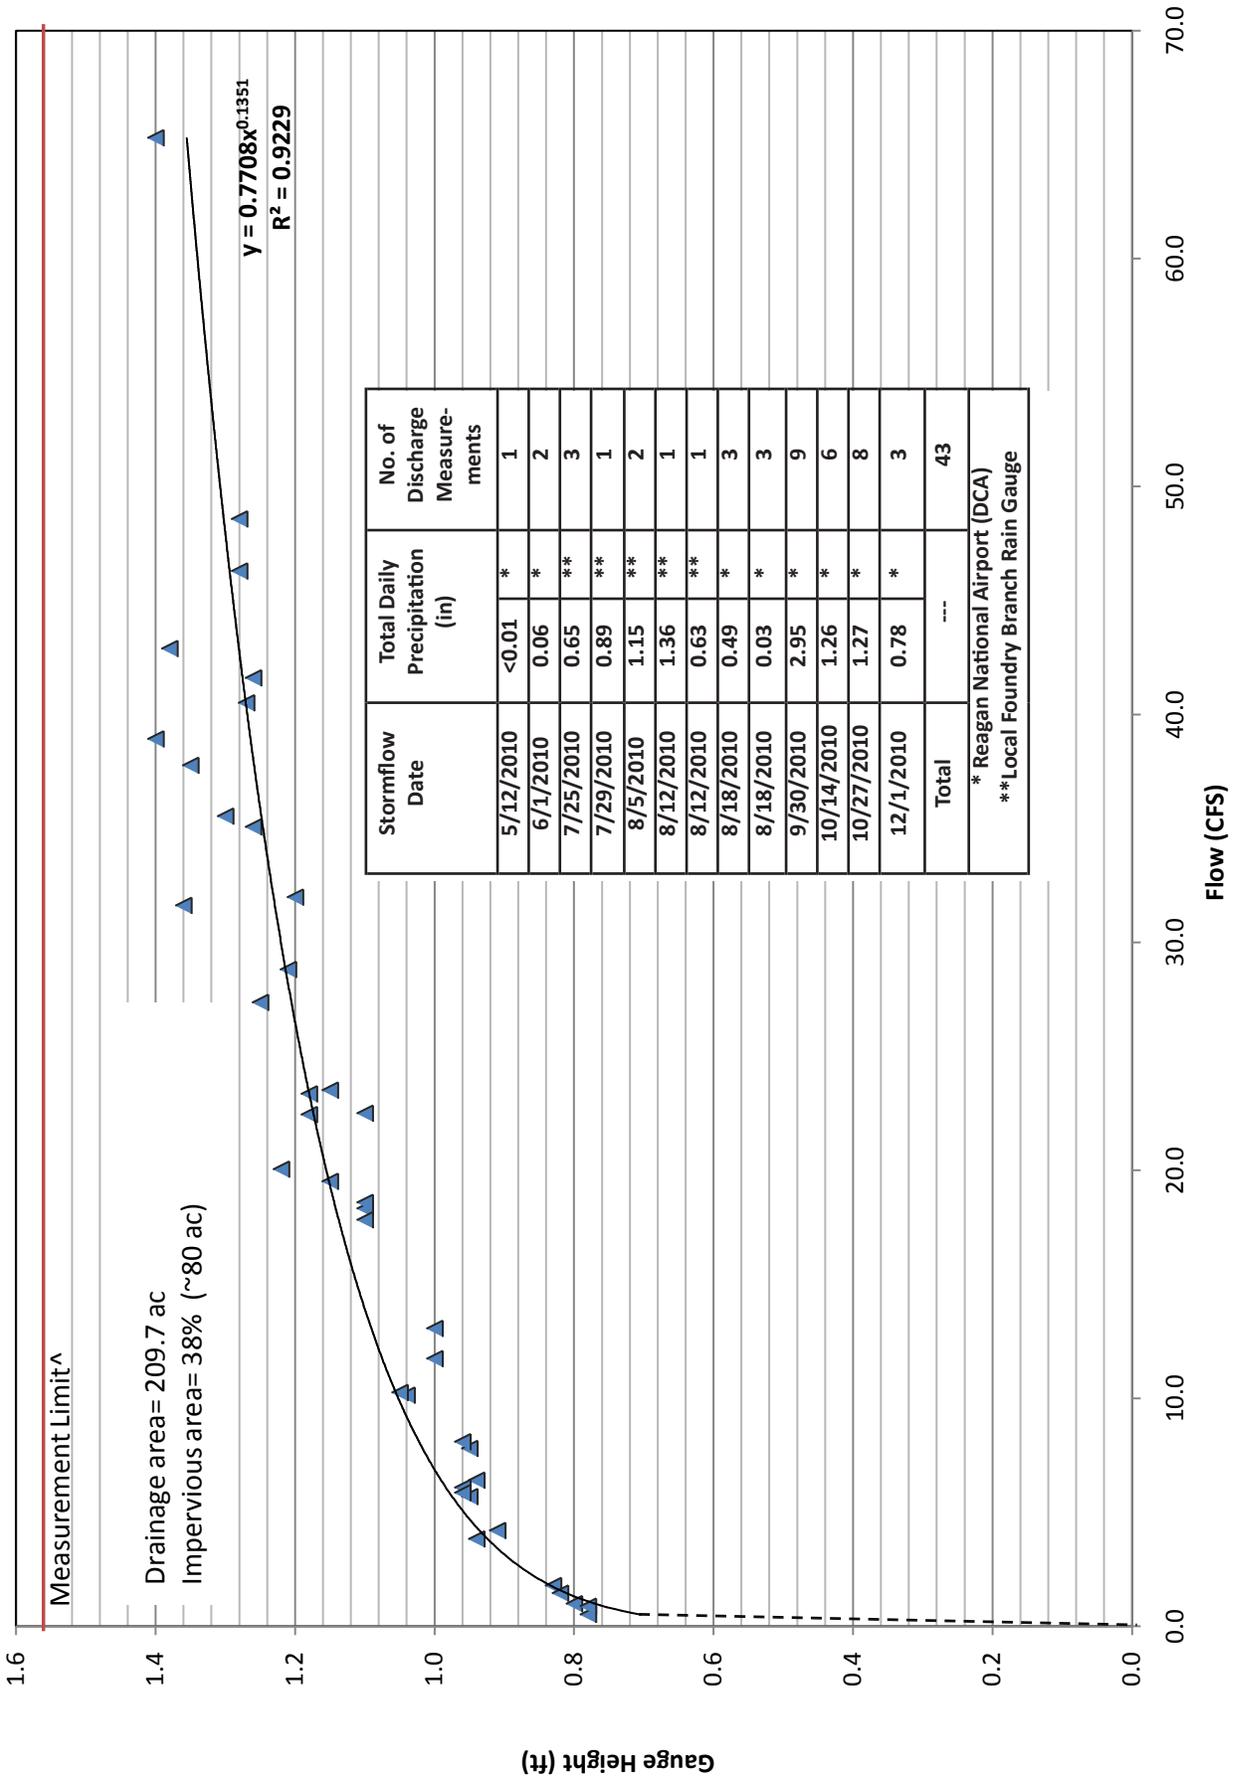
Figure 24. Upper Foundry Branch - Station 3 - Stage Discharge Rating Curve (Storm Flow)*

A total of 13 separate stormfall events were monitored for the generation of the stage-discharge rating curve (i.e., 43 discharge measurements, total, taken during the ascending portion of the hydrograph). Importantly, at stream discharges in the approximately 100-200 cfs range, backwater conditions created by the partially clogged Massachusetts Avenue storm drain debris/trash grate rack precluded further measurements.

In an effort to better predict stormflow discharges in the upper Foundry Branch main stem, COG staff developed a stage-discharge rating curve. As shown in Figure 24, 13 stormfall events (43 discharge measurements, total, taken during the ascending portion of the hydrograph) were used to generate the rating curve. From the “Rational Method”, the following general storm frequency/discharge levels were additionally calculated:

^Discharge measurements limited at CFS greater than 100 - 200 cfs due to stream backing up created by downstream clogged debris/trash storm drain grate

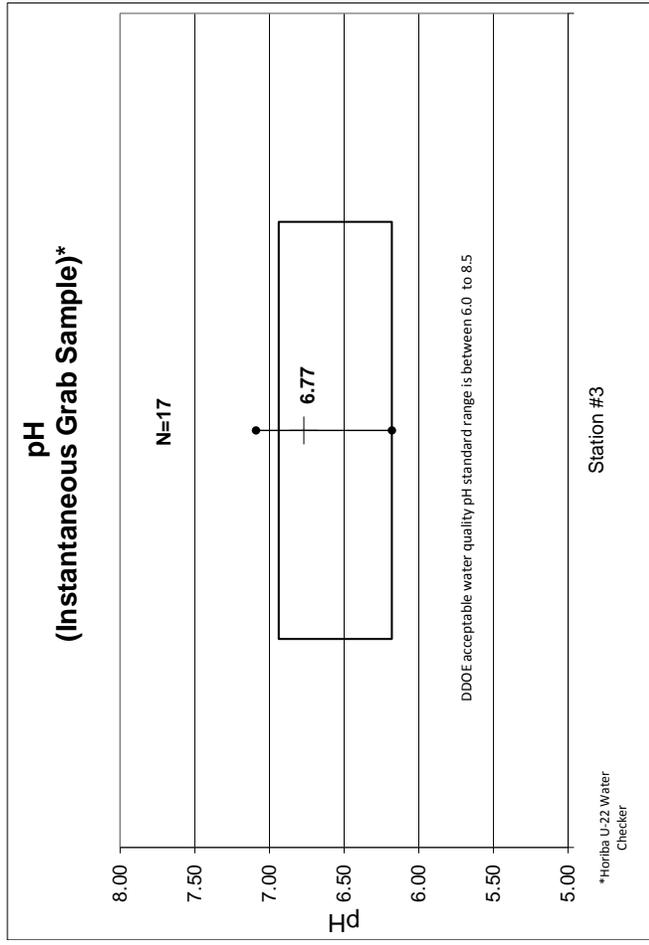
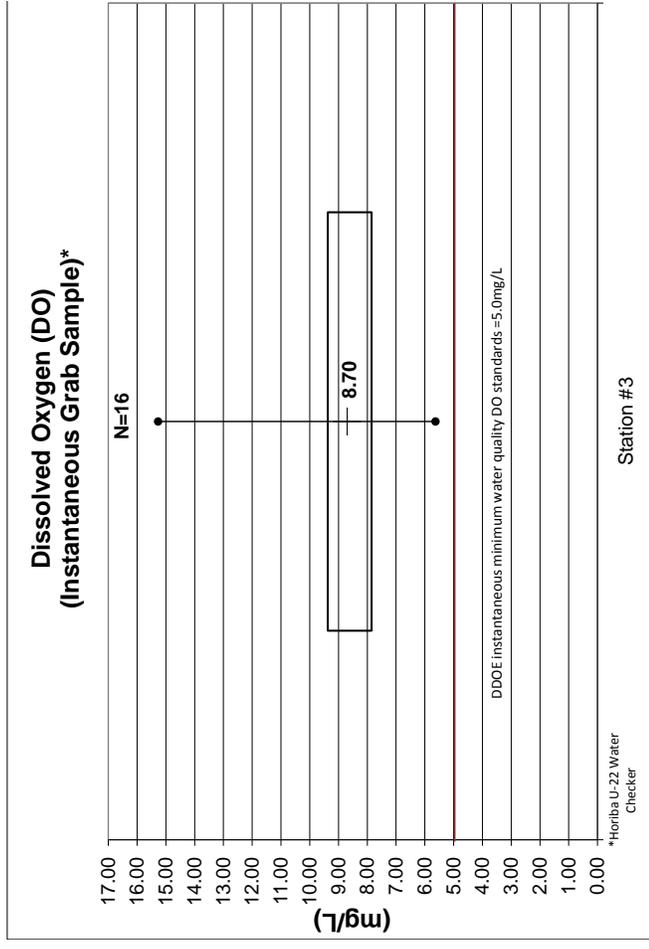
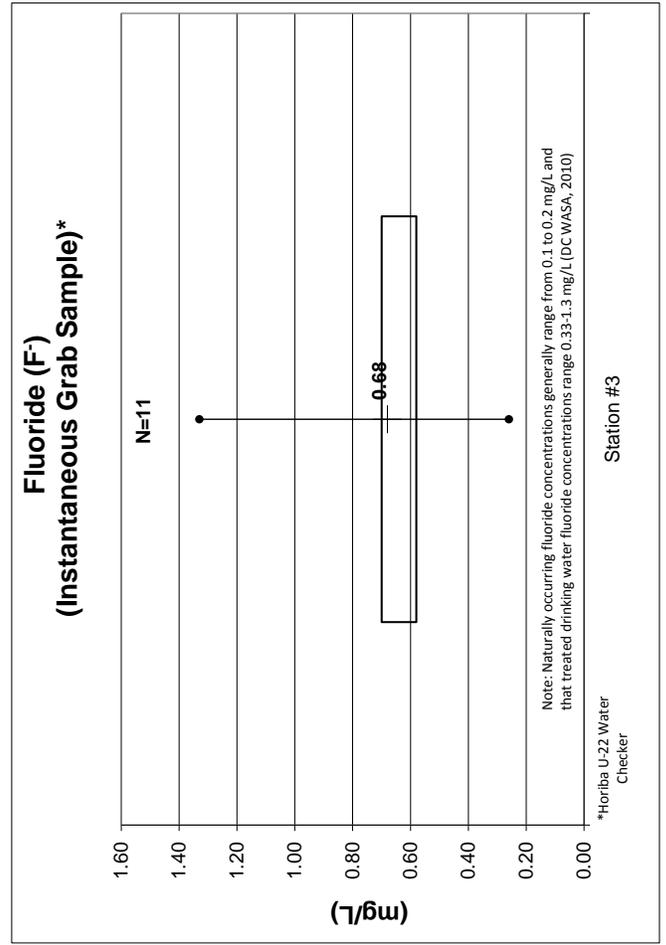
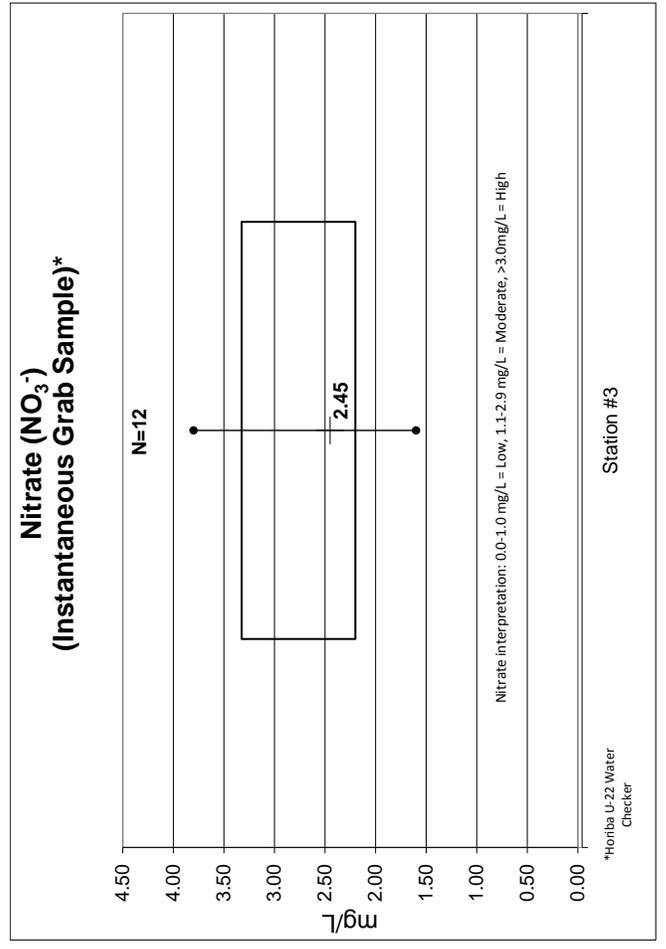
Figure 26. Upper Foundry Branch - Station 3 - Baseflow Dissolved Oxygen, pH, Nitrate, and Fluoride

Instantaneous baseflow nitrate (NO₃) readings revealed: 1) concentrations ranged from a low of 1.60 to a high of 3.8 mg/L, with a median value of 2.45 mg/L. All of the observed values (N=12) were, per USGS (1993) interpretation, in the moderate to high range.

Foundry Branch instantaneous baseflow fluoride (F) concentrations ranged from a low of 0.28 mg/L to an extremely high 1.33 mg/L, with a median value of 0.68 mg/L; thereby, strongly suggesting an inflow of either municipal drinking water and/or sewage. It should be noted that naturally occurring fluoride concentrations for local, non-urban streams generally ranges from 0.1 to 0.2 mg/L, and that the District of Columbia reports

pH, which is used to indicate the acidity or alkalinity of water, ranged from 6.20 to 7.20 (Figure 26). Generally, naturally occurring fresh water streams have a pH range of 6.5 to 8.0. This is the same range favored by most freshwater aquatic organisms (EPA, 2002). In addition, typical treated municipal water pH levels, such as those found in the District of Columbia, range is 7.5 -7.8 (DC Water, 2010).

Instantaneous baseflow nitrate (NO_3) readings (Figure 26) revealed: 1) concentrations ranged from a low of 1.6 to a high of 3.8 mg/L and 2) the observed median value was 2.45 mg/L. For interpretation purposes, NO_3 concentrations were grouped, per USGS (1993), into three concentration classes: 1) low, < 1.0 mg/L, 2) moderate, 1.0-3.0 mg/L, and 3) high, >3.0 mg/L. All of the observed values (N=12) were in the moderate to high range. This suggests that anthropogenic- related activities and sources (such as sewage from sanitary sewer line exfiltration/leakage, fertilizer applications, homeless human populations, etc) are contributing to the streams enrichment.

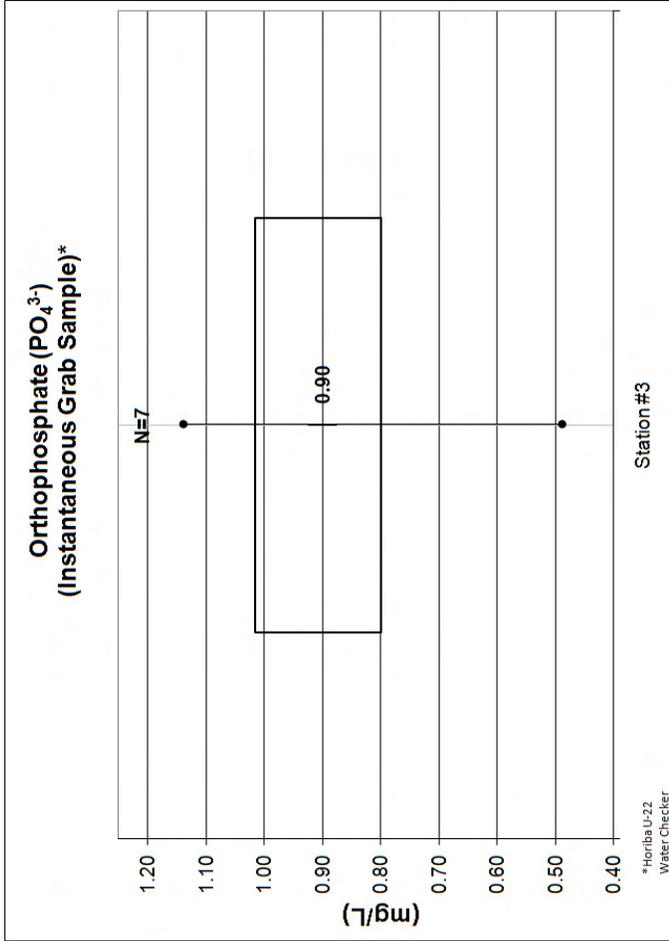
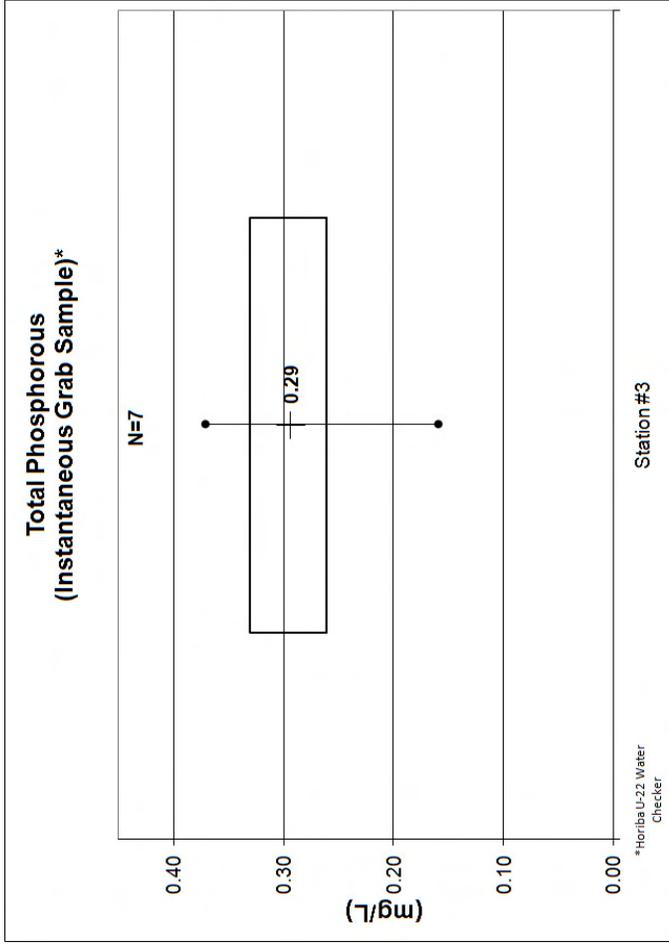
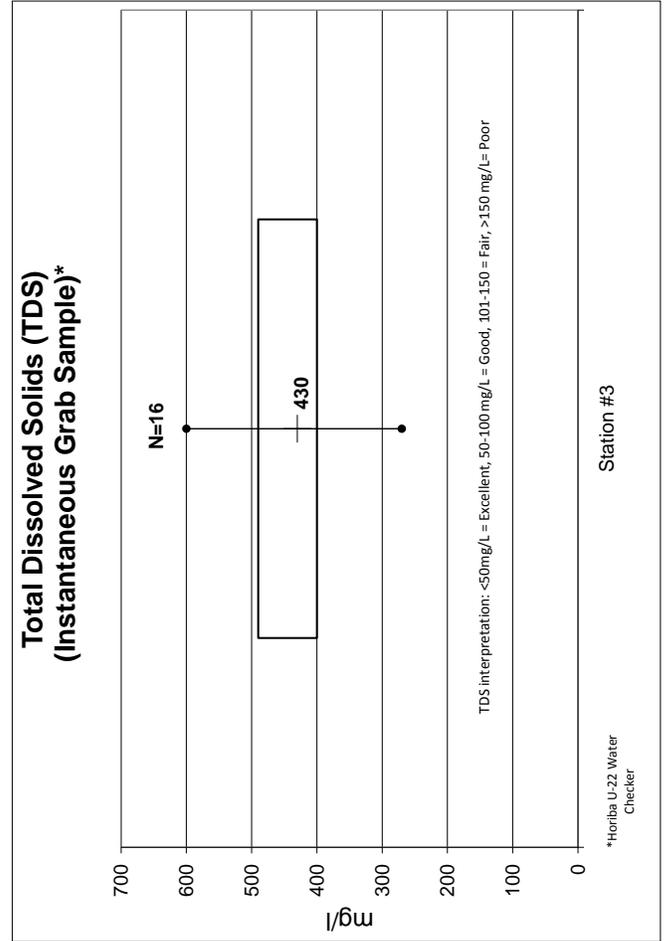
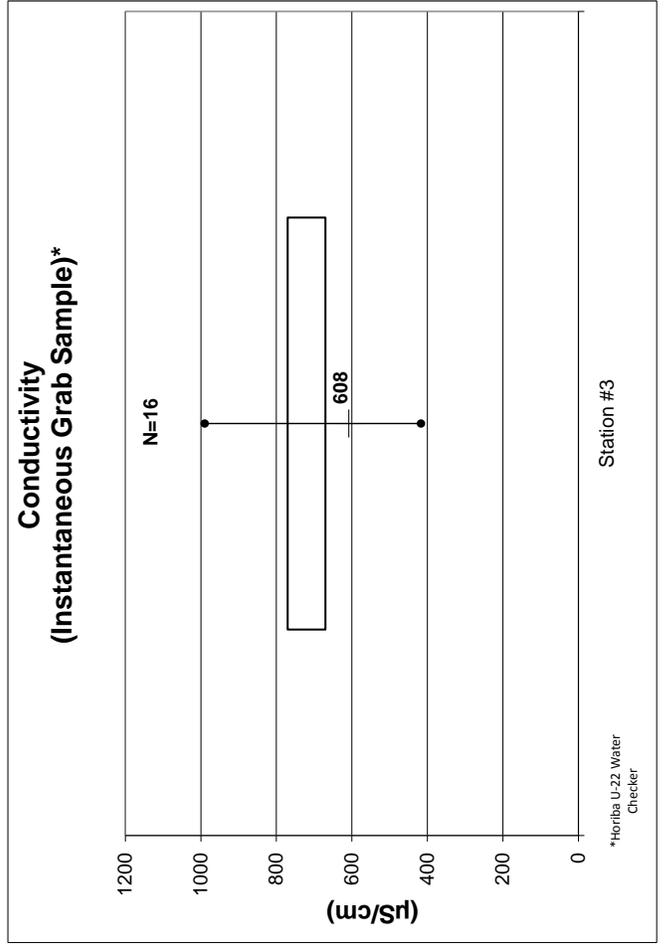
Figure 27. Upper Foundry Branch - Station 3 - Baseflow Orthophosphate, Total Phosphorus, Total Dissolved Solids, Conductivity

Conductivity, which provides an indirect measure of dissolved anions and cations present in water (e.g., carbonates, chlorides, sulfates, nitrates, sodium, potassium, calcium and magnesium), was very high. As seen in Figure 27, instantaneous baseflow conductivity ranged from 400 mS/cm to 1,000 mS/cm, with a median value of 608 mS/cm. Limited water quality surveys of relatively undisturbed Piedmont and Coastal Plain streams in Maryland and other mid-Atlantic states strongly suggest that Foundry Branch baseflow conductivity levels should be in the 60-160 mS/cm range (Thomas, 1966; Janicki et al., 1995; Galli et al., 1997, MCDEP, 1998; Stribling et al., 1999). The preceding findings further suggest a variety of anthropogenic-related activities and pollutant sources (such as sewage from sanitary sewer line exfiltration/leakage, municipal water leaks, fertilizer applications, road salting, etc).

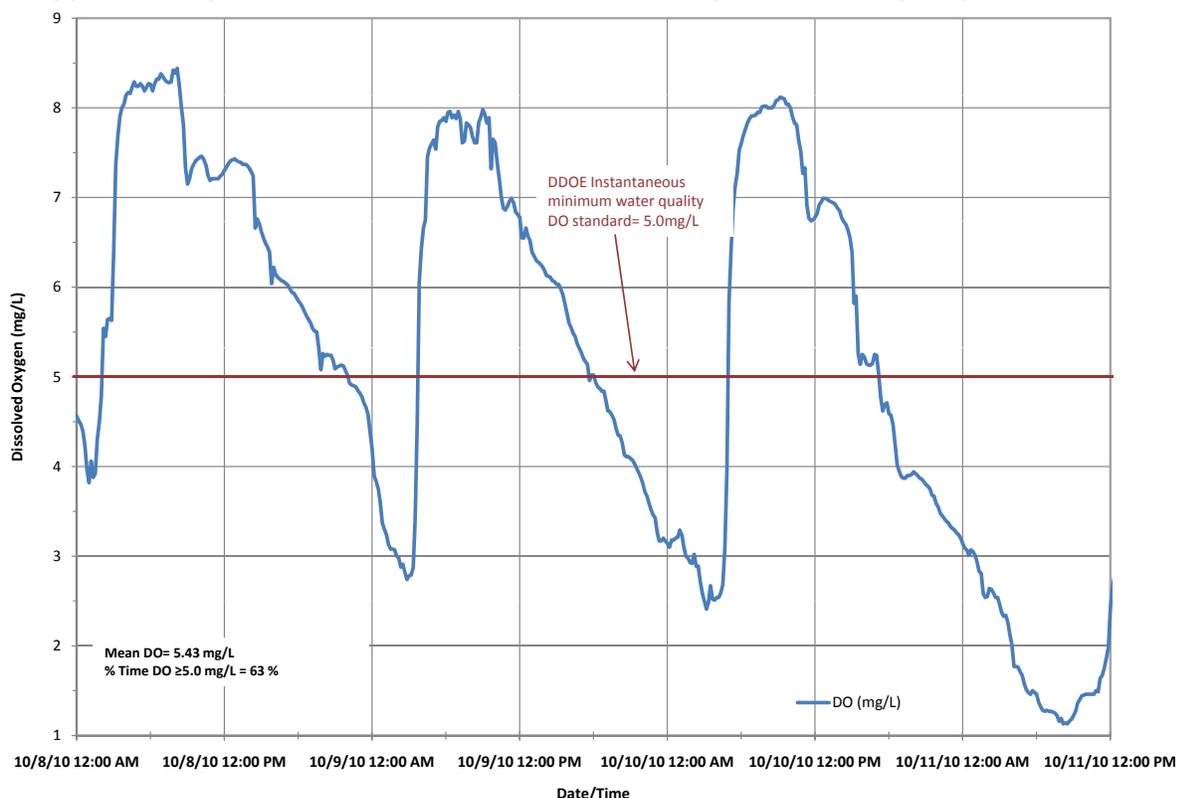
Figure 28. Upper Ffoundry Branch - Station 3 - Baseflow Three Day DO Diurnal Cycle (October 8 - 11, 2010)

Throughout the study, the lowest observed DO levels (i.e., 2.0 mg/L, or less) occurred intermittently at both probes at station Nos. 1 and 3 during baseflow conditions. As seen in Figure 28, these extremely low levels were generally recorded between late afternoon and 2 a.m., with highest DO readings observed in the early morning hours; exactly the opposite of the normally expected diurnal pattern. The maximum 2010

baseflow DO level was 12.47 mg/L (i.e., 110 percent saturation) most likely reflecting high photosynthetic activity in the stream during early leaf-off conditions.

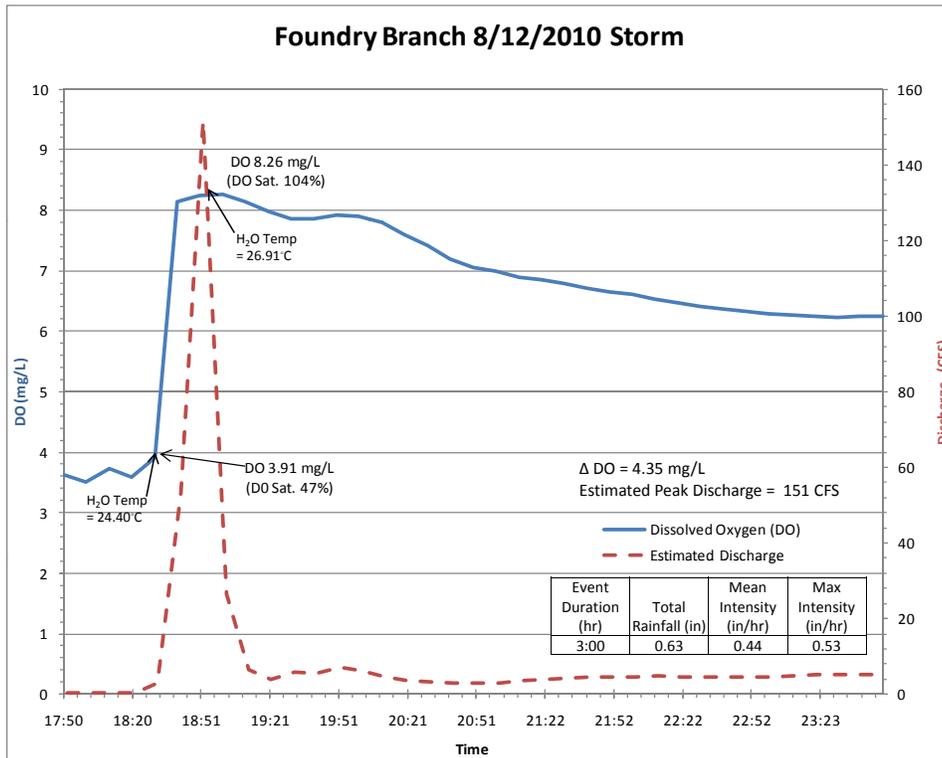
Figure 29. Upper Foundry Branch - Station 3 - DO and Discharge Conditions During The August 2010 Storm Event

Under stormflow (wet weather) conditions, Foundry Branch DO levels actually increased. As seen in Figures 29 and 30, the increased stream discharge (associated with the inflow of stormwater runoff) generally resulted in a temporary DO increase on the order of 3-4 mg/L (i.e., the Delta DO).

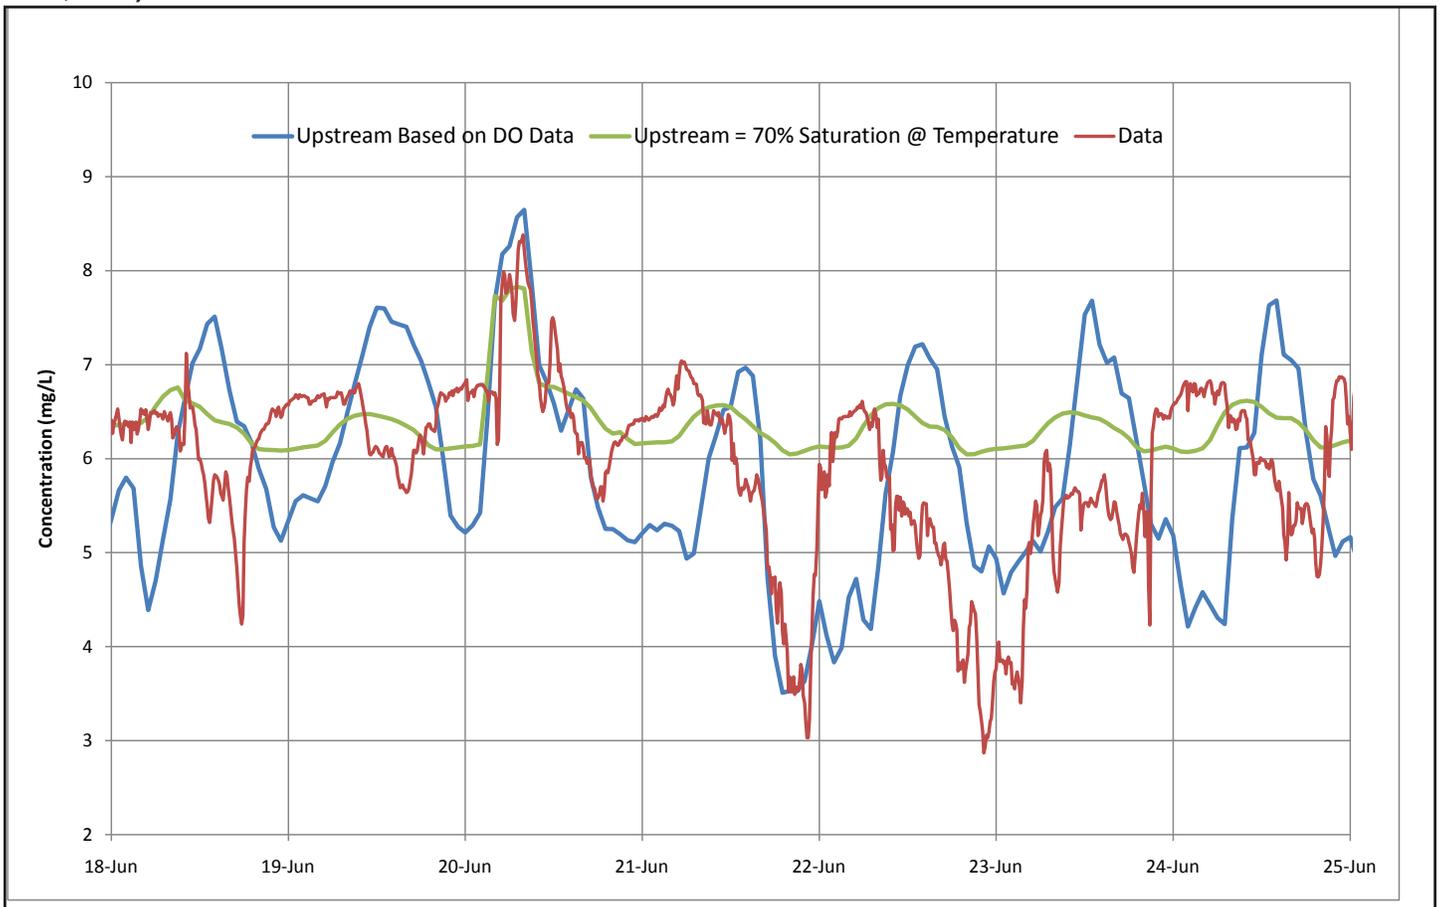
Figure 31. Upper Foundry Branch - DO Comparison at Sewer Crossing #4 (Wet Weather, June 2011 event) (Limno-Tech, 2011)

Per LimnoTech modeling results, Figure 31 shows a wet weather event that is, like the 2010 events, not especially sensitive to the upstream DO formulation. It is notable that the diurnal pattern in the data in Figure 31 “does not appear to represent conventional photosynthesis effects with respect to timing; that is, the highest DO levels in the data occur in the early morning with the lowest DO levels in the late afternoon, roughly the opposite of the expected pattern.”

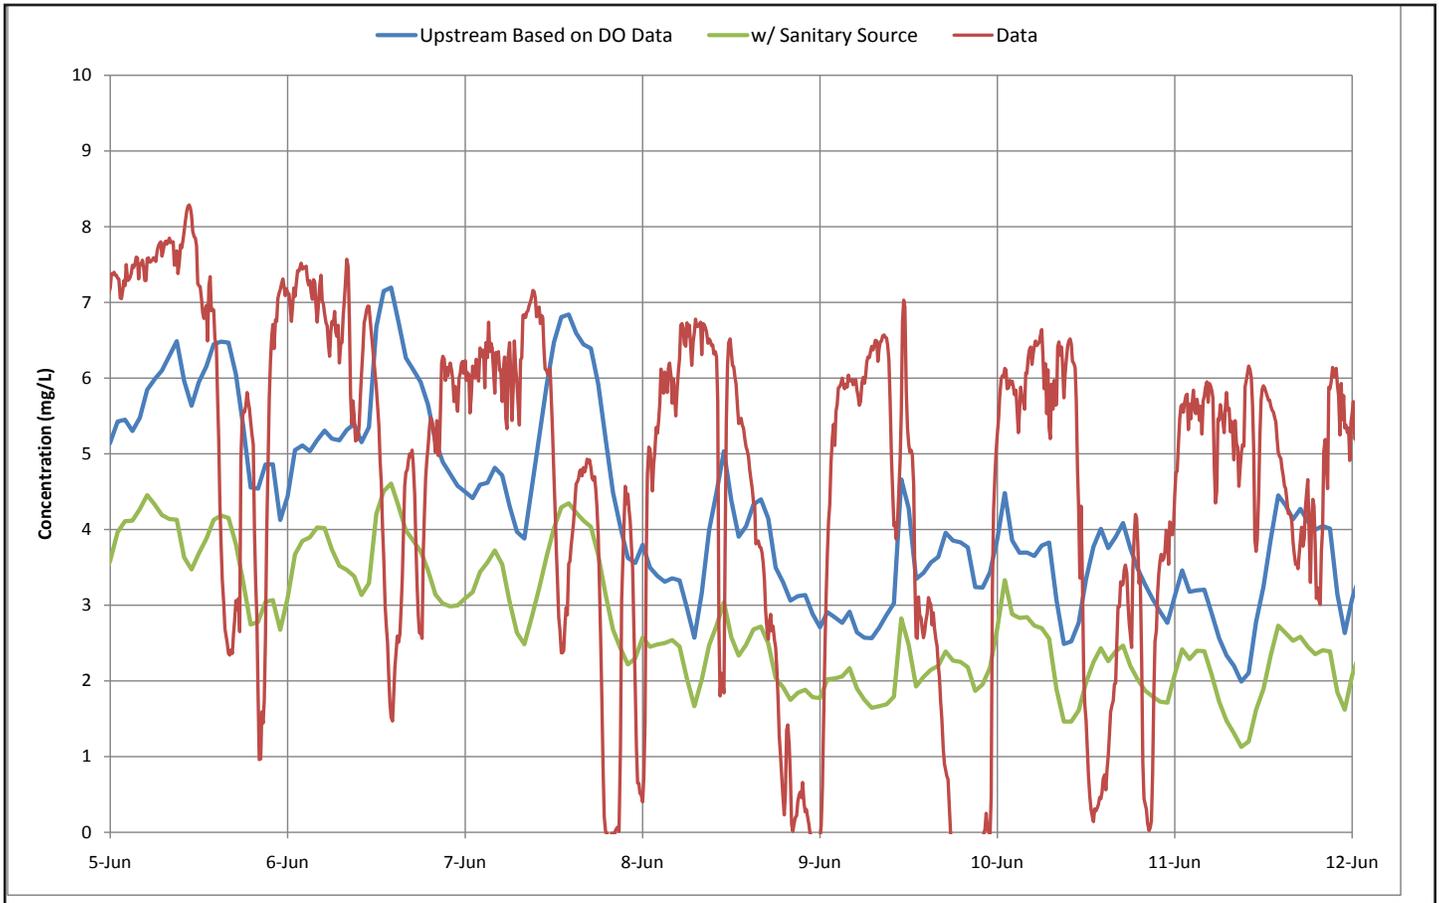
Figure 32. Upper Foundry Branch - Effect of Sanitary Source on DO at Sewer Crossing #4 (2011 Dry Weather) (LimnoTech, 2011)

Additional LimnoTech modeling results (Figure 32) show the effects of the inclusion of a hypothetical dry weather sanitary source. This simulation used the data-based upstream DO boundary condition, and results are shown with and without the sanitary source for comparison. “While the sanitary source does reduce DO levels, it does not drive it as low as observed in the data.”

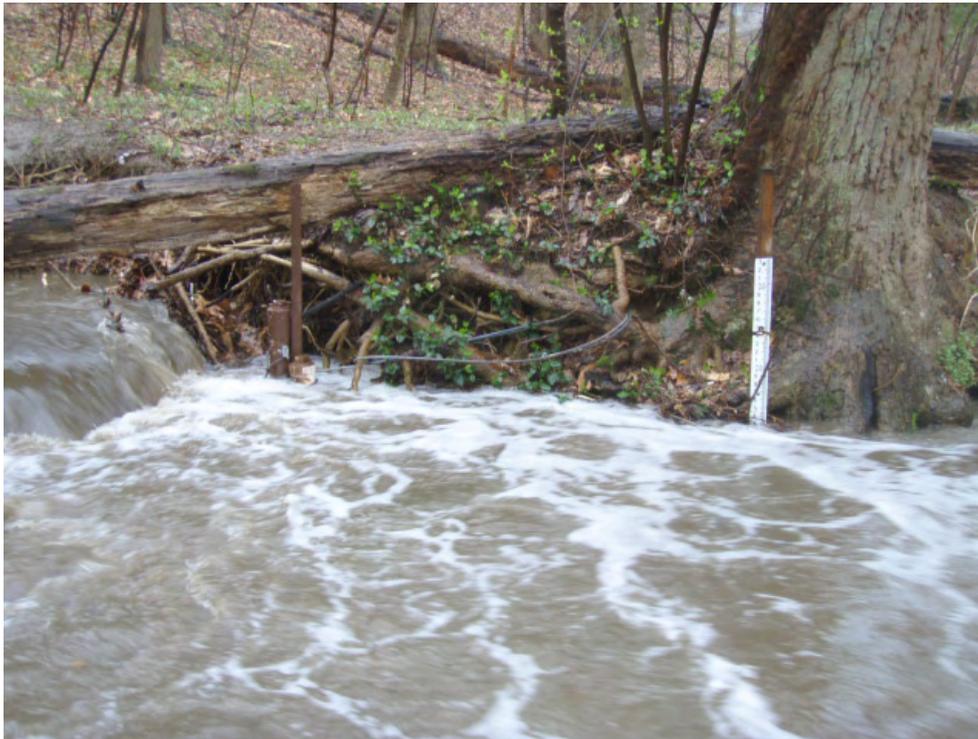
Figure 33. Upper Foundry Branch - Station 3 - Mechanical Reaeration During Stormflow

Due to Foundry Branch's small drainage area and the presence of high amounts of impervious surfaces (coupled with a lack of stormwater management controls and high number of storm drain outfalls), both stream flow and DO levels/water quality were highly responsive to even small rainfall events. Typical of small urban watersheds, the Foundry Branch stormflow hydrograph exhibited a short duration, sharp, spike-shaped peak with rapid rising and falling limbs. Dissolved oxygen levels also generally followed this pattern, rising in response to increased stream discharge and mechanical reaeration (i.e., turbulent flow conditions, created by the presence of several perched sewer line crossings and storm drain outfalls, with corresponding high atmospheric mixing and entrainment, Figure 33). Stormflow maximum water temperatures for the May - August 2010 and May-June 2011 periods were in the 22.1 – 28.6 range with associated DO levels that were generally in the 8.85 – 9.64 mg/L range. These DO levels reflect slightly supersaturated conditions.
