**Palisades Recreation Center**

**Project Area Assessment Report, July 2019**

DPR II – Design and Build 4 LID Sites

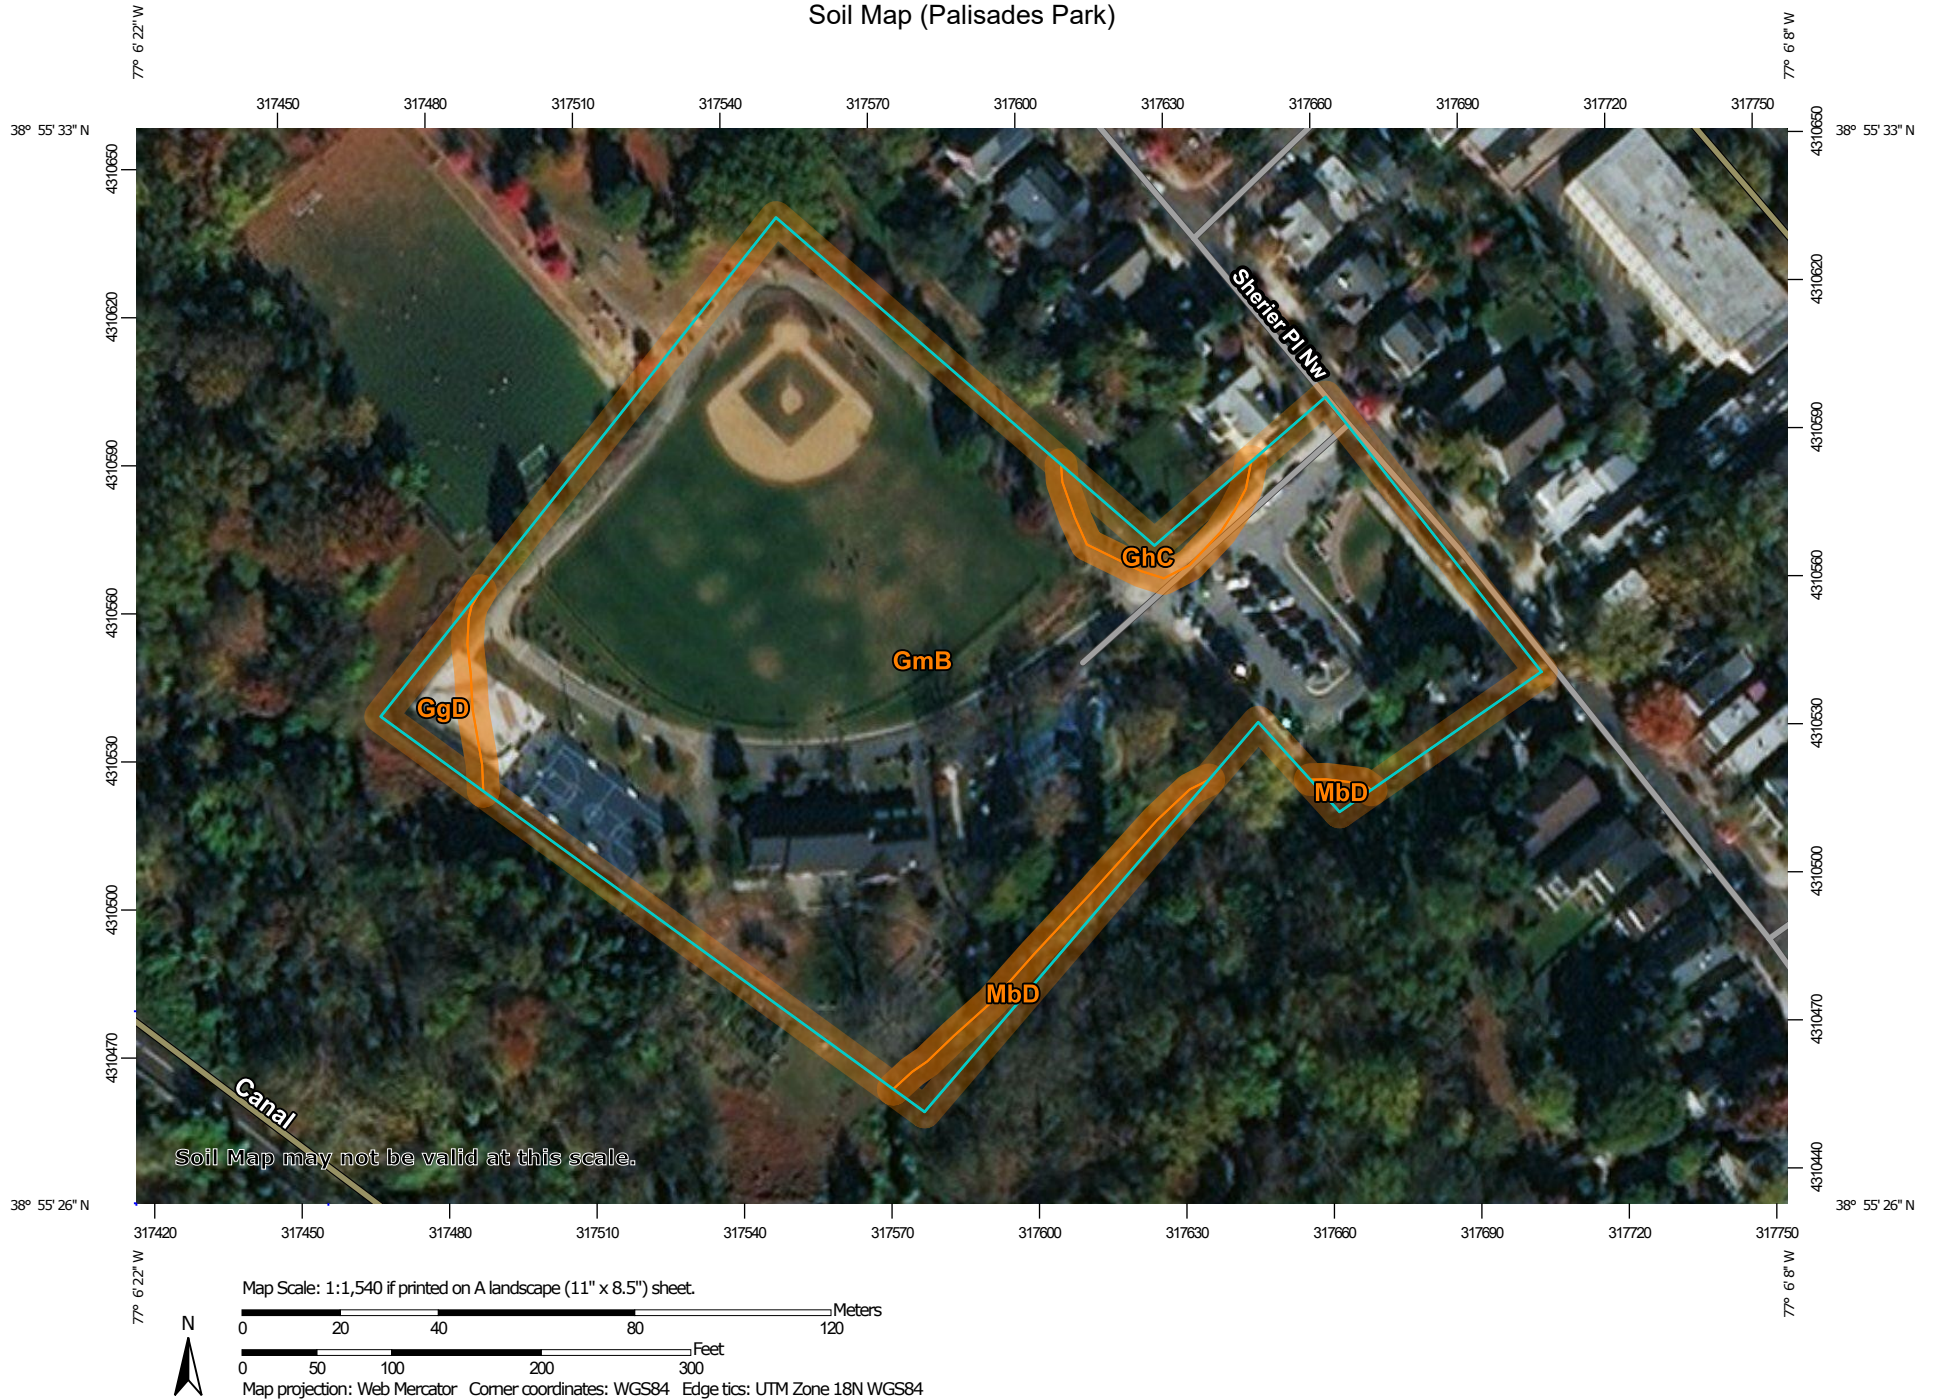
# Custom Soil Resource Report Soil Map (Palisades Park)

Based upon the USDA Websoil Survey (included as part of the geotechnical evaluation report

(Appendix B), soils across the site consist of an urban land variant of the Glenelg series soil. Where

undisturbed, the original base soil is a well-drained loam with good infiltration characteristics.
